Appendix IR2020-1.1-A11

T2 Habitat Offsetting Engineering Support – Updated Hydrodynamic Model of Roberts Bank

Subject: T2 Habitat Offsetting Engineering Support - Updated Hydrodynamic Model of Roberts Bank

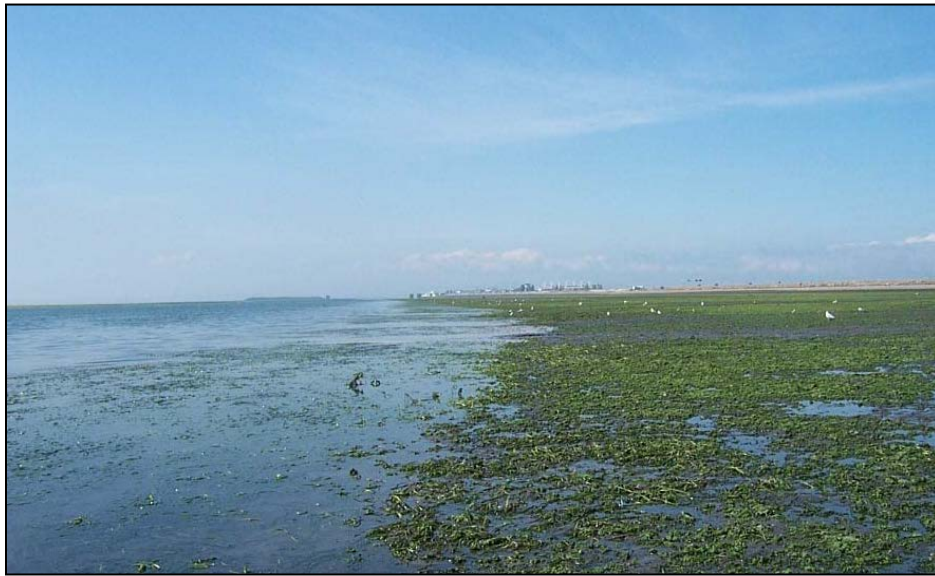
**FIGURE 2-2: NEARBY EXISTING EELGRASS BEDS AT NORTH EAST END OF TSAWWASSEN CAUSEWAY
LOOKING SOUTH WEST**

A photo at low tide of the successful 2008 eelgrass development located adjacent to the Project site is shown in Figure 2-2.

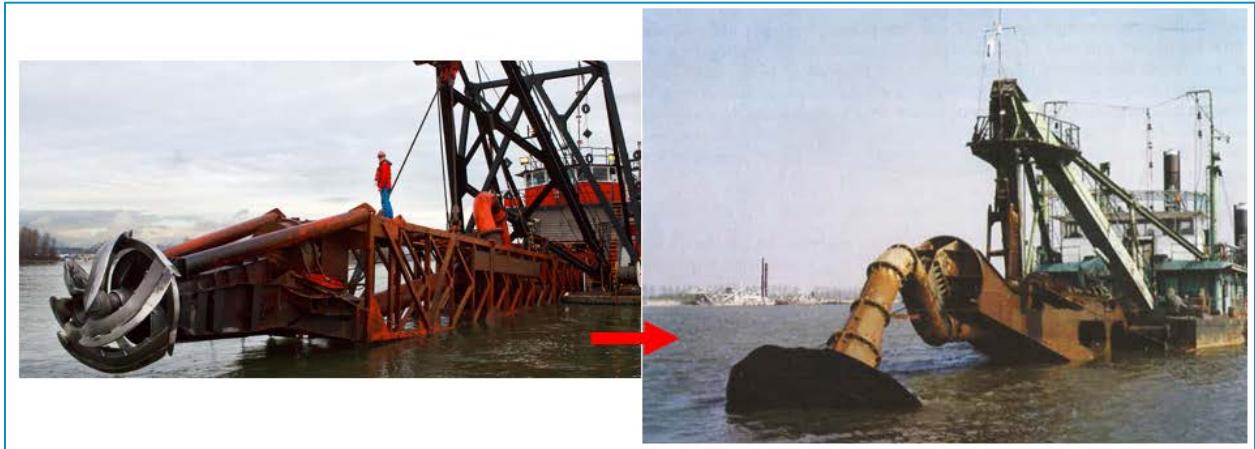
FIGURE 4-1: FRPD COLUMBIA CUTTER SUCTION DREDGE (LEFT) AND PROPOSED DIFFUSER MODIFICATION (SOURCE: FRPD)

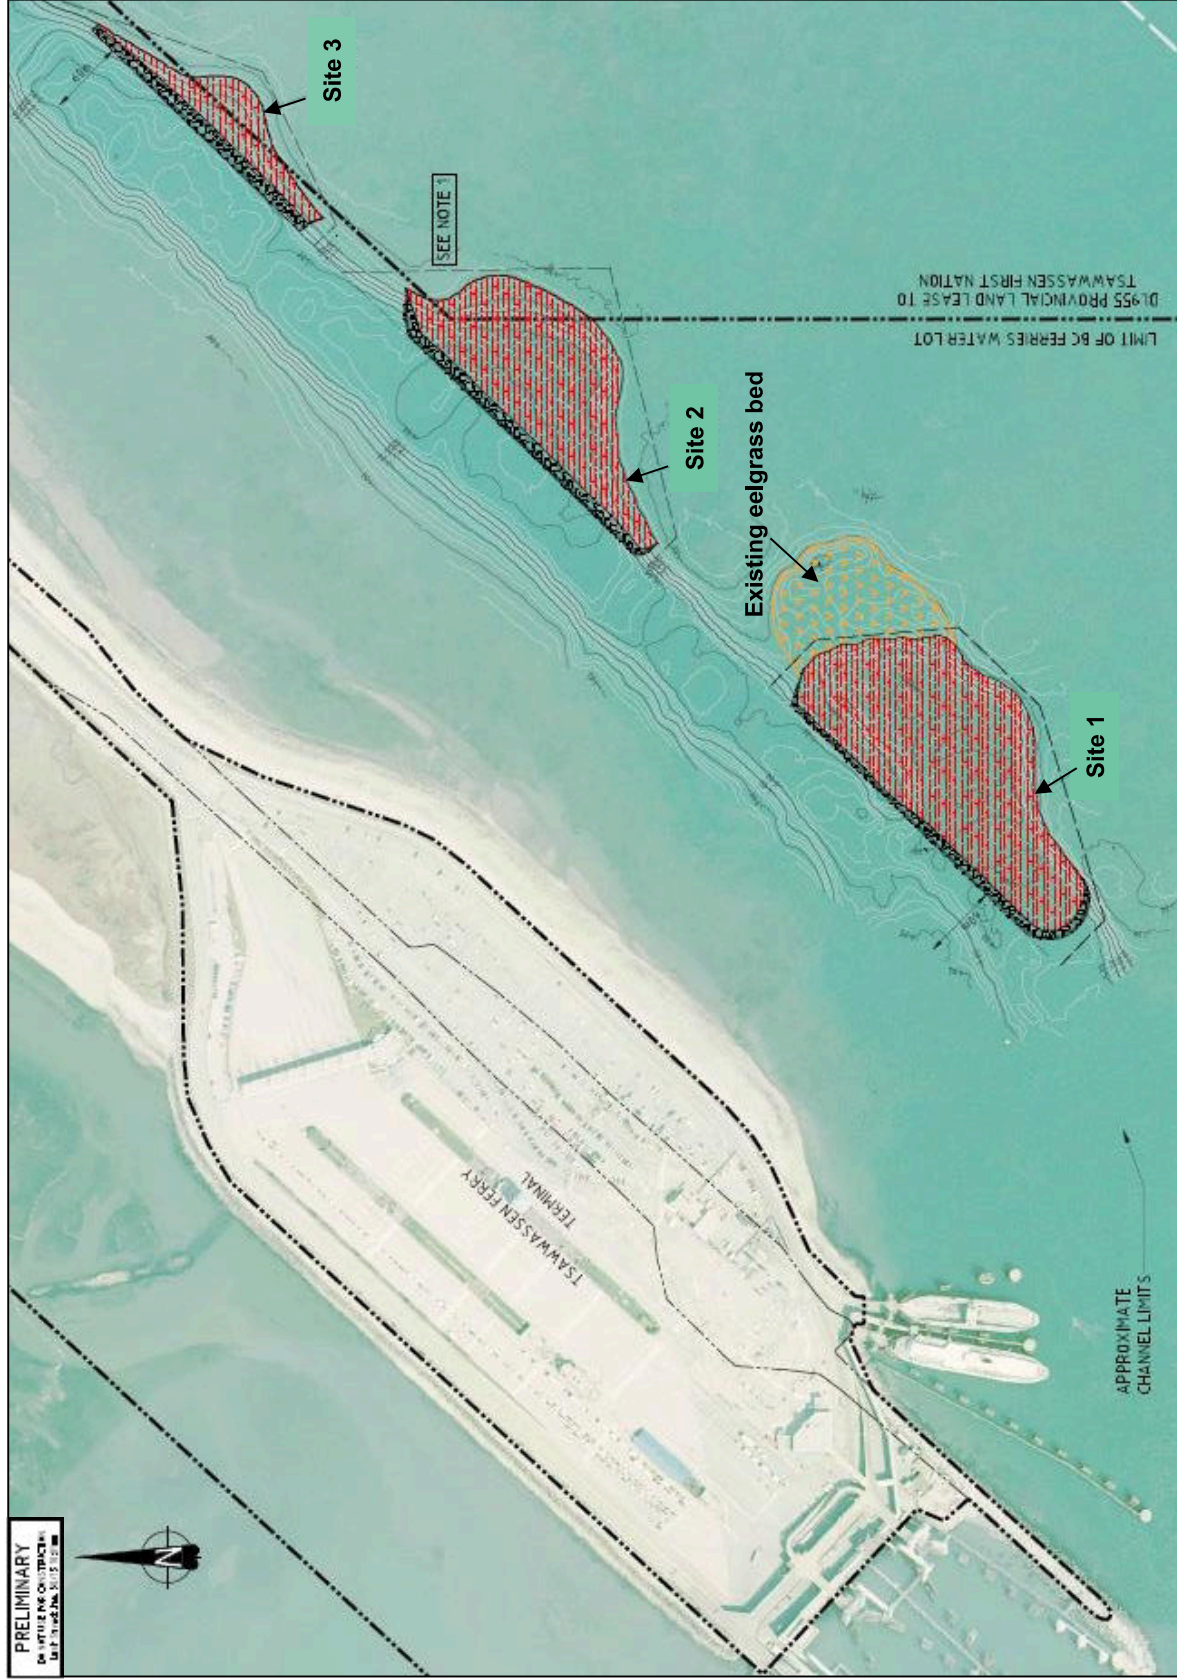
Figure 4 Proposed Tsawwassen Eelgrass Project sites (Moffatt & Nichol 2015)

The proposed Project will raise the seabed elevation at three subtidal depressions (approximately -4.0 m to -6.0 m CD) formed by historic dredging activities, to elevations suitable for the establishment and persistence of native eelgrass (*Zostera marina*; approximately -2.25 m CD to -1.0 m CD). Perimeter berms will be created along the western edge (adjacent to the deep channel) of each proposed site to reduce erosion along the outer edges of the eelgrass beds and to contain fill added to the depressions. The eastern edges of the proposed eelgrass enhancement sites will be blended (e.g. elevations will match) with the adjacent eelgrass beds, with reasonably even and uniform substrate surfaces. After a substrate settlement period, the raised seabed will be transplanted using plants from a nearby suitable donor site.

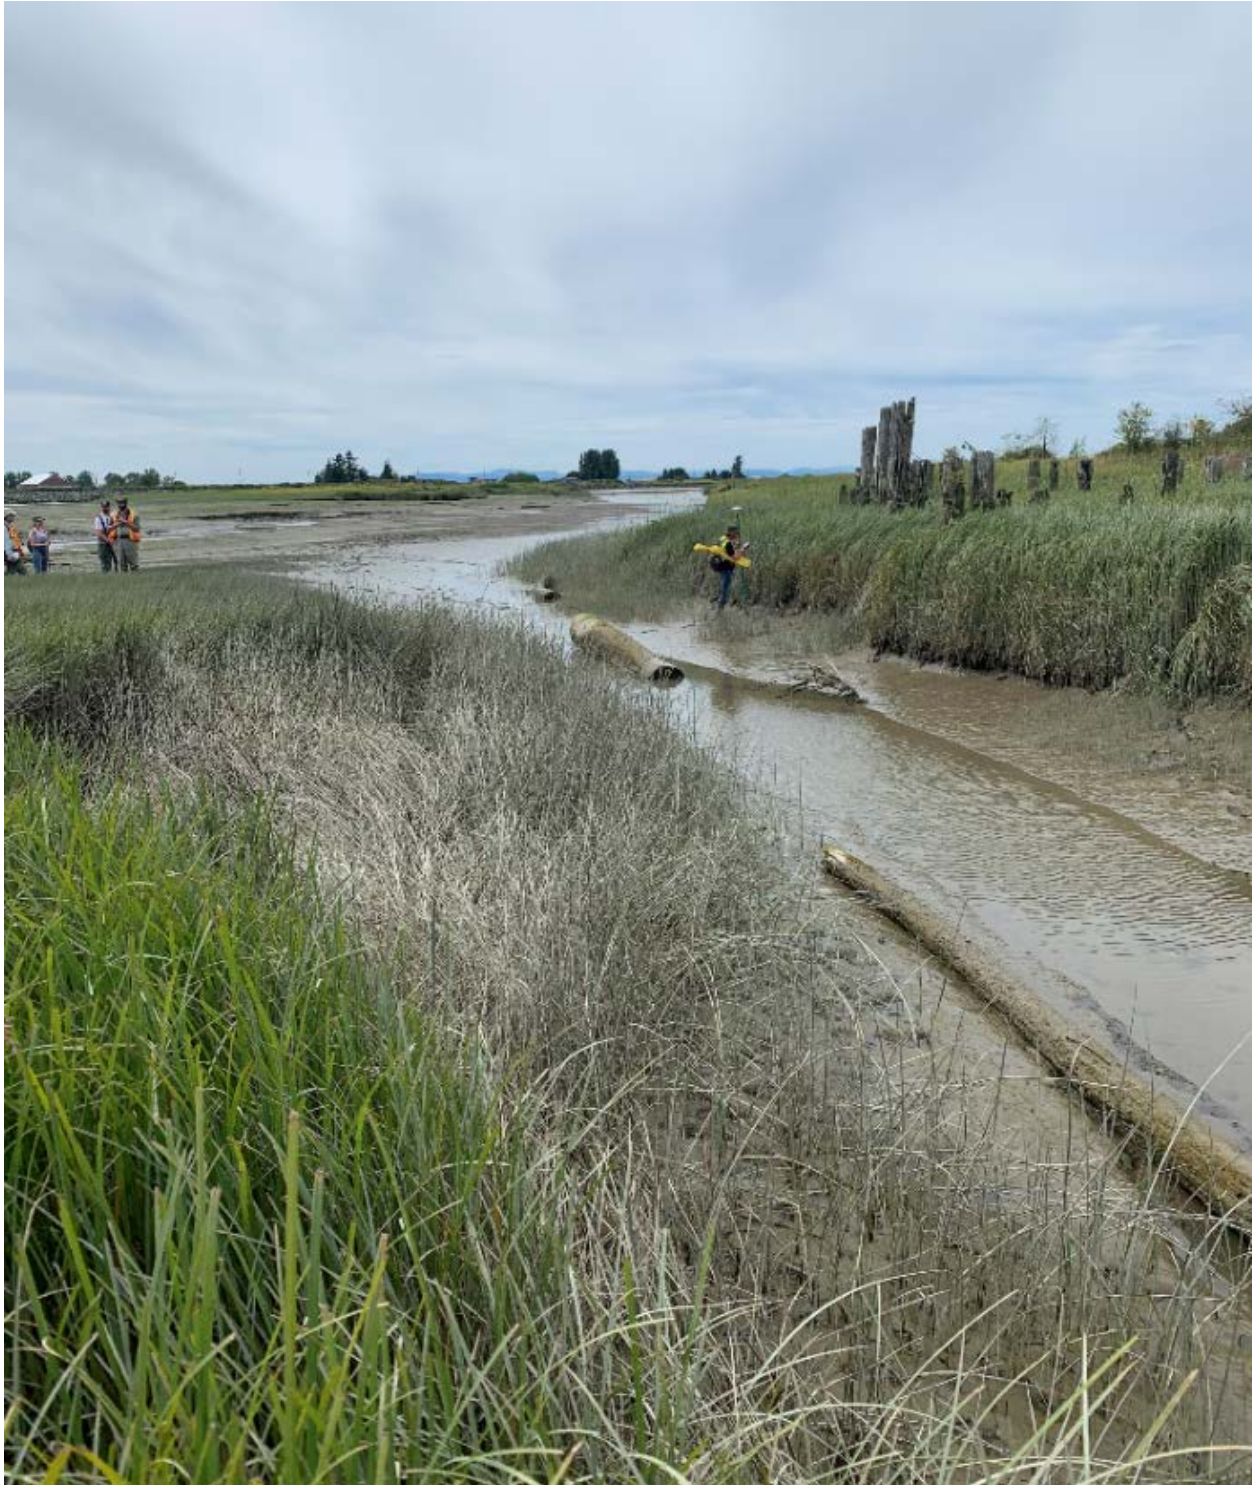
FIGURE 2-7: EXISTING DRAINAGE CHANNELS AT THE WESTHAM SITE.

Some photographic snapshots captured during low water on August 19, 2020 are shown in Figure 2-7 through Figure 2-10. They indicate present morphological features and conditions of the Westham site, which are summarized in Table 2-2.

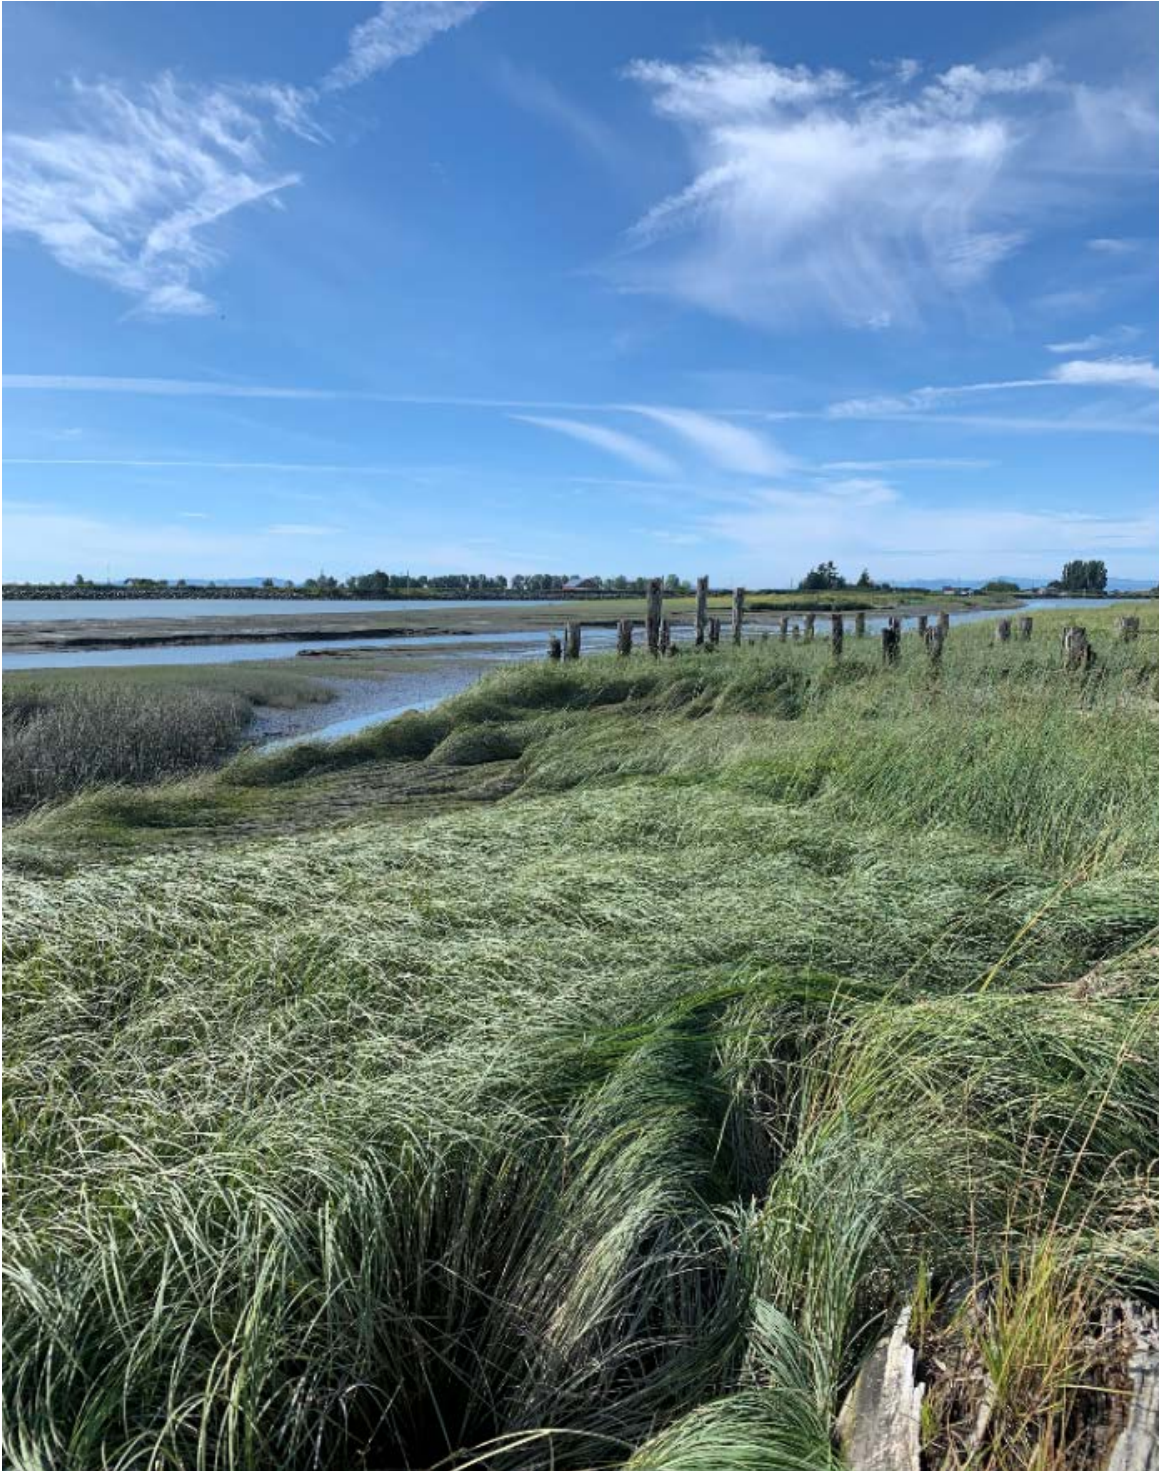
FIGURE 2-8: WESTHAM SITE LOOKING SOUTH FROM FORESHORE

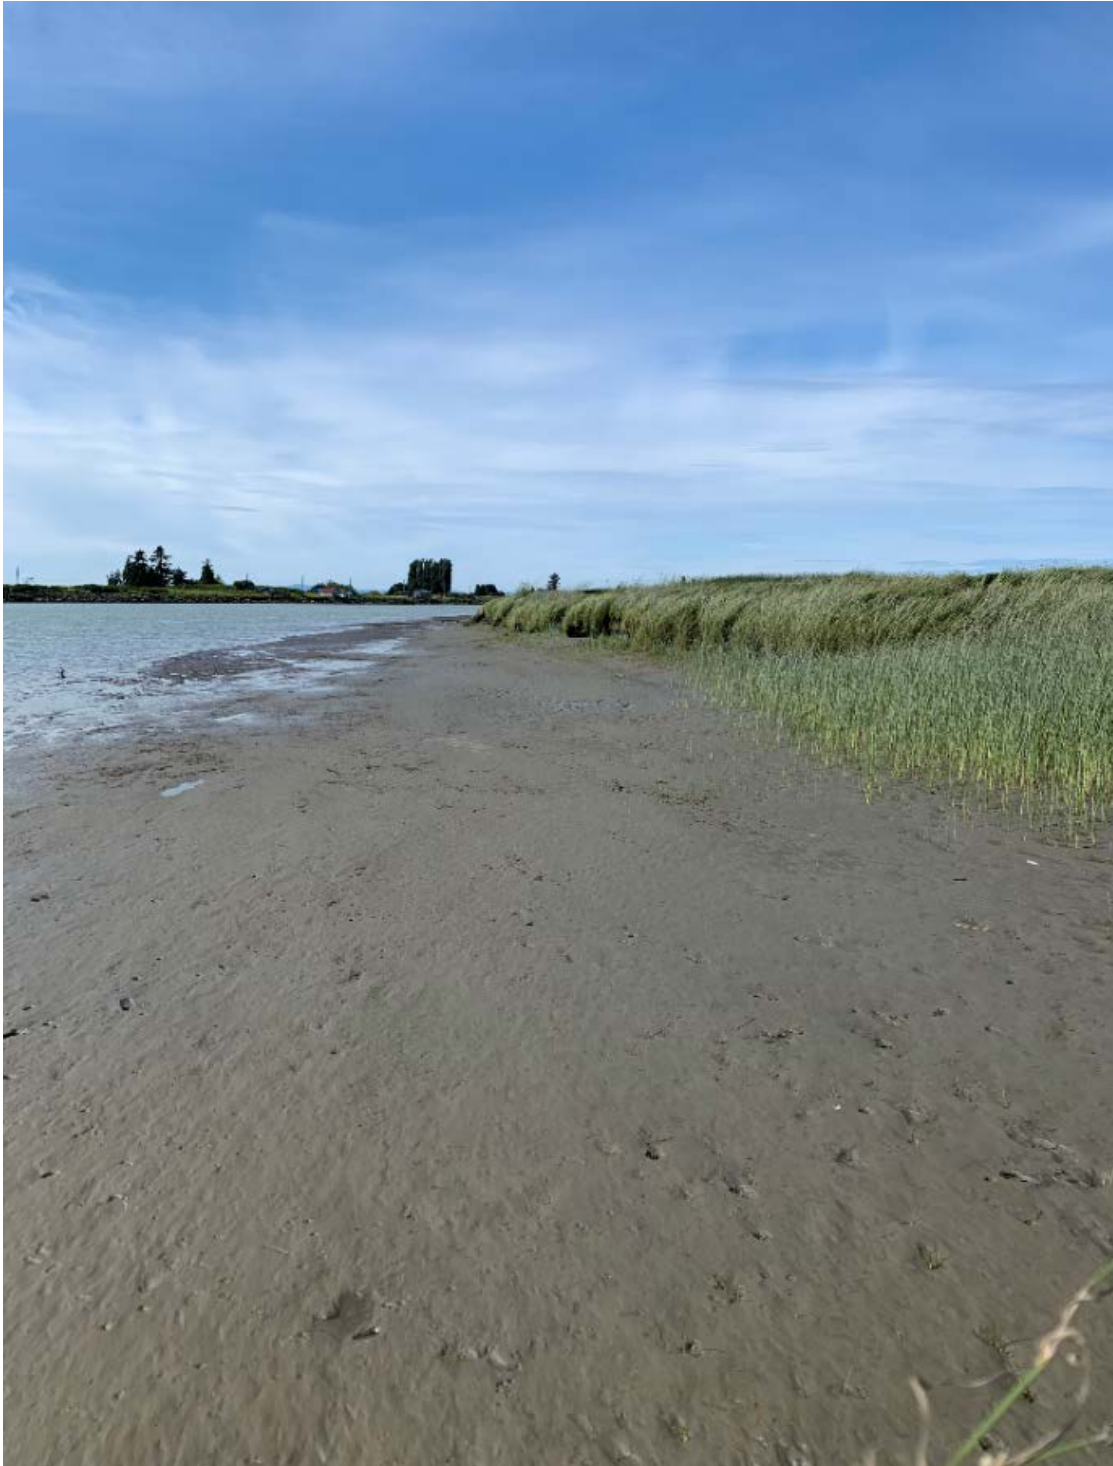
FIGURE 2-9: SEAWARD EDGE OF EXISTING TIDAL MARSH AT WESTHAM SITE

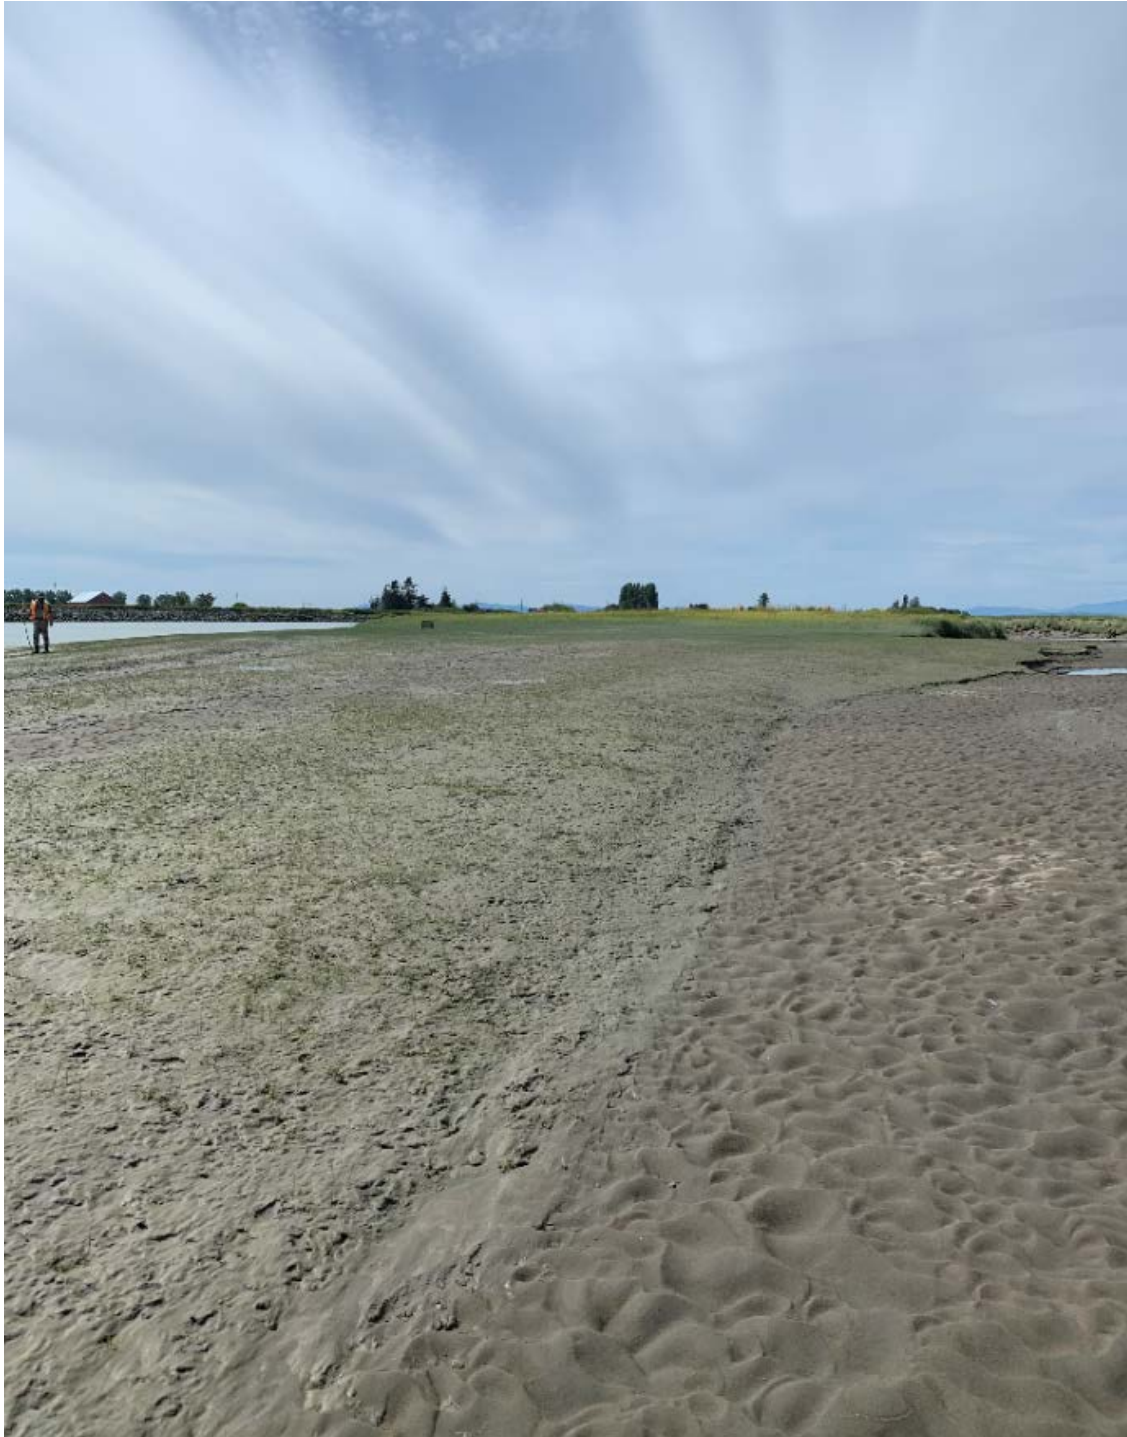
FIGURE 2-10: NEW MARSH GROWTH ON MARSH ISLAND – LOOKING WEST
