Geotechnical Investigation: Data Report –  
Beaver Dam Mine, January 15, 2021as  
Completed for the Updated 2021 Beaver Dam Mine EIS

# Geotechnical Investigation: Data Report

## *Beaver Dam Mine*

20142100-004-R-Rev0

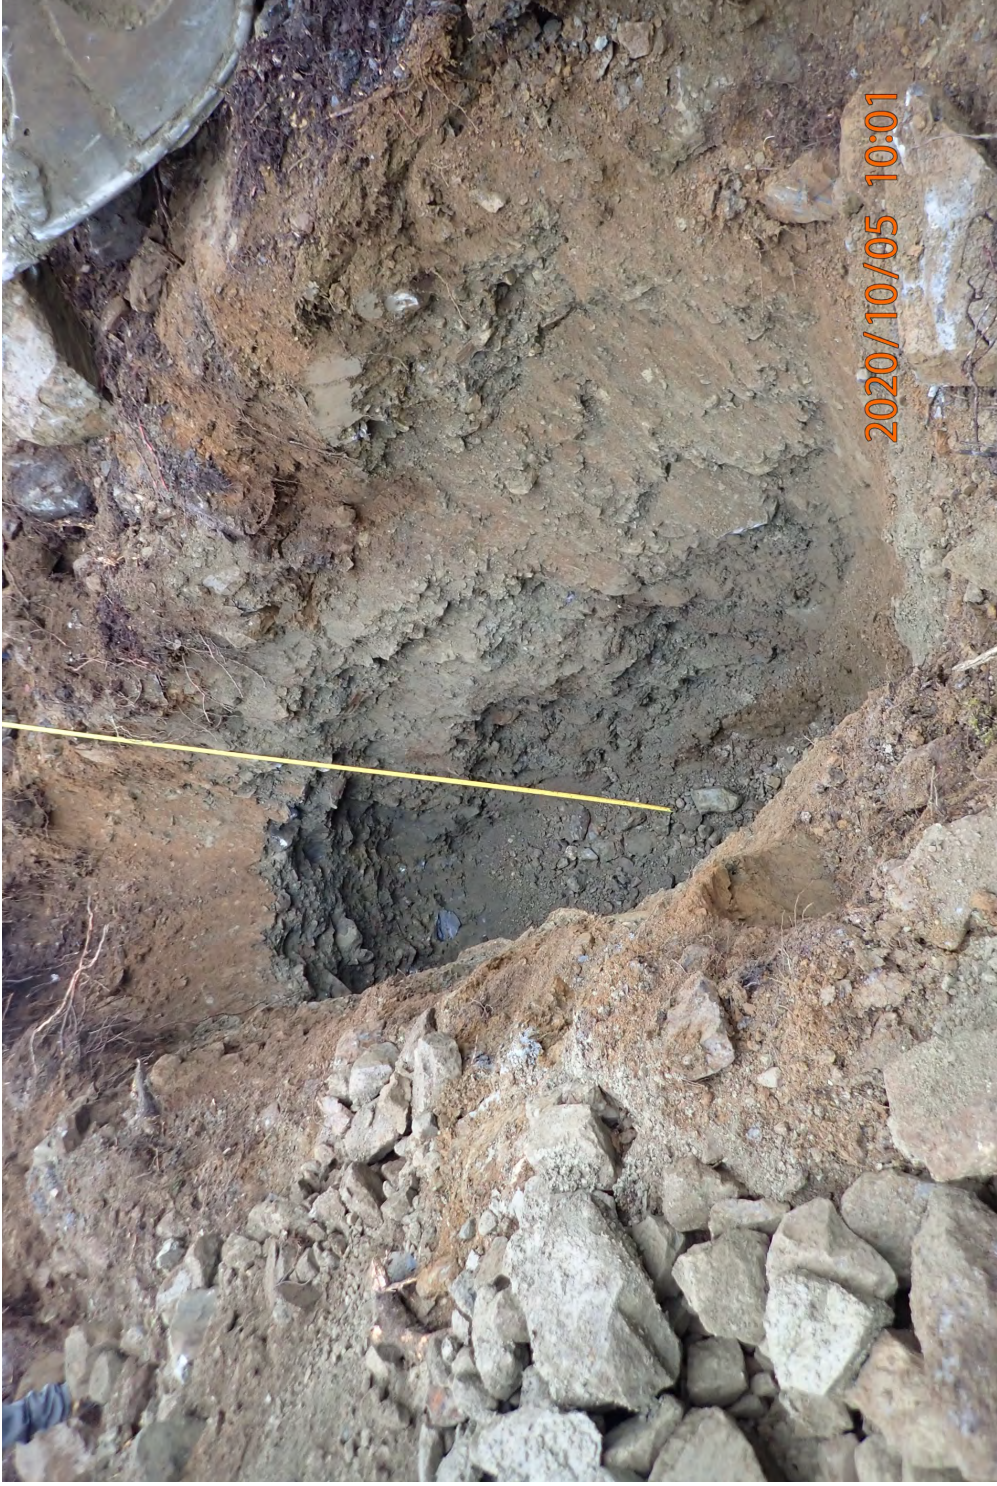
TITLE  
**Completed Test Pit**  
**RWY-TP20-01** Depth: 3.60m  
PROJECT NO.  
20142100  
CONTROL NO.  
007  
REV. 0  
FIGURE NO.  
D1

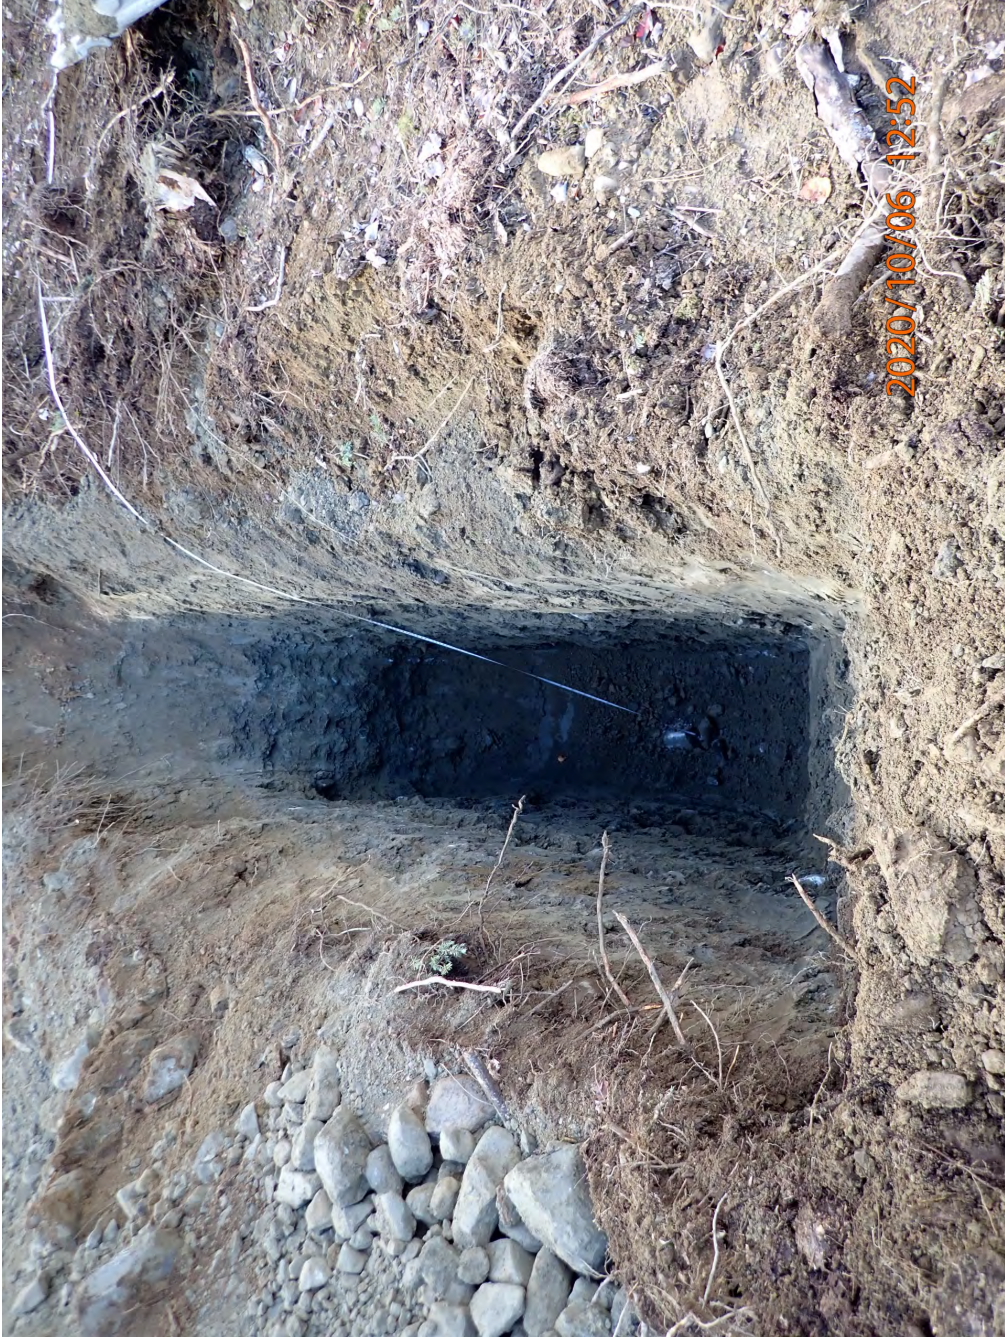
FIGURE NO.  
D14

Completed Test Pit GHD-TP06  
Depth: 4.50m

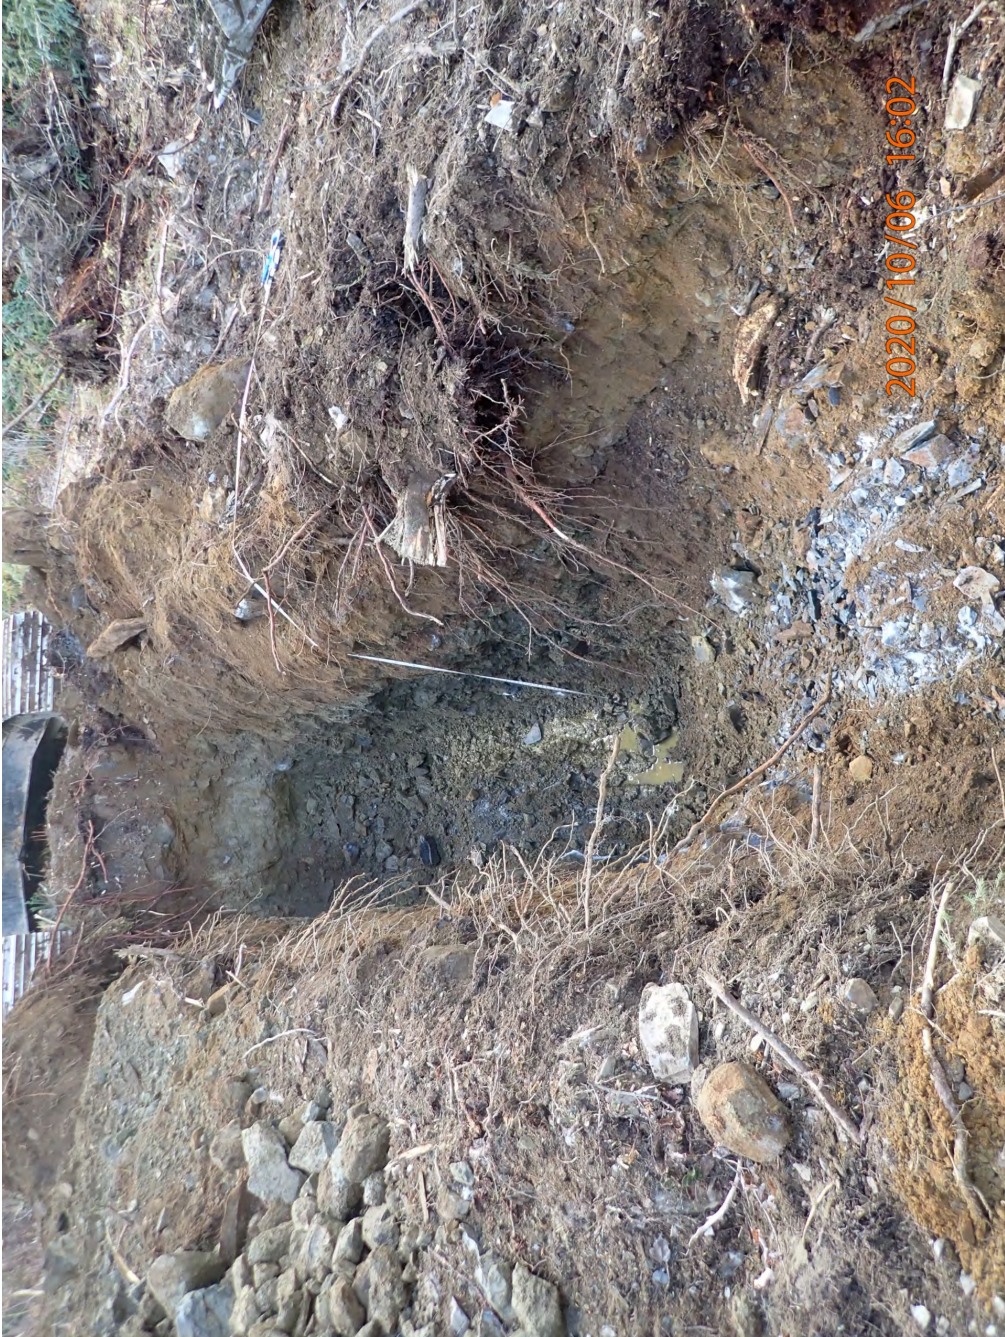
TITLE  
Completed Test Pit RWY-TP20-03  
Depth: 2.40m  
PROJECT NO.  
20142100  
CONTRACT NO.  
007  
REV.  
0  
PLATE NO.  
D16

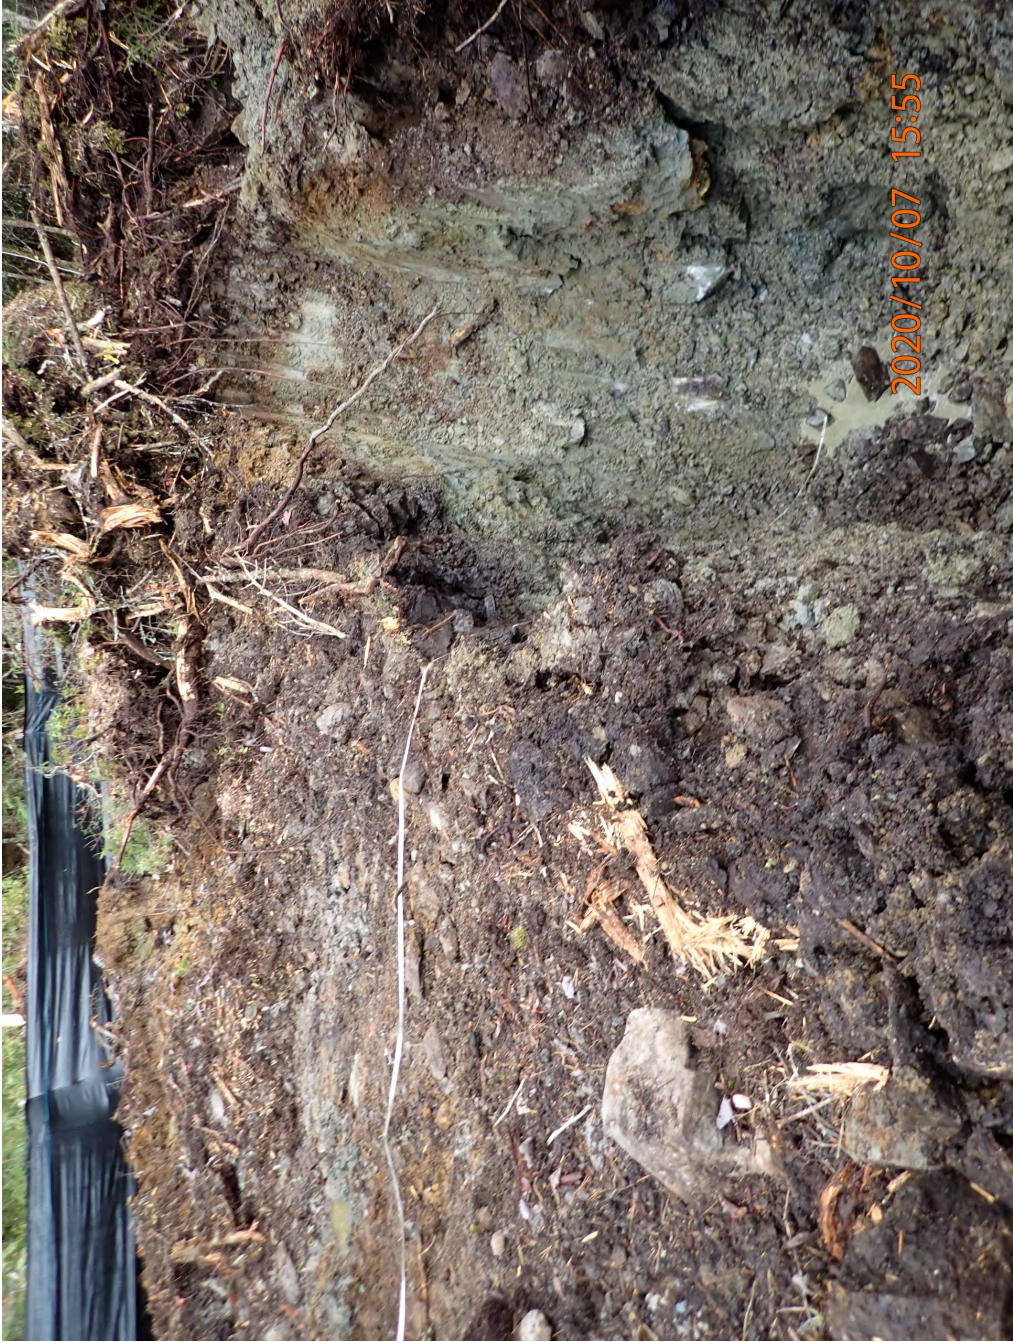
PLATE NO.  
D23

TITLE  
**Completed Test Pit TP2020-03**  
Depth: 2.80m

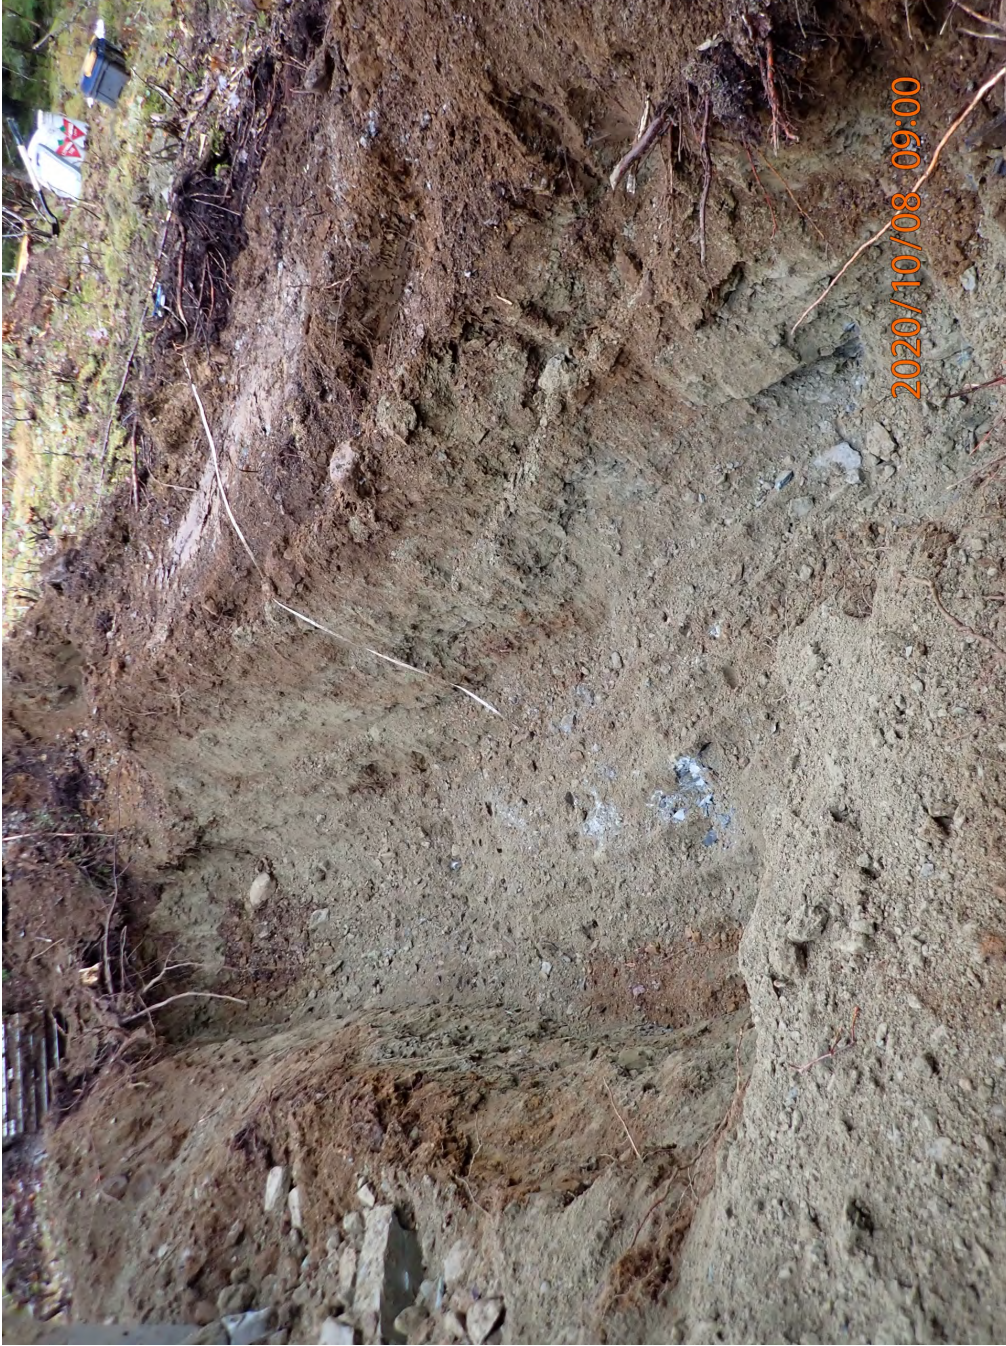
PROJECT NO. 20142100  
DRAWING NO. 007  
REV. 0  
PLATE NO. D25

TITLE  
**Completed Test Pit TP2020-04**  
**Depth: 1.80m**

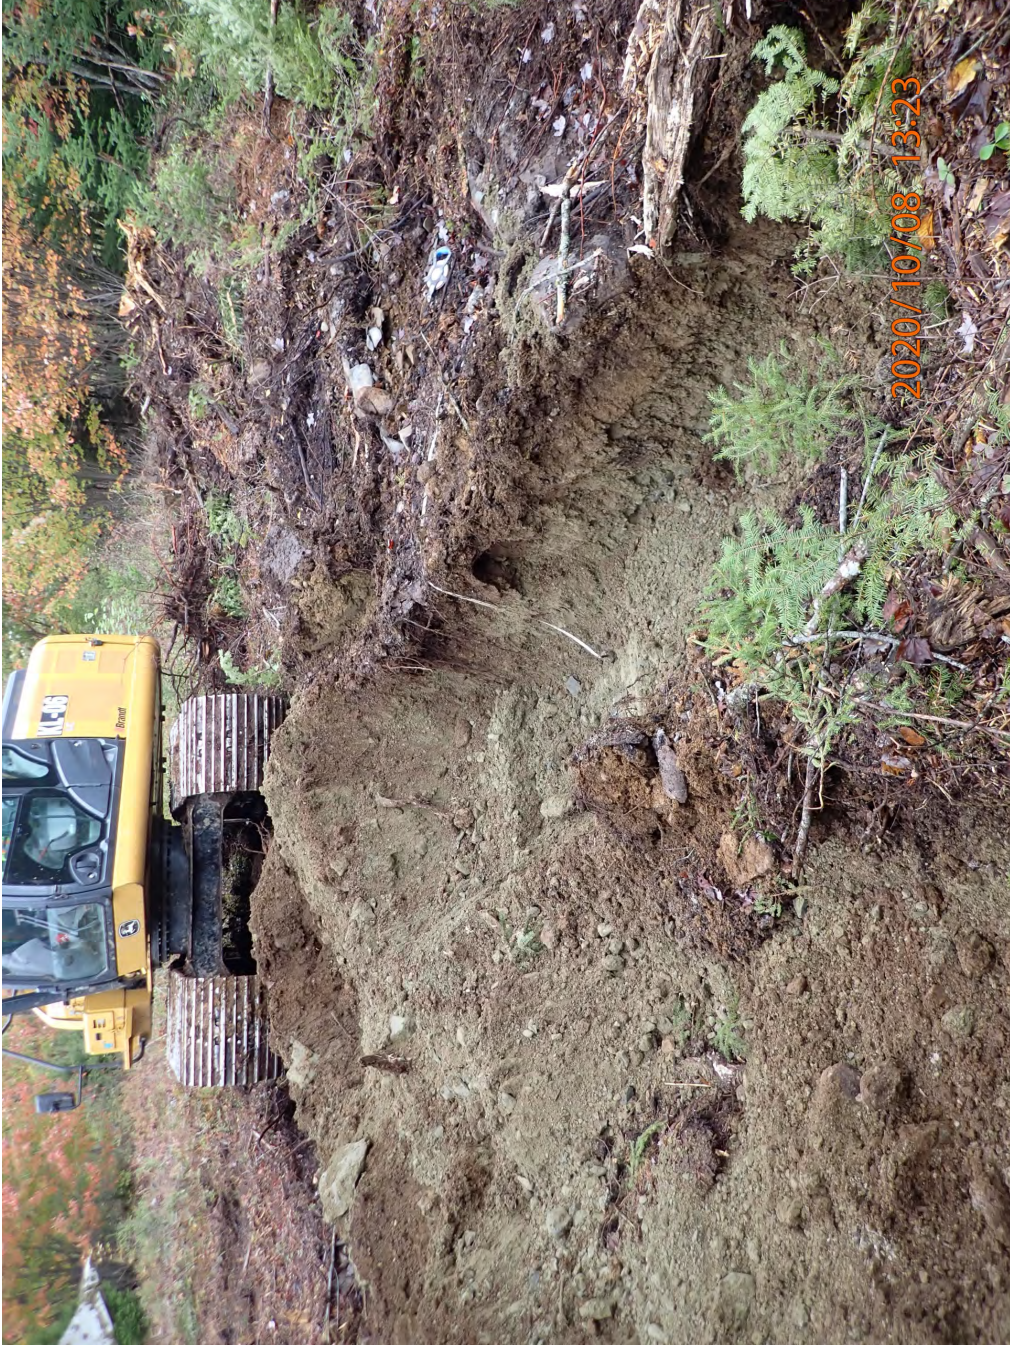
PLANS NO.  
D28

TITLE  
**Completed Test Pit OMS-TP20-03**  
Depth: 1.00m

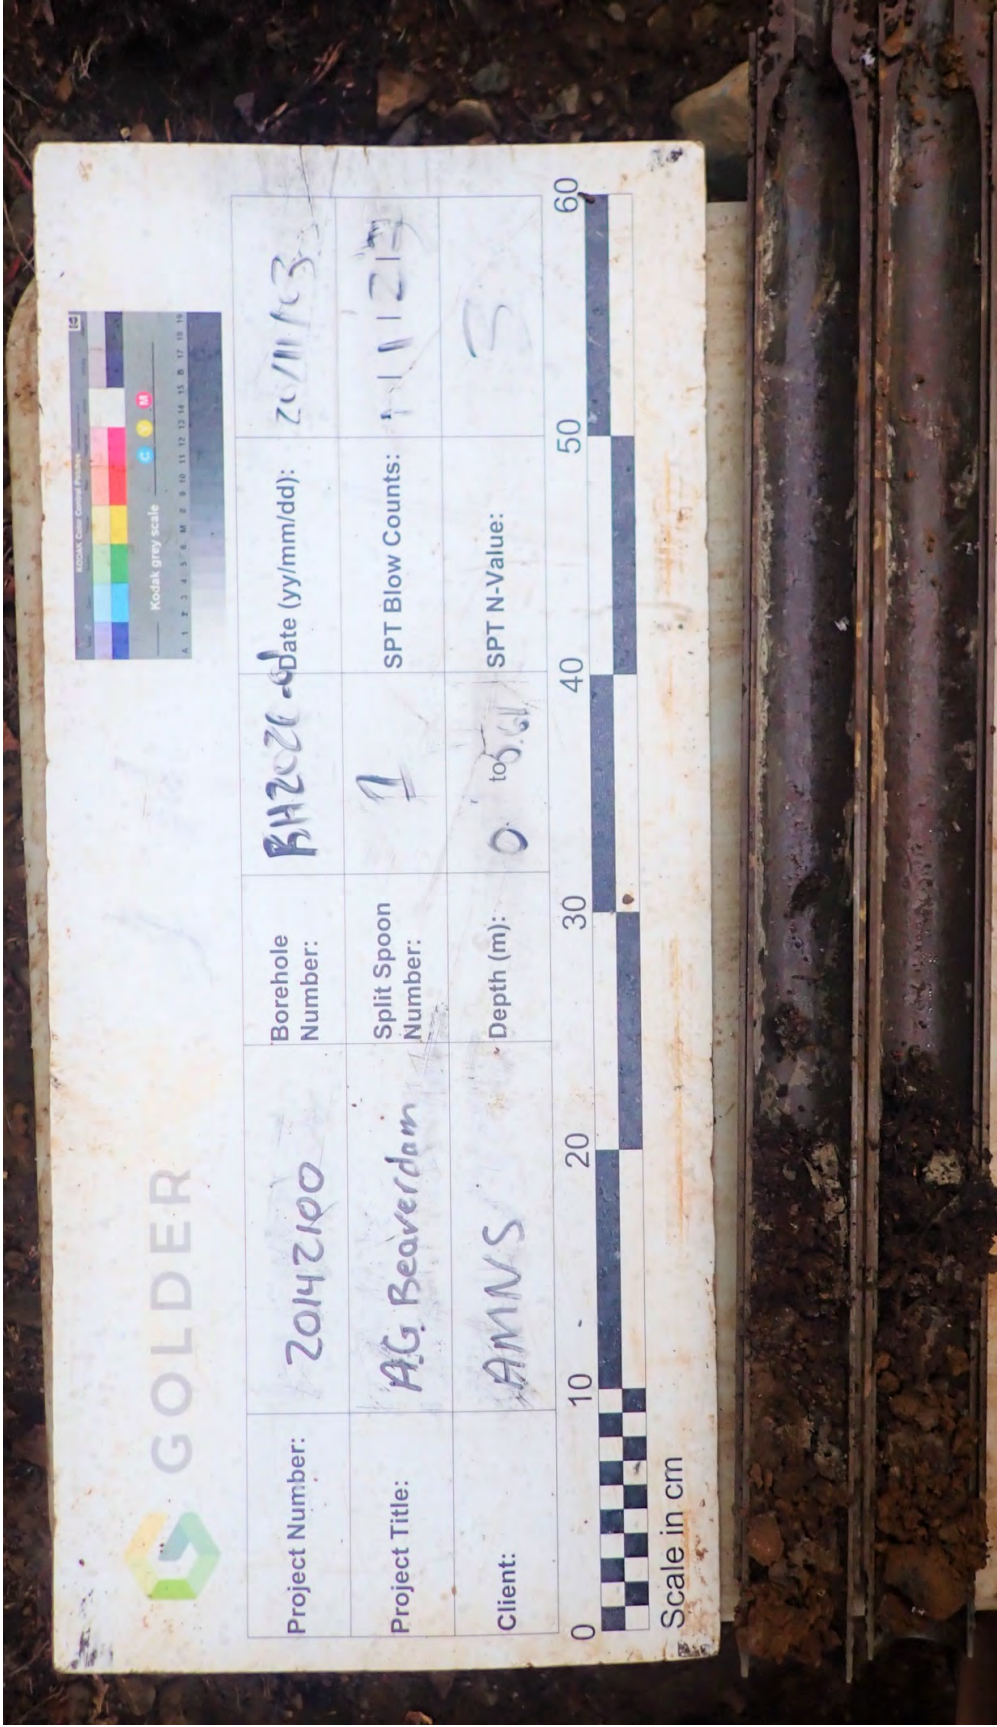
Project Number:	20142100	Borehole Number:	BH2020-01	Date (yy/mm/dd):	20/11/16
Project Title:	AG, Beaverdam	Split Spoon Number:	1	SPT Blow Counts:	111213
Client:	AMNS	Depth (m):	0 to 0.61	SPT N-Value:	3

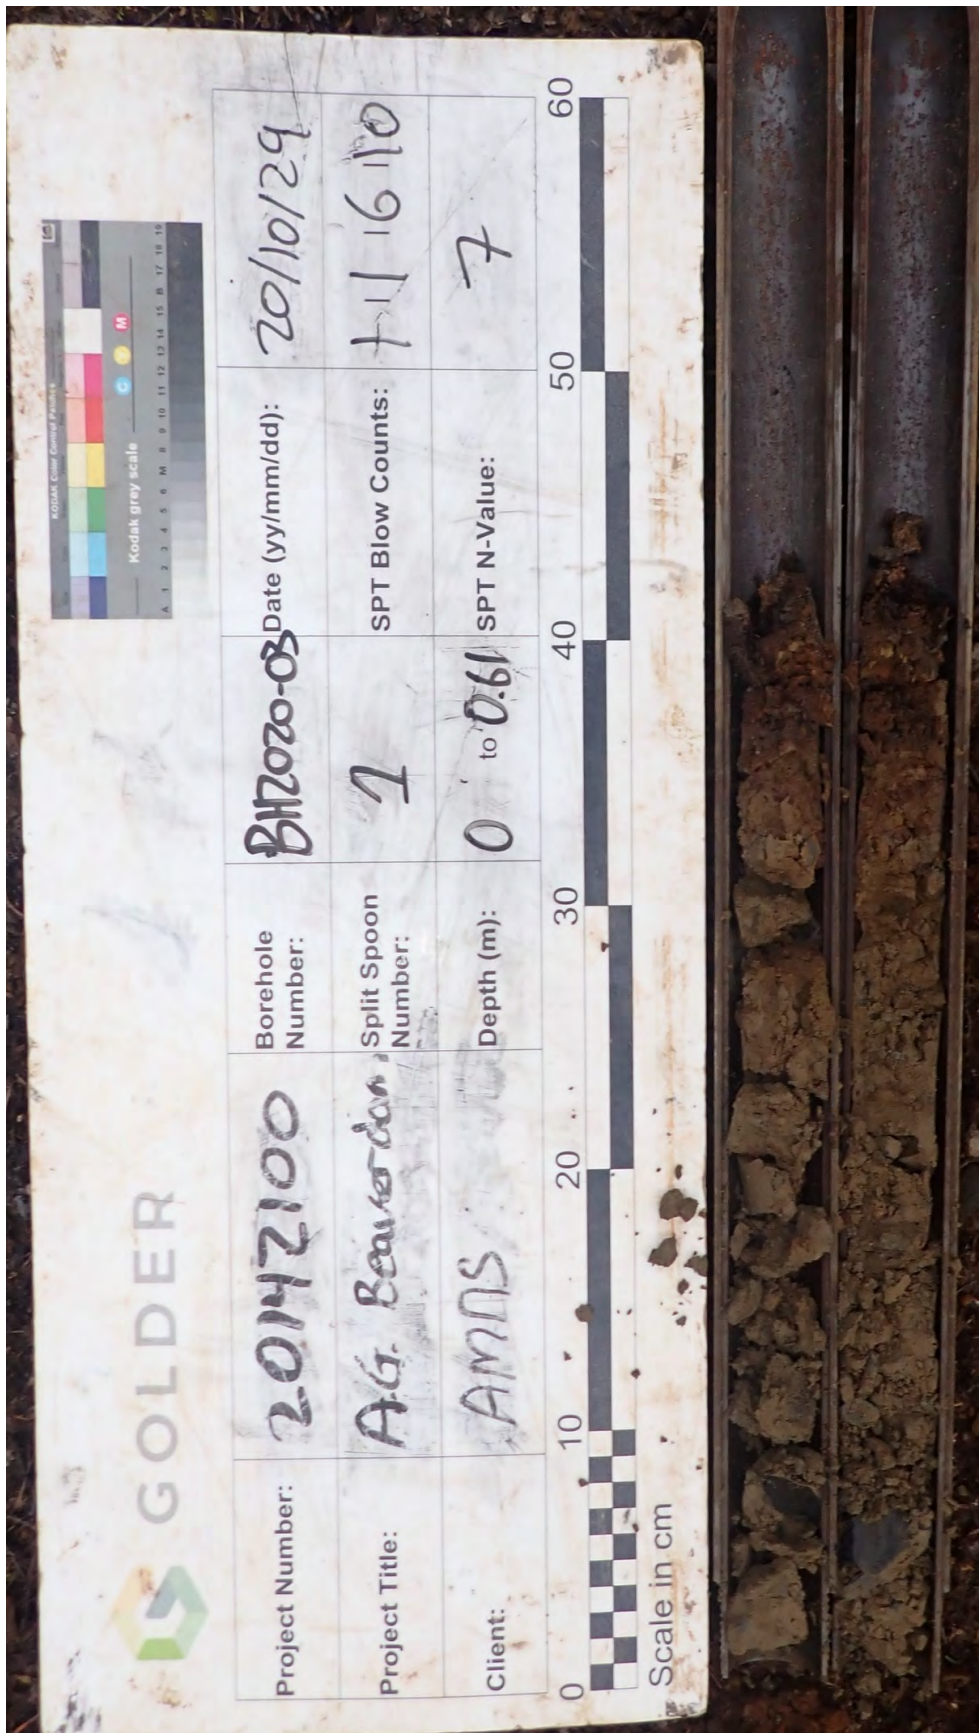
Project Number:	20142100	Borehole Number:	BH2020-03	Date (yy/mm/dd):	20/10/29
Project Title:	Ag. Beaver Dam	Split Spoon Number:	7	SPT Blow Counts:	11 16 10
Client:	AMNS	Depth (m):	0 to 0.61	SPT N-Value:	7

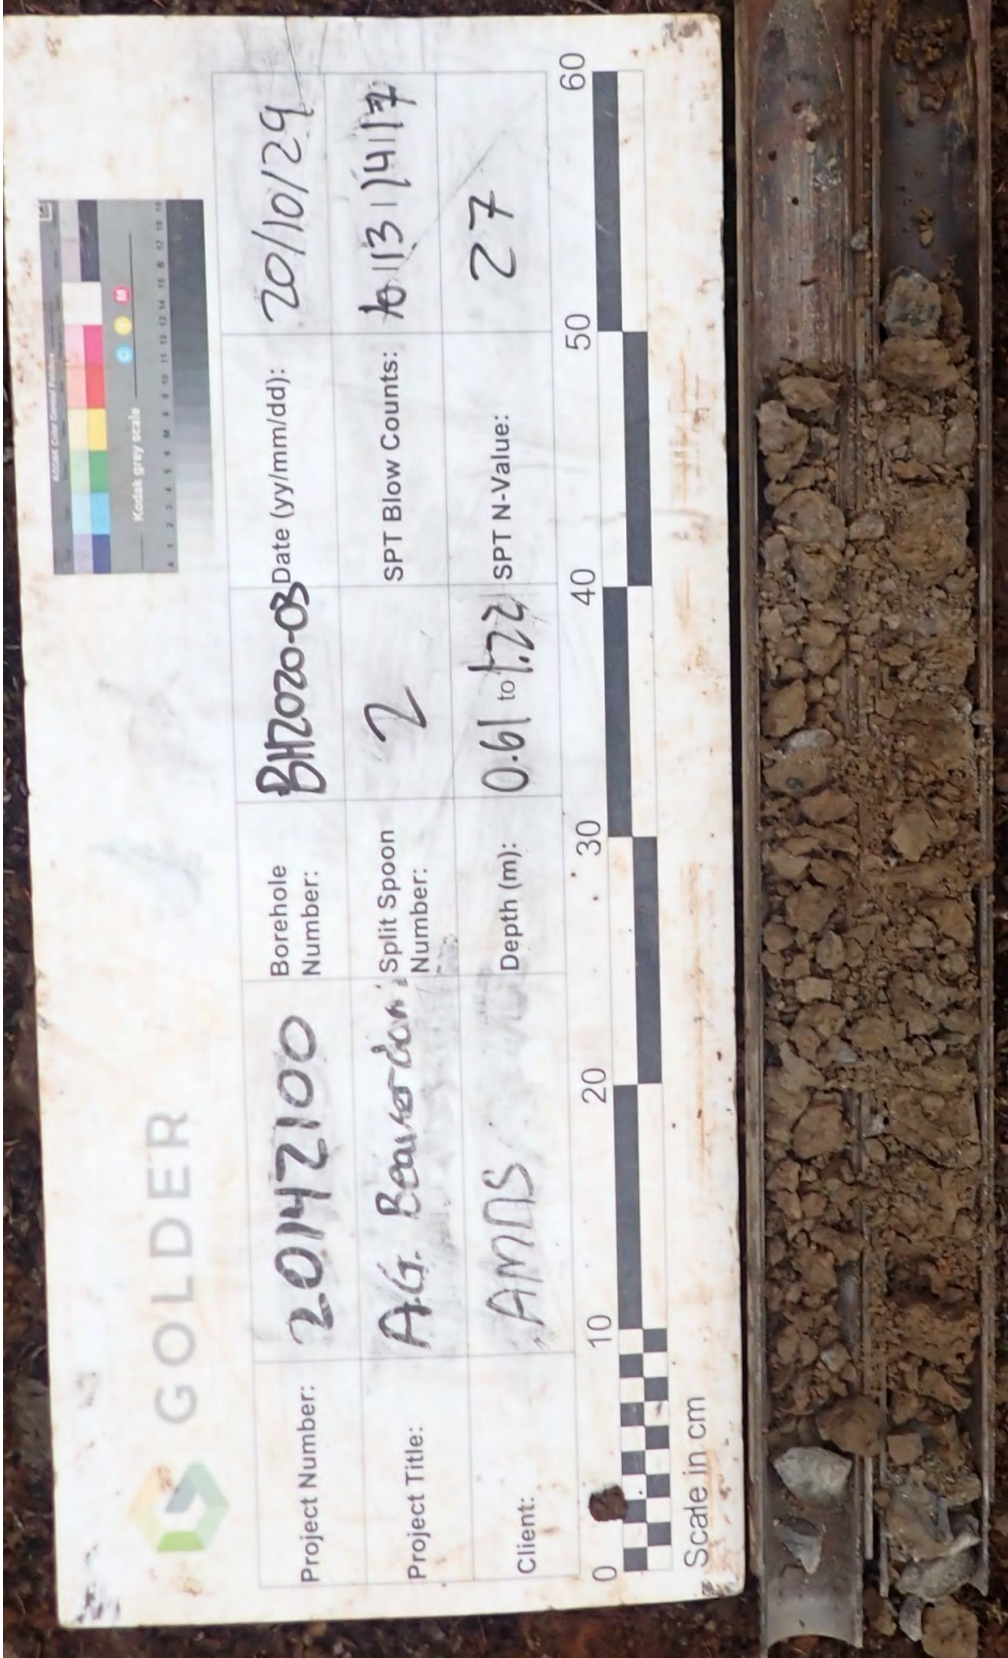
Figure No. E8

Project Number:	20142100	Borehole Number:	BH2020-03	Date (yy/mm/dd):	20/10/29
Project Title:	A.G. Beaverdam	Split Spoon Number:	2	SPT Blow Counts:	10, 13, 14, 17
Client:	AMNS	Depth (m):	0.61 to 1.22	SPT N-Value:	27

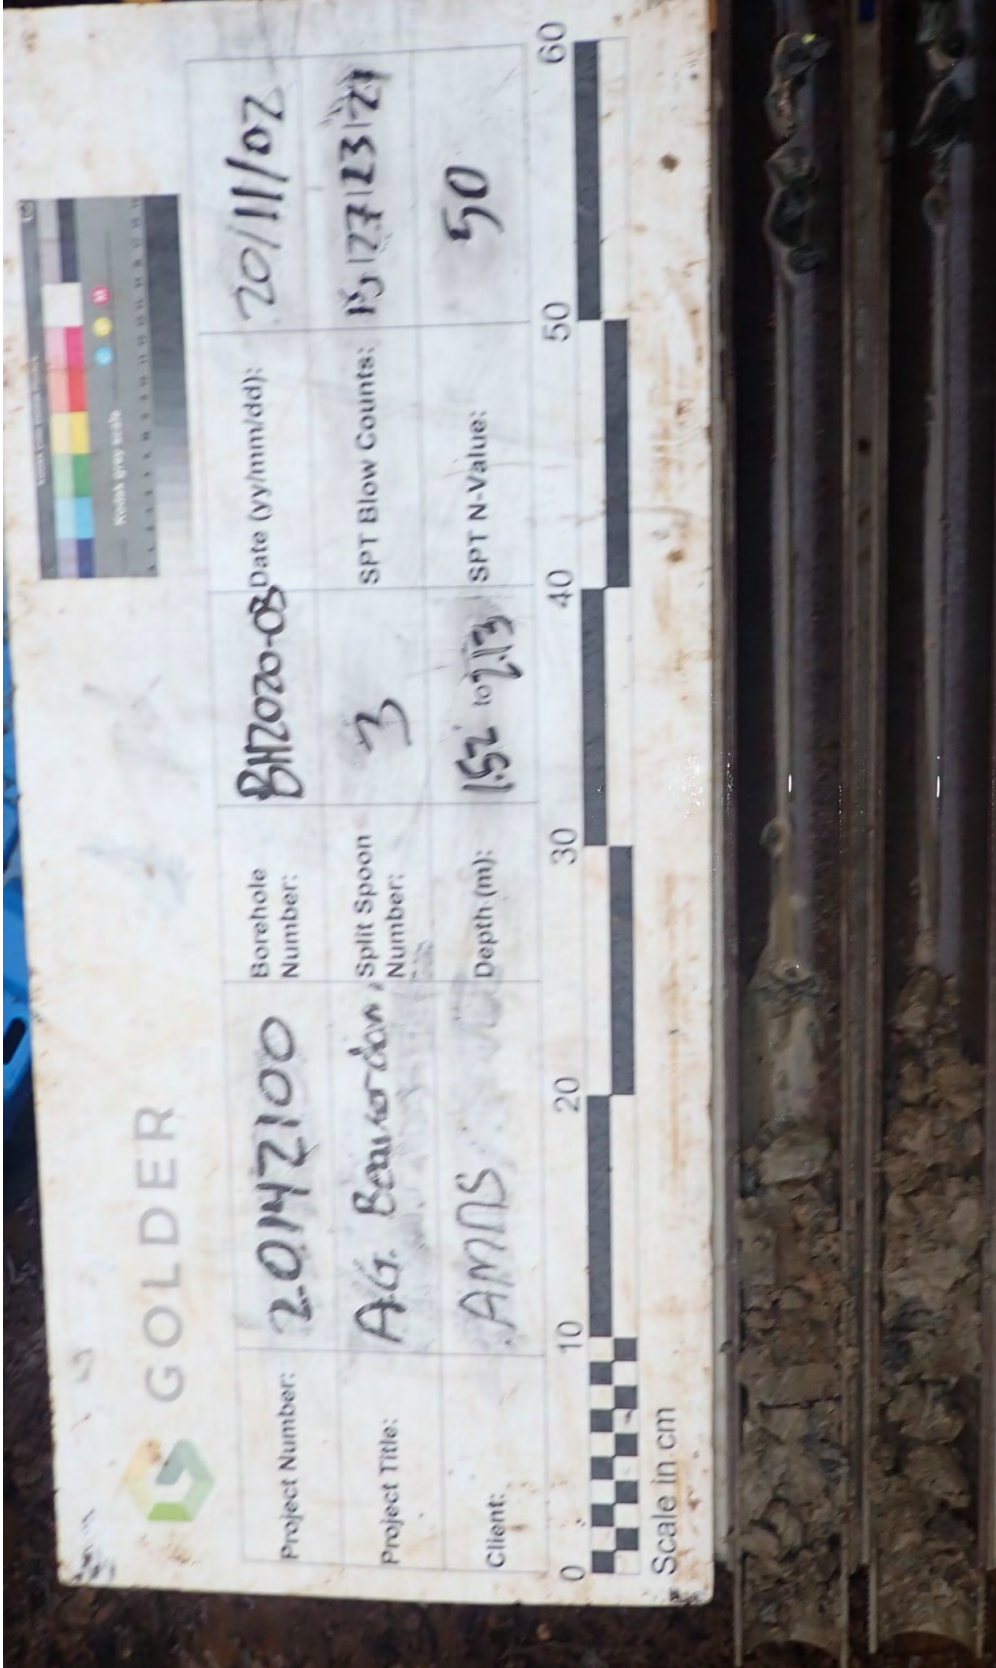
Figure No. E9

Project Number:	2-0M2100	Borehole Number:	BH2020-03	Date (yy/mm/dd):	20/11/07
Project Title:	A.G. Beaverdam	Split Spoon Number:	3	SPT Blow Counts:	15   27   23   21
Client:	AMNS	Depth (m):	1.52 to 2.13	SPT N-Value:	50

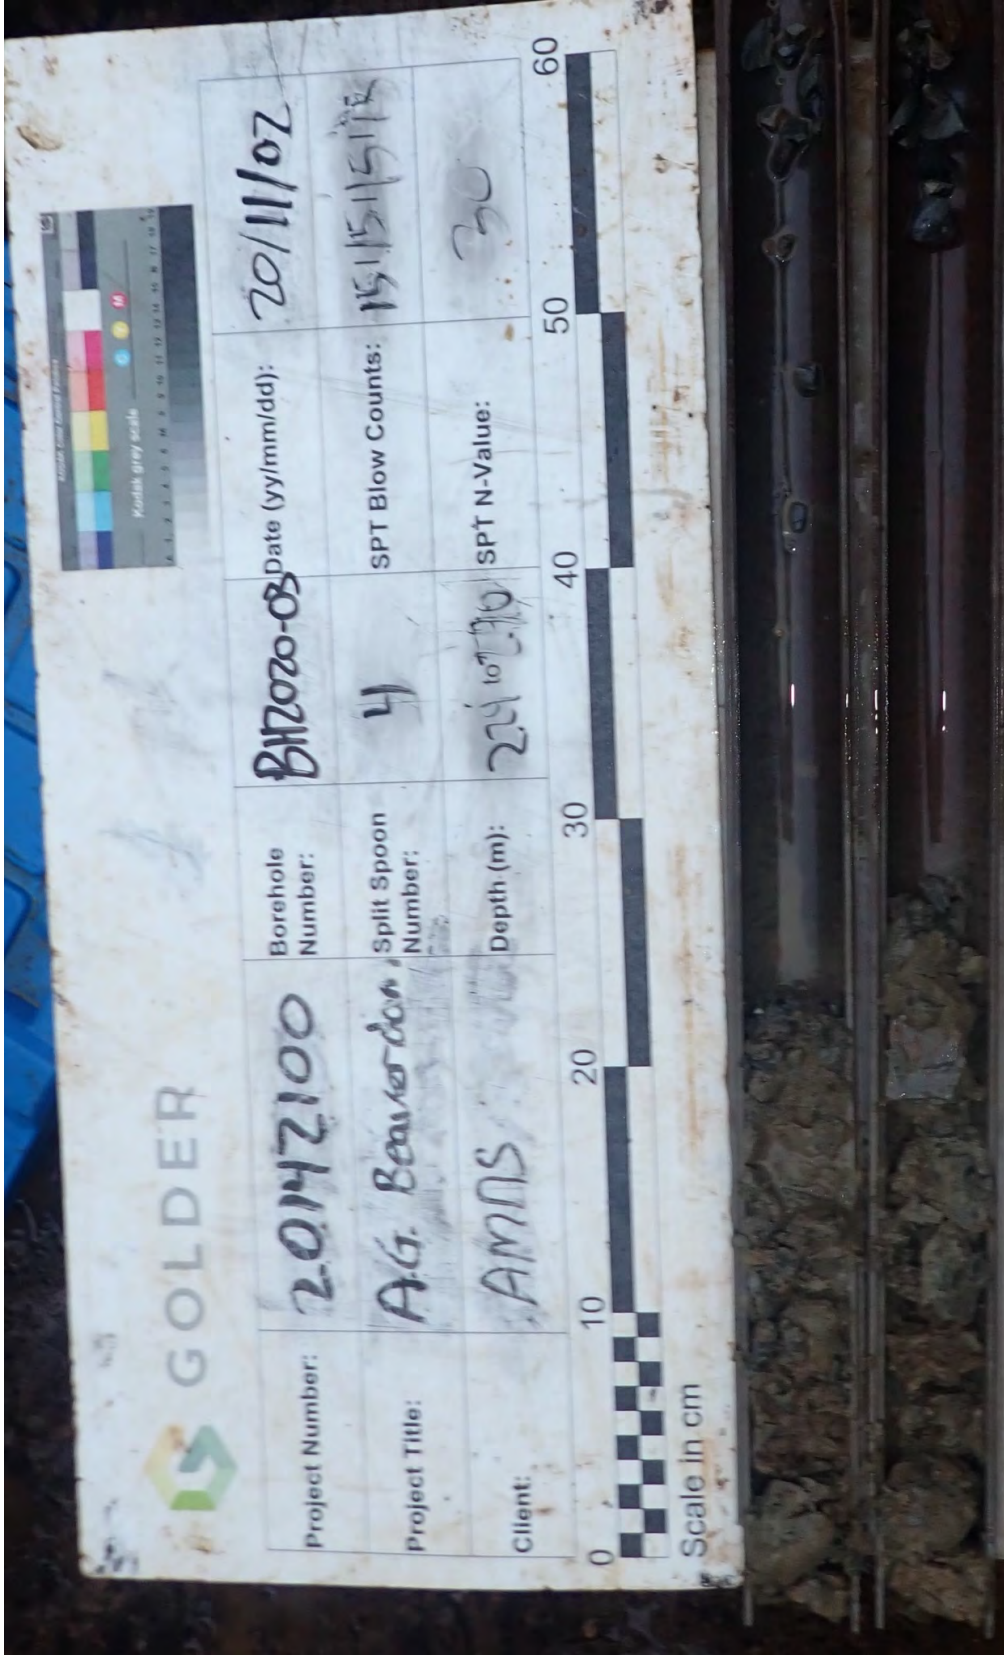
Project No.	20142100	Control	007	Rev.	0	Figure No.	E10
-------------	----------	---------	-----	------	---	------------	-----

TITLE  
**SPLIT SPOON SAMPLE PHOTOGRAPH**  
**BH2020-03 SS3**

Project Number:	20142100	Borehole Number:	BH2020-03	Date (yy/mm/dd):	20/11/07
Project Title:	A.G. Beaverdam	Split Spoon Number:	4	SPT Blow Counts:	15
Client:	AMNS	Depth (m):	2.4	SPT N-Value:	30

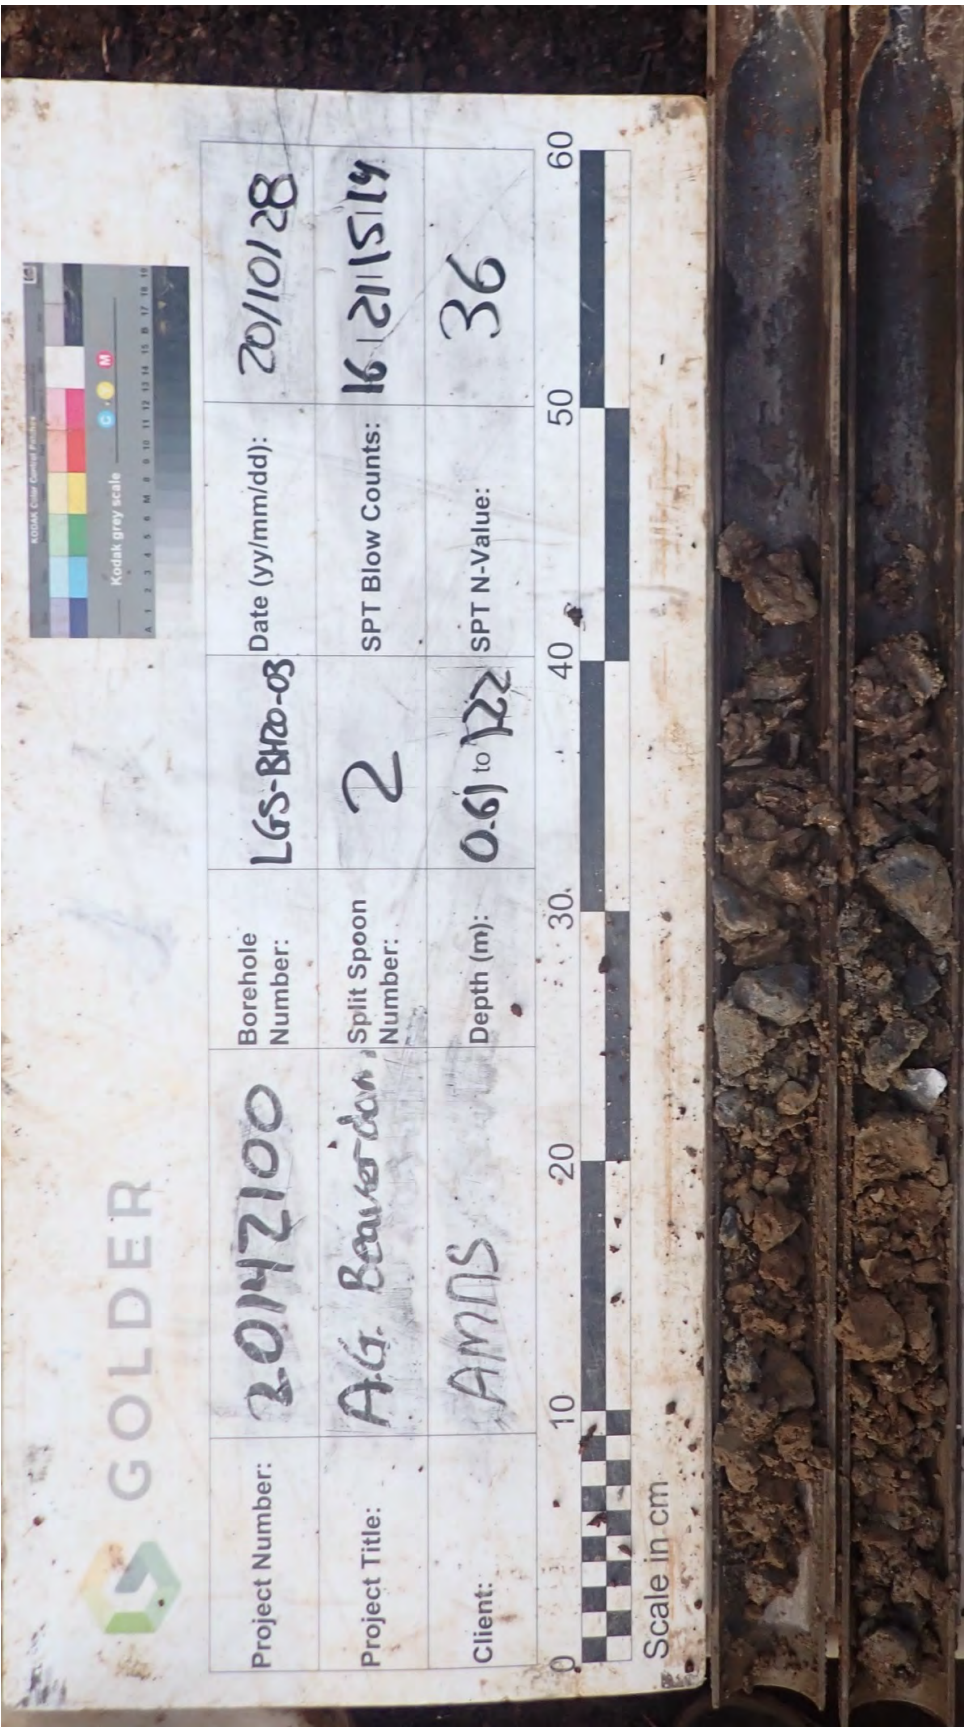
Rev. 0  
Figure No. E16

Project Number:	20142100	Borehole Number:	LGS-BH20-03	Date (yy/mm/dd):	20/10/28
Project Title:	A.G. Beaverdam	Split Spoon Number:	2	SPT Blow Counts:	16   21   5   14
Client:	AMNS	Depth (m):	0.61 to 1.22	SPT N-Value:	36

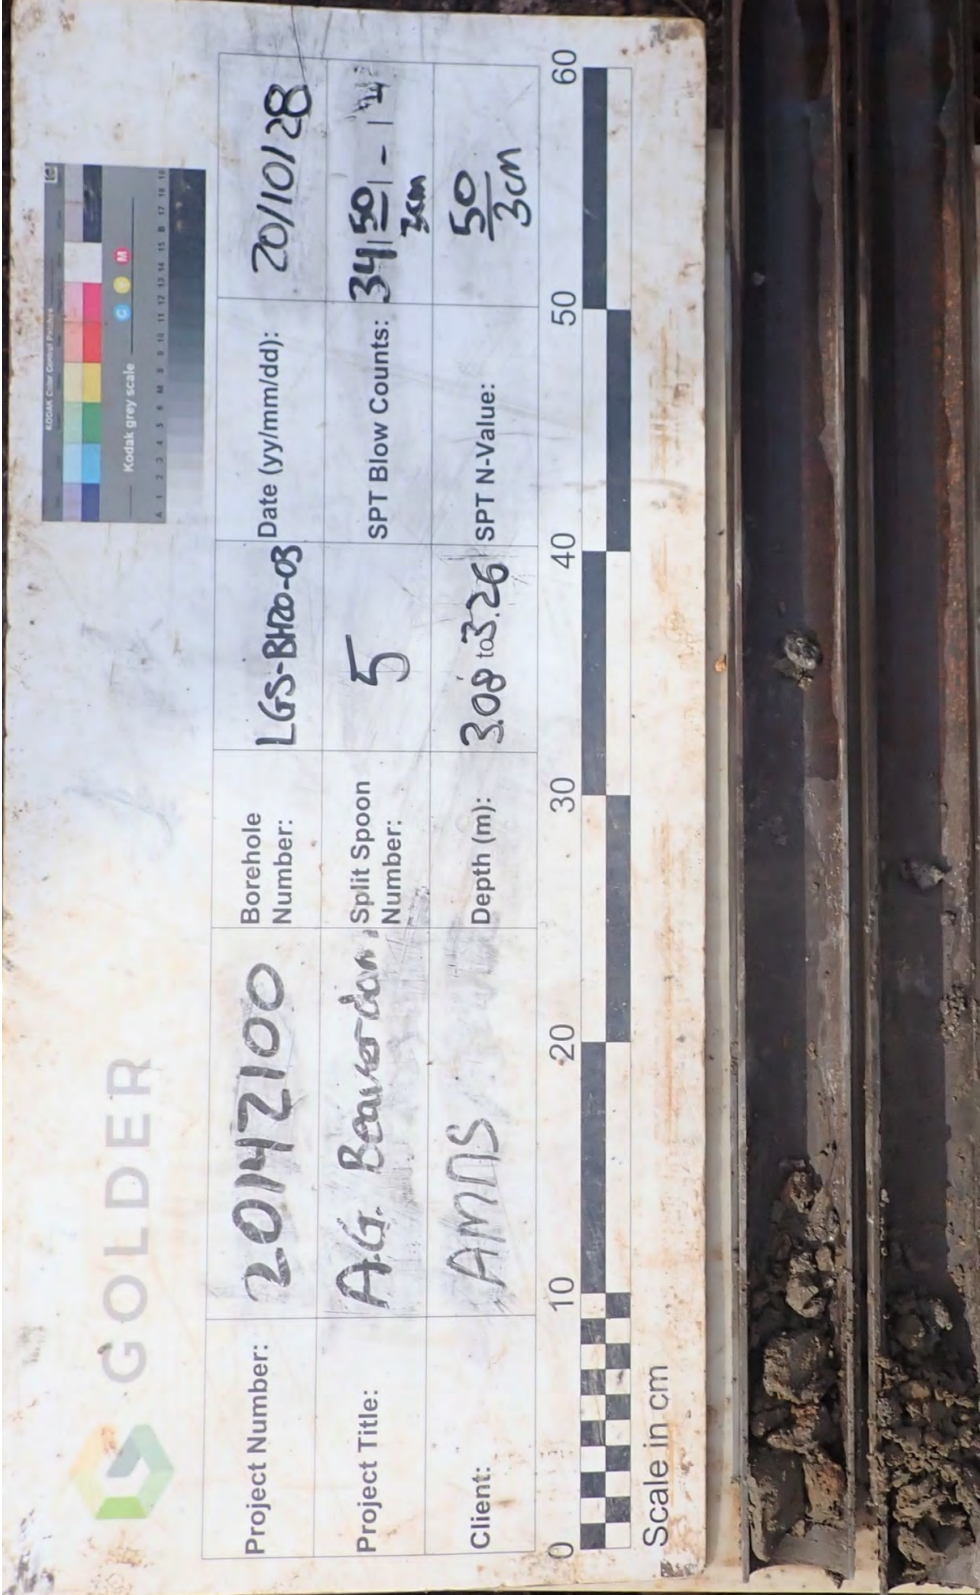
Rev. Figure No.  
0 **E19**

Project Number:	20142100	Borehole Number:	LGS-BH20-03	Date (yy/mm/dd):	20/10/28
Project Title:	Ag. Beaver dam	Split Spoon Number:	5	SPT Blow Counts:	34   50   3cm
Client:	AMNS	Depth (m):	3.08 to 3.26	SPT N-Value:	50 / 3cm

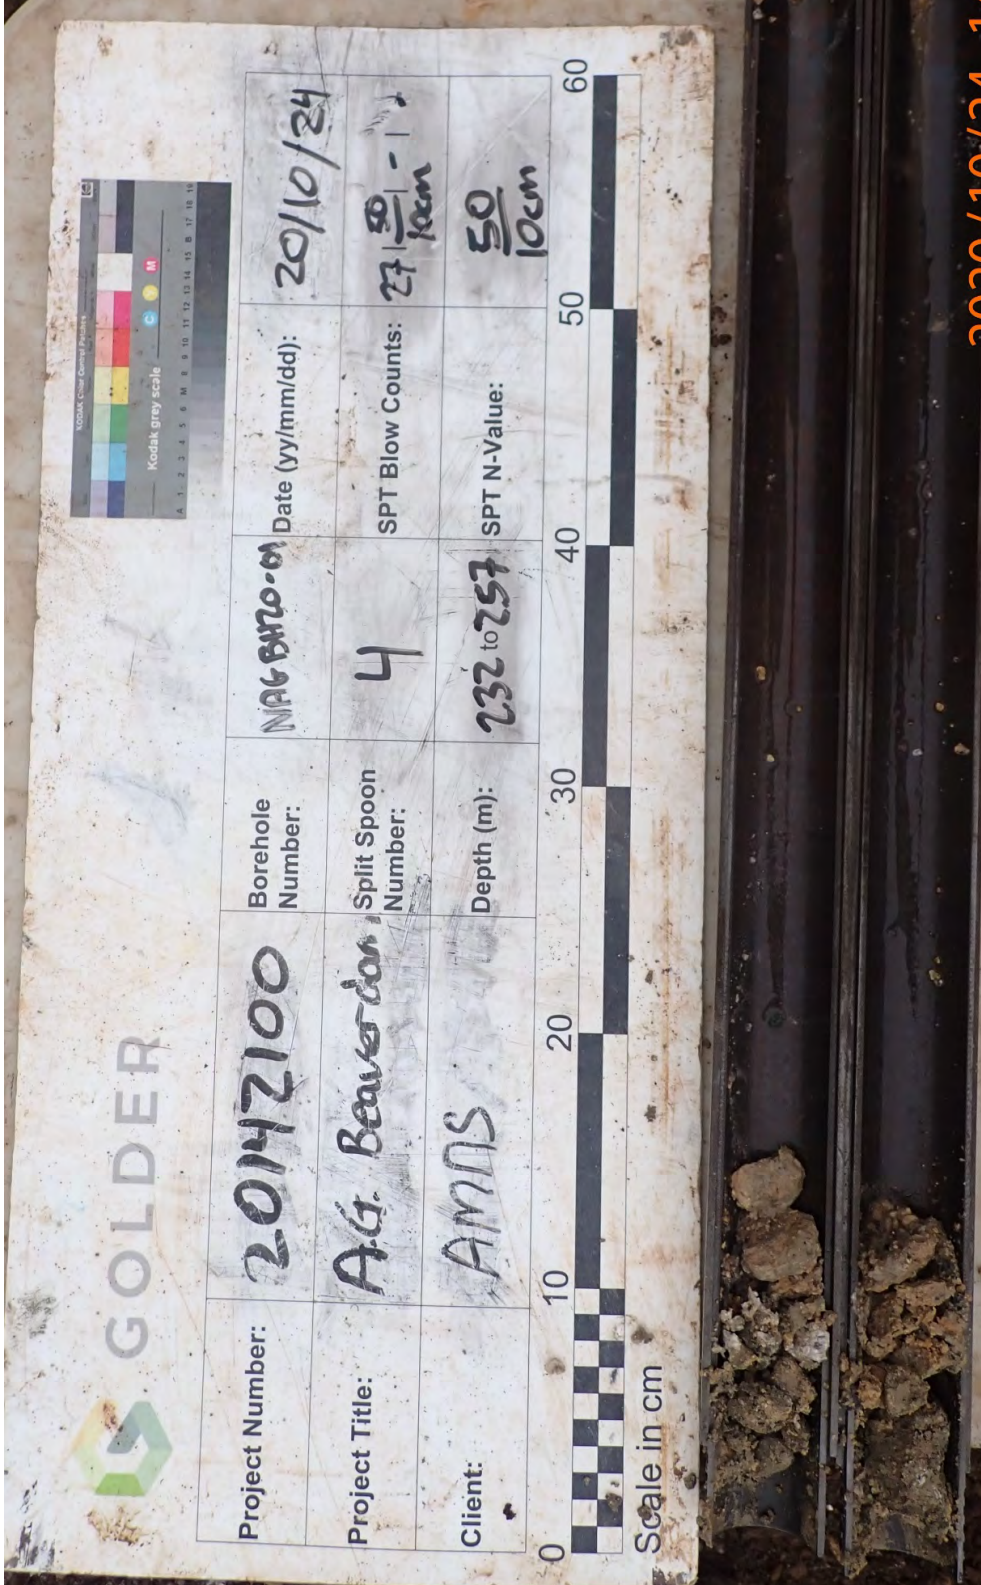
Project No. Control 20142100 007  
Rev. 0  
Figure No. E24

Project Number:	20142100	Borehole Number:	NAG-BH20-01	Date (yy/mm/dd):	20/10/24
Project Title:	Ag. Beaver dam	Split Spoon Number:	4	SPT Blow Counts:	27 $\frac{50}{10cm}$
Client:	AMNS	Depth (m):	232 to 257	SPT N-Value:	50 $\frac{50}{10cm}$
