Geotechnical Investigation: Data Report –  
Beaver Dam Mine, January 15, 2021as  
Completed for the Updated 2021 Beaver Dam Mine EIS

# Geotechnical Investigation: Data Report

## *Beaver Dam Mine*

20142100-004-R-Rev0

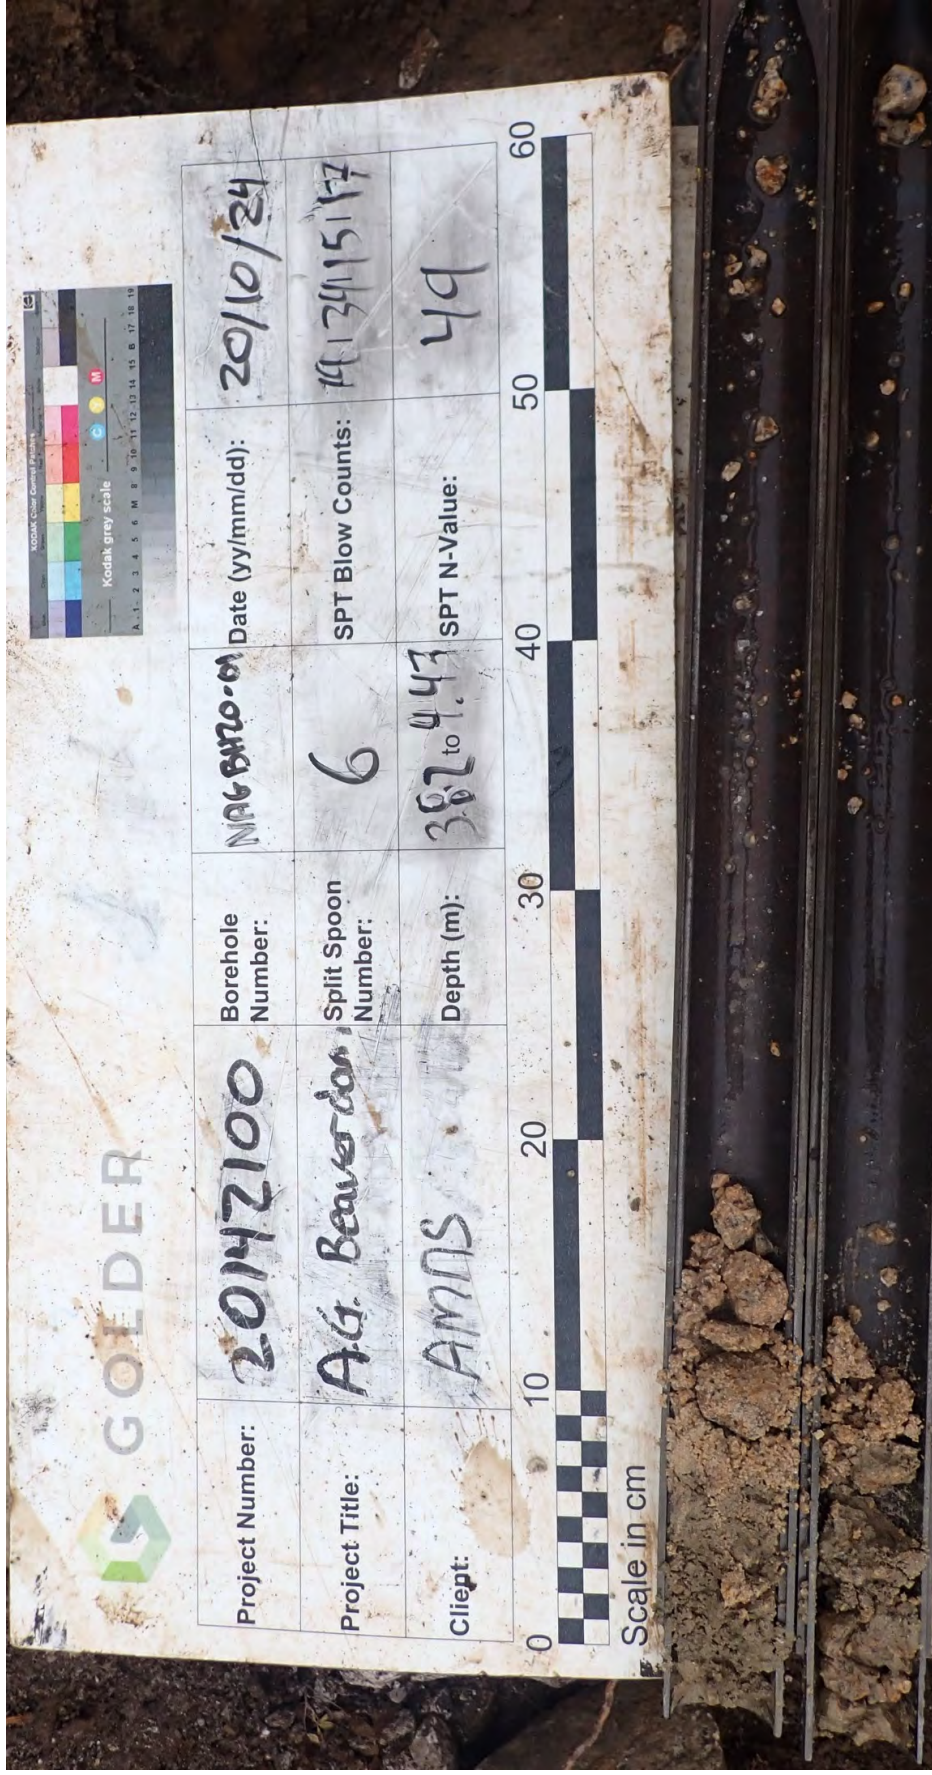
Project No. Control: 20142100 007  
Rev. 0  
Figure No. E26

Project Number:	20142100	Borehole Number:	NAG-BH20-01	Date (yy/mm/dd):	20/10/24
Project Title:	A.G. Beaverdam	Split Spoon Number:	6	SPT Blow Counts:	19, 34, 15, 17
Client:	AMNS	Depth (m):	3.62 to 4.43	SPT N-Value:	49

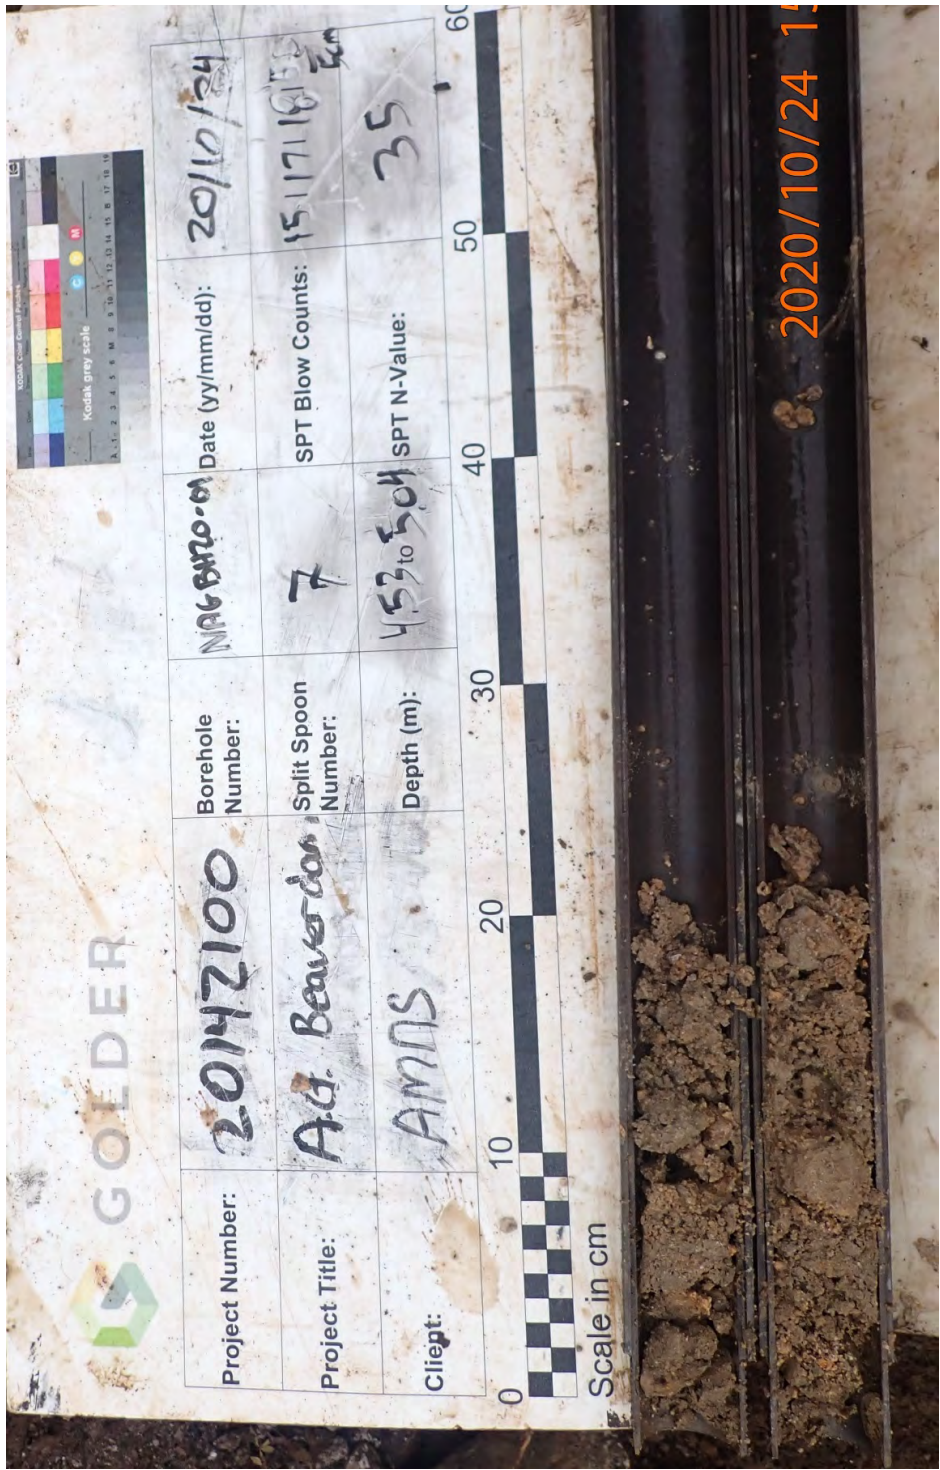
Project No.	20142100	Control	007	Rev.	0	Figure No.	E27
-------------	----------	---------	-----	------	---	------------	-----

TITLE  
SPLIT SPOON SAMPLE PHOTOGRAPH  
NAG-BH20-01 SS6

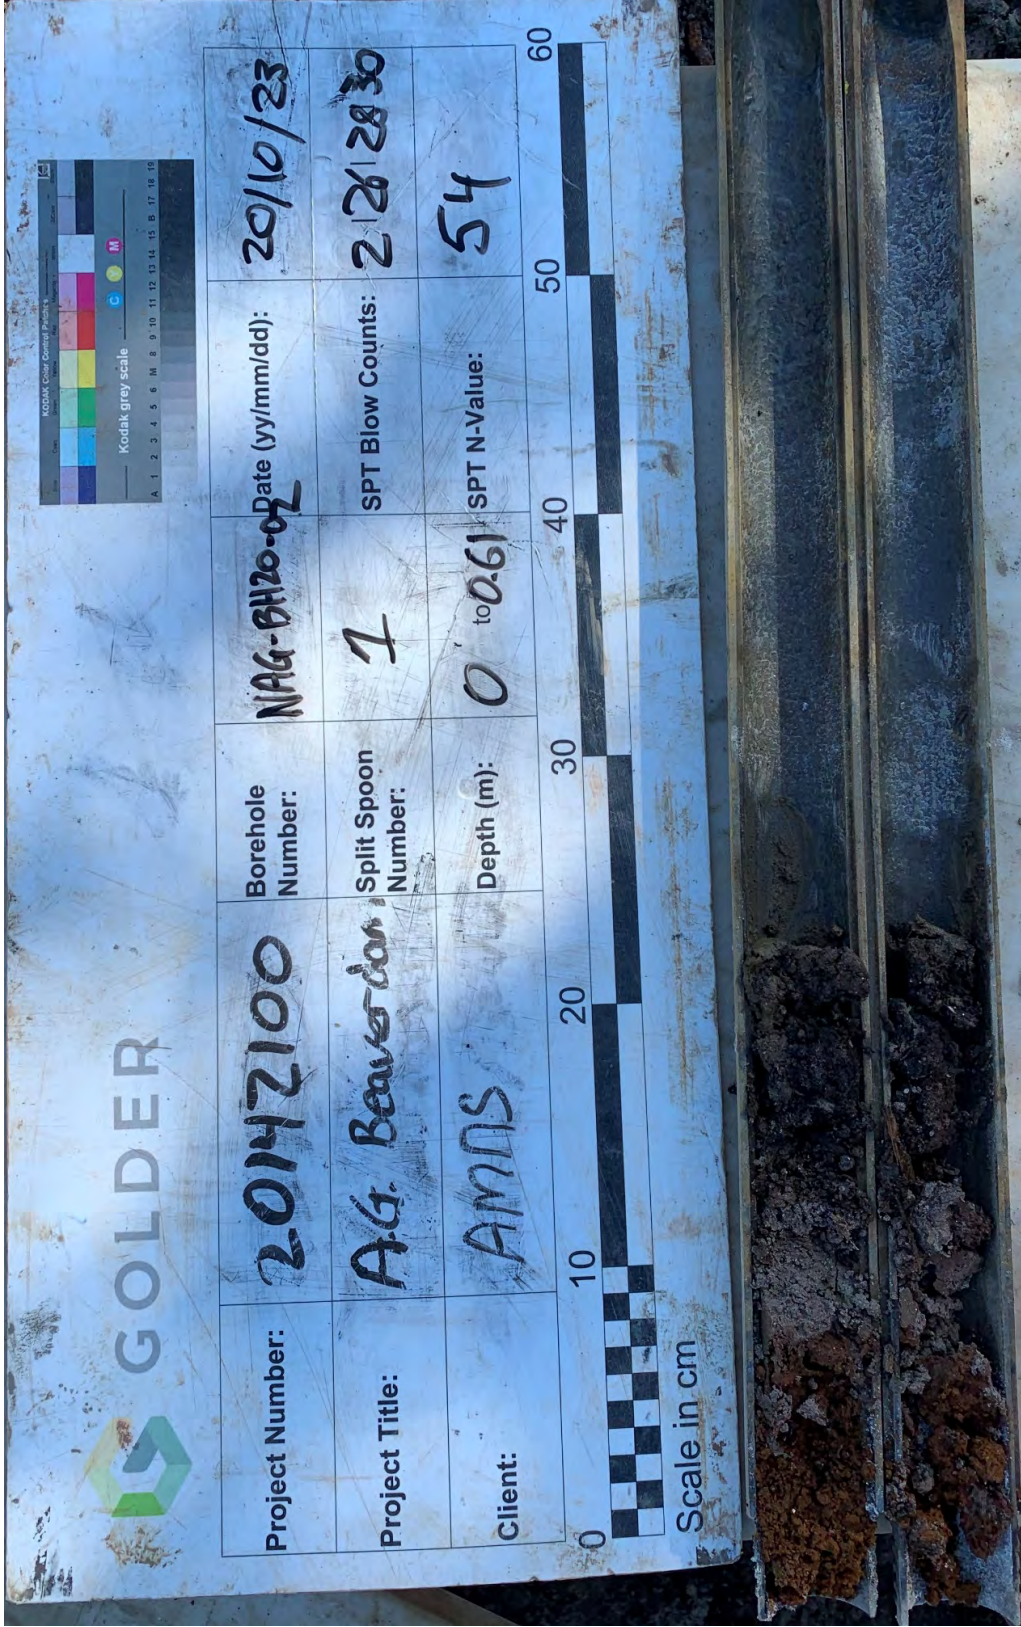
Project No.	Control	Rev.	Figure No.
20142100	007	0	E28

TITLE  
SPLIT SPOON SAMPLE PHOTOGRAPH  
NAG-BH20-01 SS7

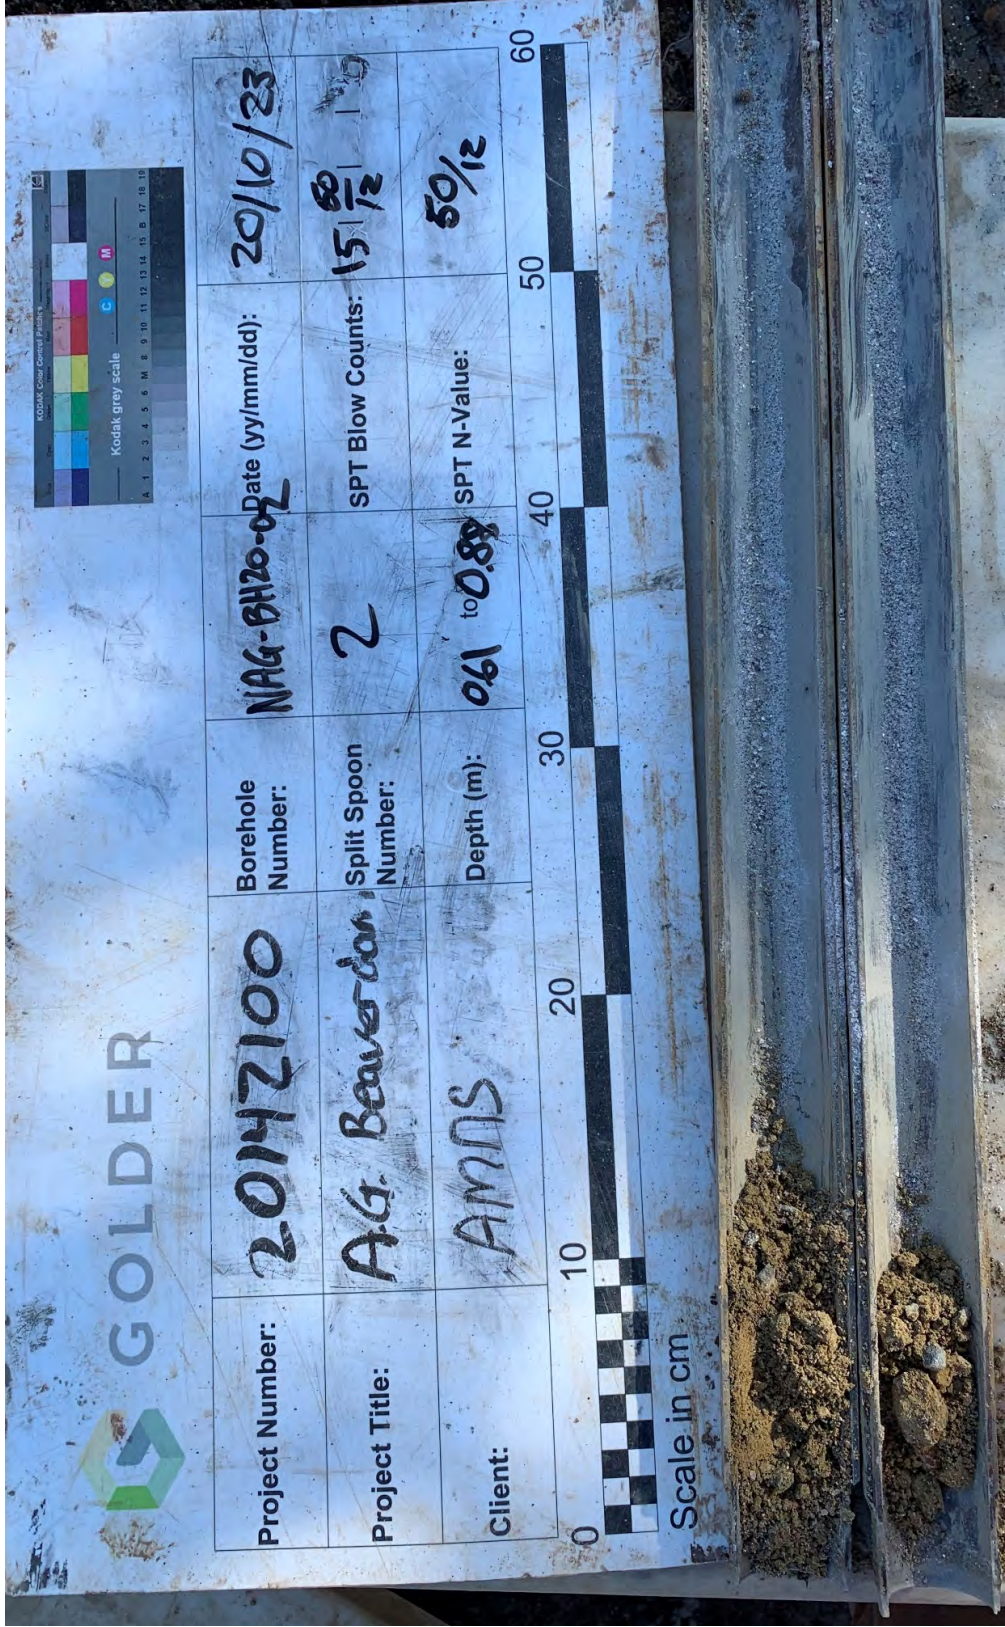
Project No.	20142100	Control	007	Rev.	0	Figure No.	E29
-------------	----------	---------	-----	------	---	------------	-----

TITLE  
**SPLIT SPOON SAMPLE PHOTOGRAPH**  
**NAG-BH20-02 SS1**

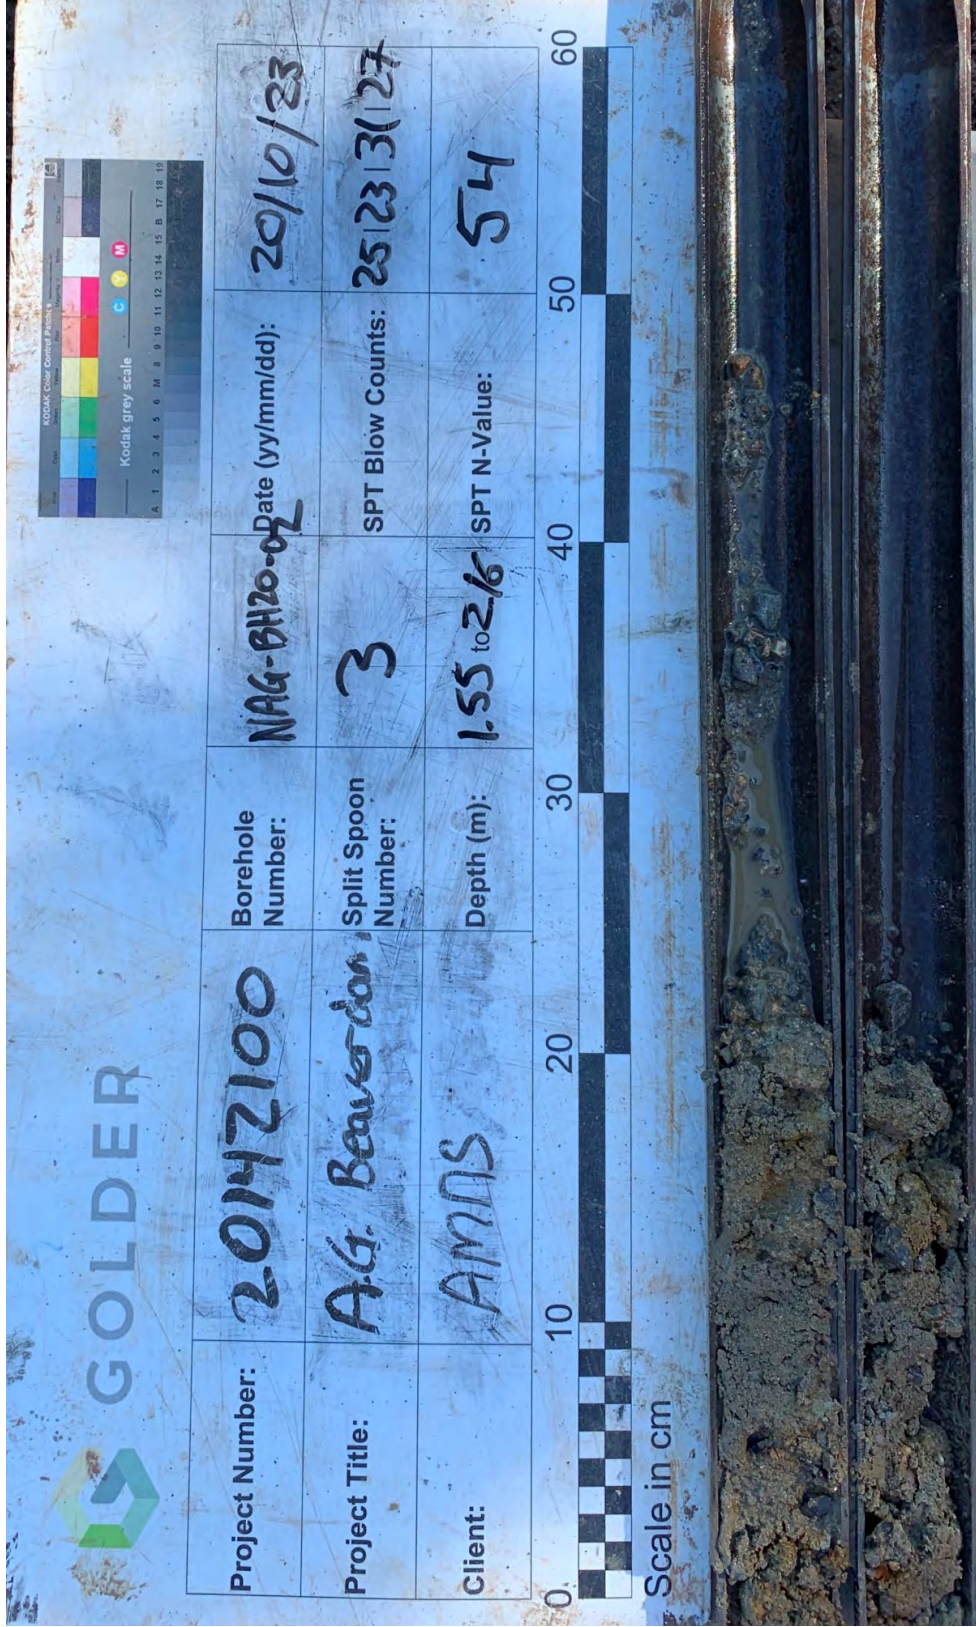
Project No. Control: 20142100 007  
 Rev. 0  
 Figure No. E30

TITLE  
SPLIT SPOON SAMPLE PHOTOGRAPH  
NAG-BH20-02 SS2

Project Number:	20142100	Borehole Number:	NAG-BH20-02	Date (yy/mm/dd):	20/10/23
Project Title:	A.G. Beaverdam	Split Spoon Number:	3	SPT Blow Counts:	25   23   3   27
Client:	AMNS	Depth (m):	1.55 to 2.16	SPT N-Value:	54

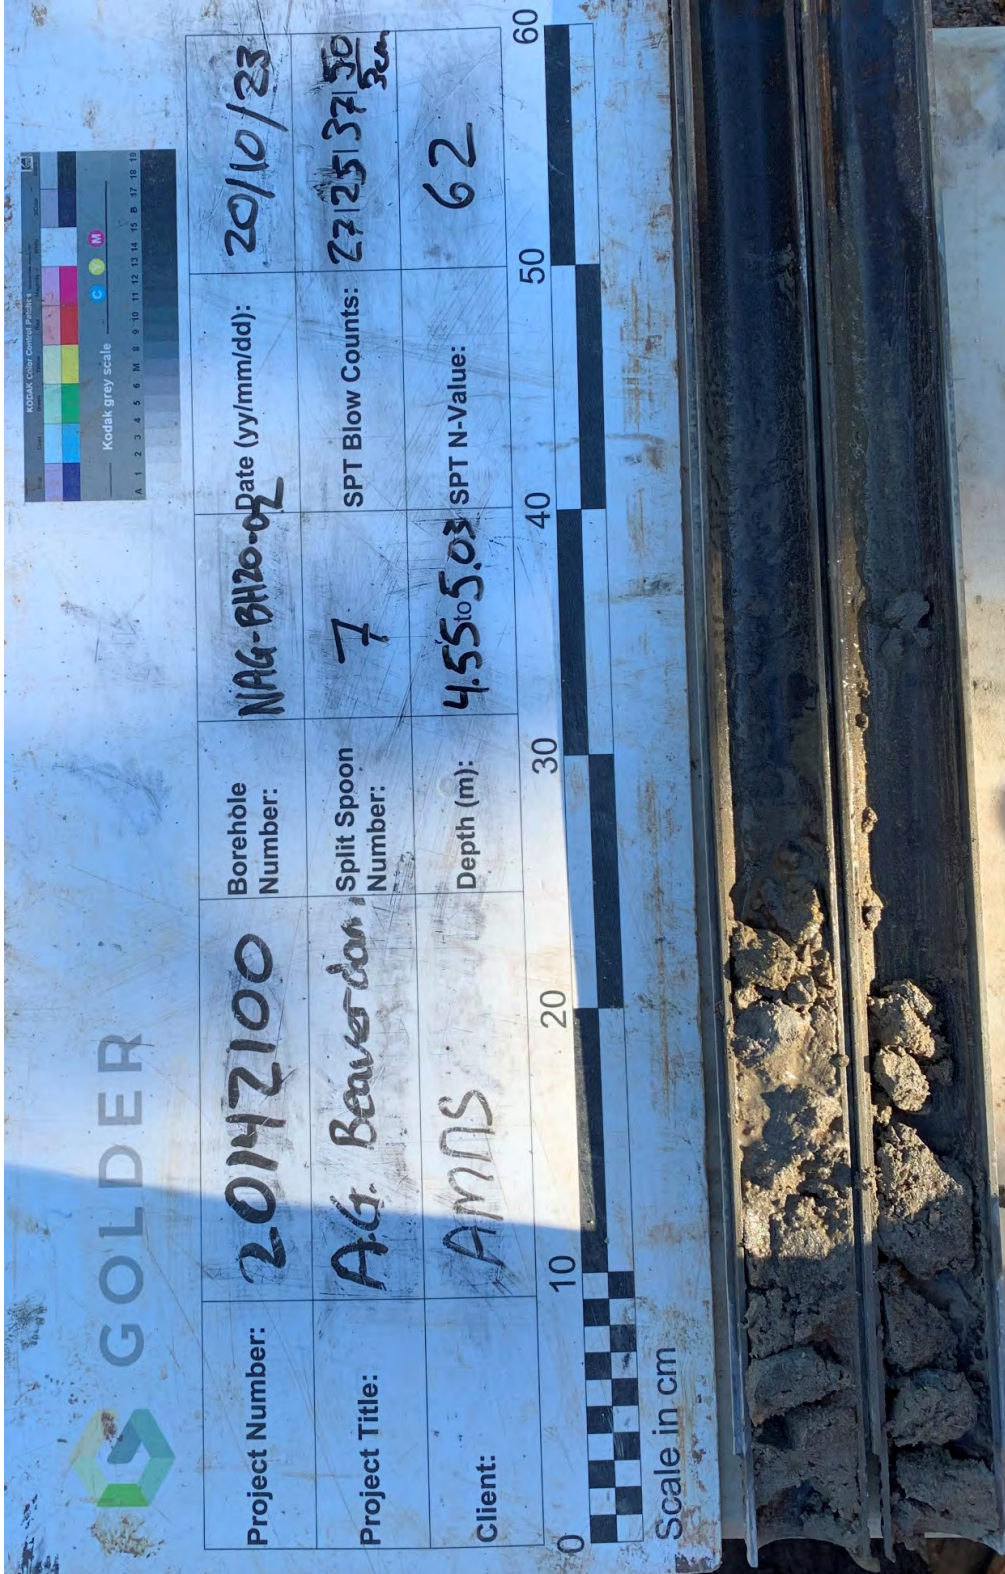
Project No.	20142100	Control	007	Rev.	0	Figure No.	E33
-------------	----------	---------	-----	------	---	------------	-----

TITLE  
SPLIT SPOON SAMPLE PHOTOGRAPH  
NAG-BH20-02 SS6

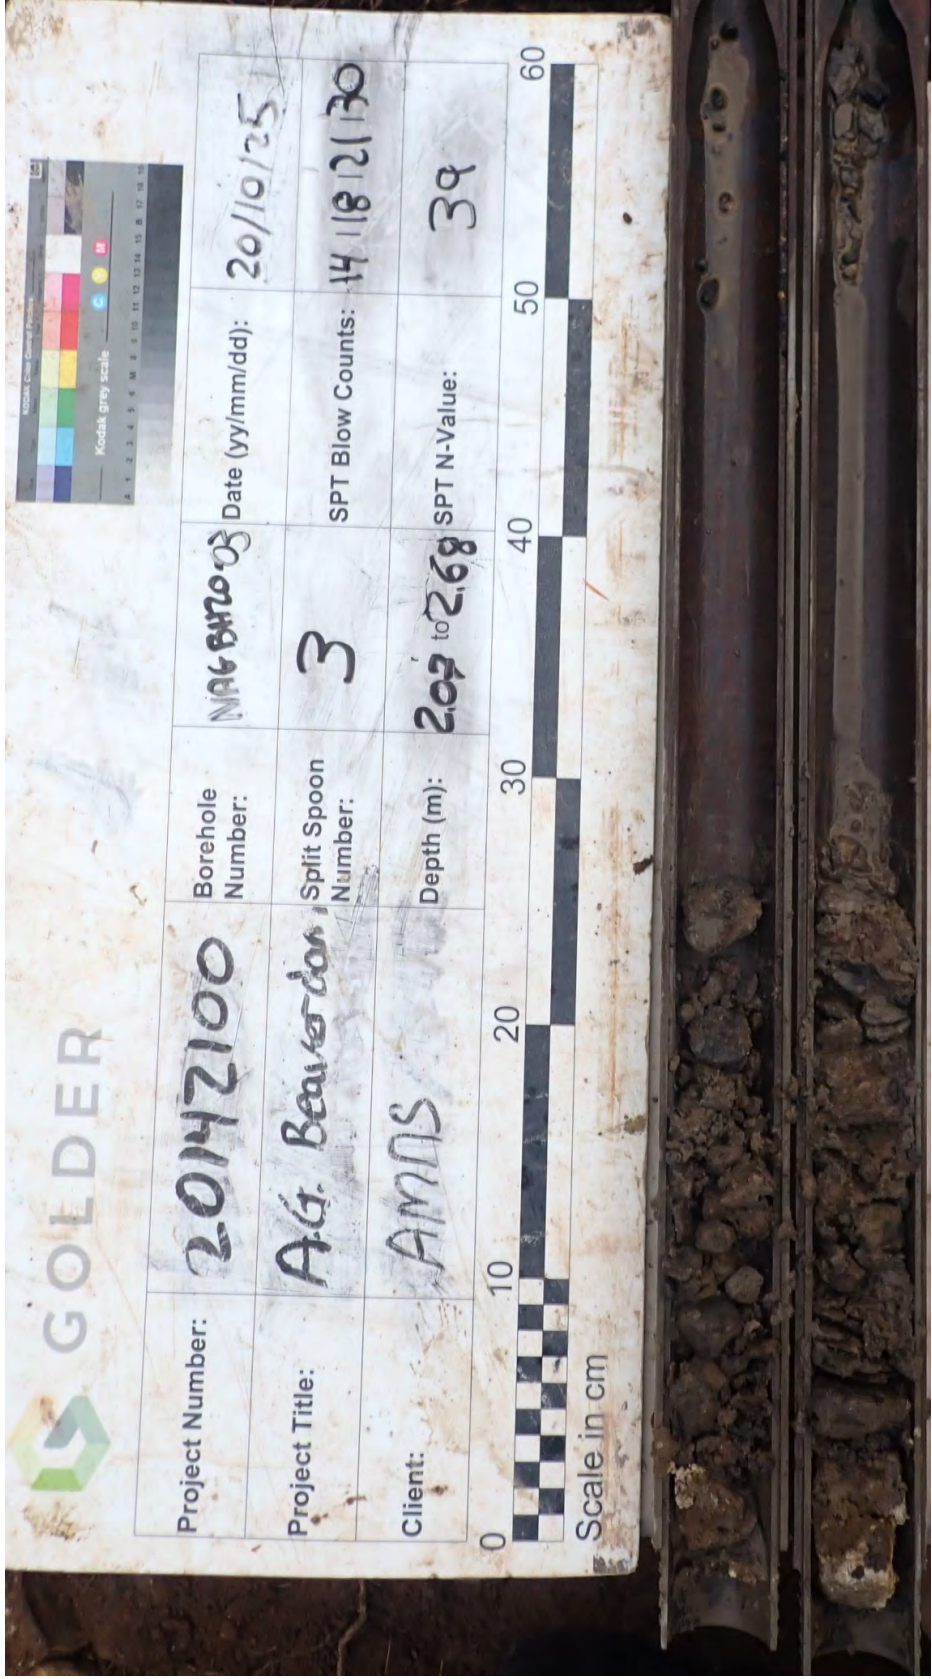
Rev. 0  
Figure No. E37

Project Number:	20142100	Borehole Number:	NAG-BH20-03	Date (yy/mm/dd):	20/10/25
Project Title:	A.G. Beaverdam	Split Spoon Number:	3	SPT Blow Counts:	14 18 21 30
Client:	AMNS	Depth (m):	2.03 to 2.68	SPT N-Value:	39

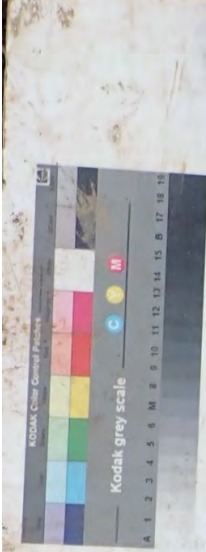
Project Number:	20142100	Borehole Number:	NAG BH20-03	Date (yy/mm/dd):	20/10/26
Project Title:	AG: Beaver dam	Split Spoon Number:	7	SPT Blow Counts:	22 $\frac{50}{8cm}$ - 14
Client:	AMNS	Depth (m):	5.19 to 5.42	SPT N-Value:	50 $\frac{50}{8cm}$

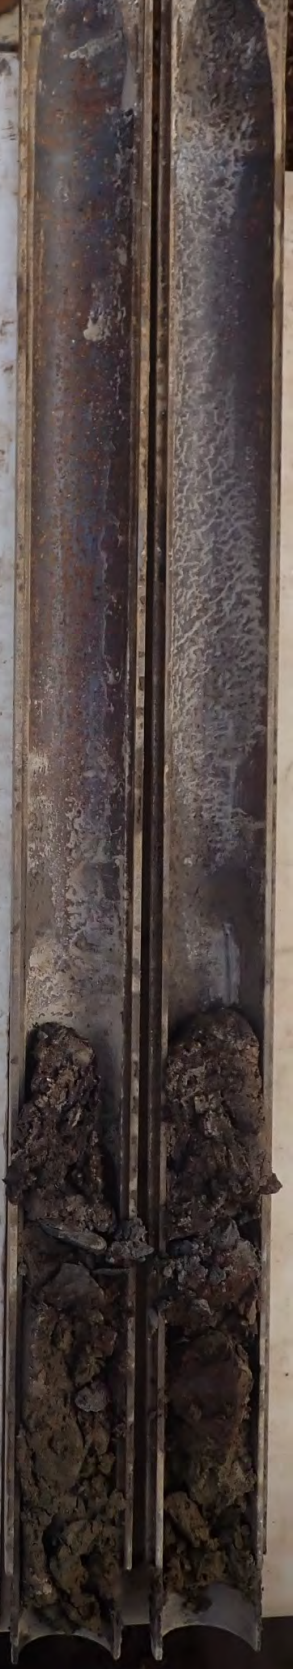
Project Number:	20142100	Borehole Number:	NAG-BH20-06	Date (yy/mm/dd):	20/10/26
Project Title:	A.G. Beaverdam	Split Spoon Number:	1	SPT Blow Counts:	5 14 13 11
Client:	AMNS	Depth (m):	0 to 0.61	SPT N-Value:	7

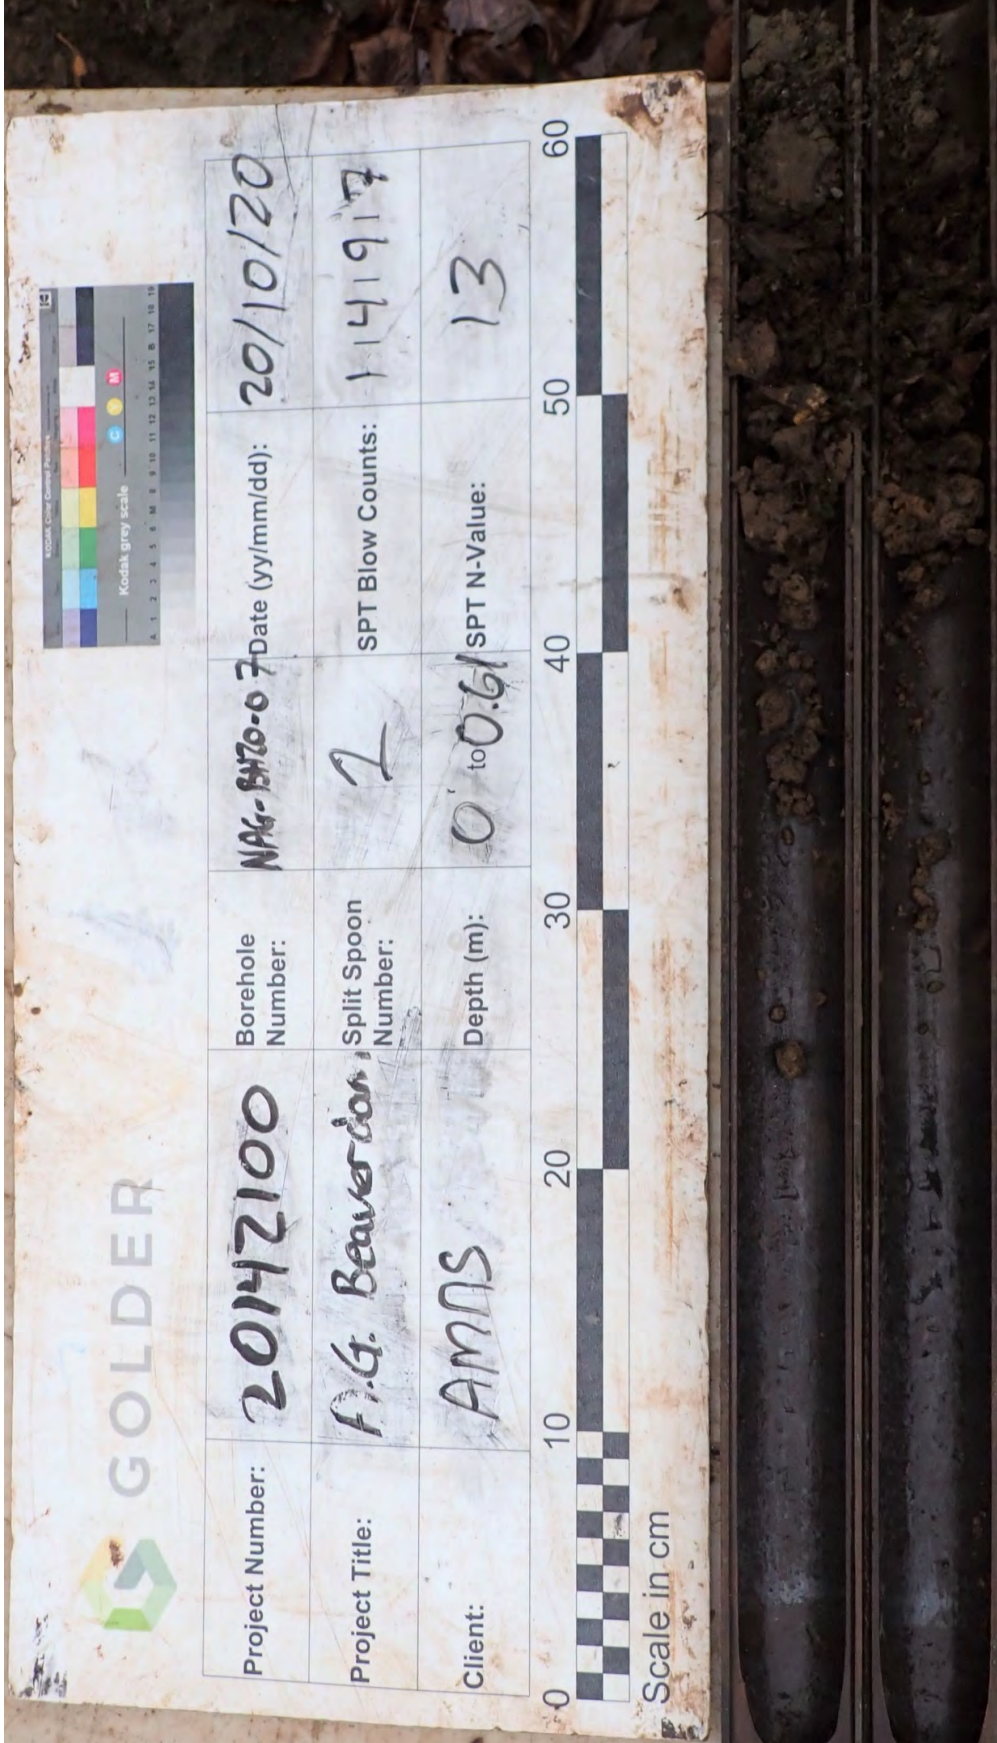
Project Number:	20142100	Borehole Number:	NAG-BH20-07	Date (yy/mm/dd):	20/10/20
Project Title:	F.G. Beaver Dam	Split Spoon Number:	2	SPT Blow Counts:	1141917
Client:	AMNS	Depth (m):	0 to 0.6	SPT N-Value:	13

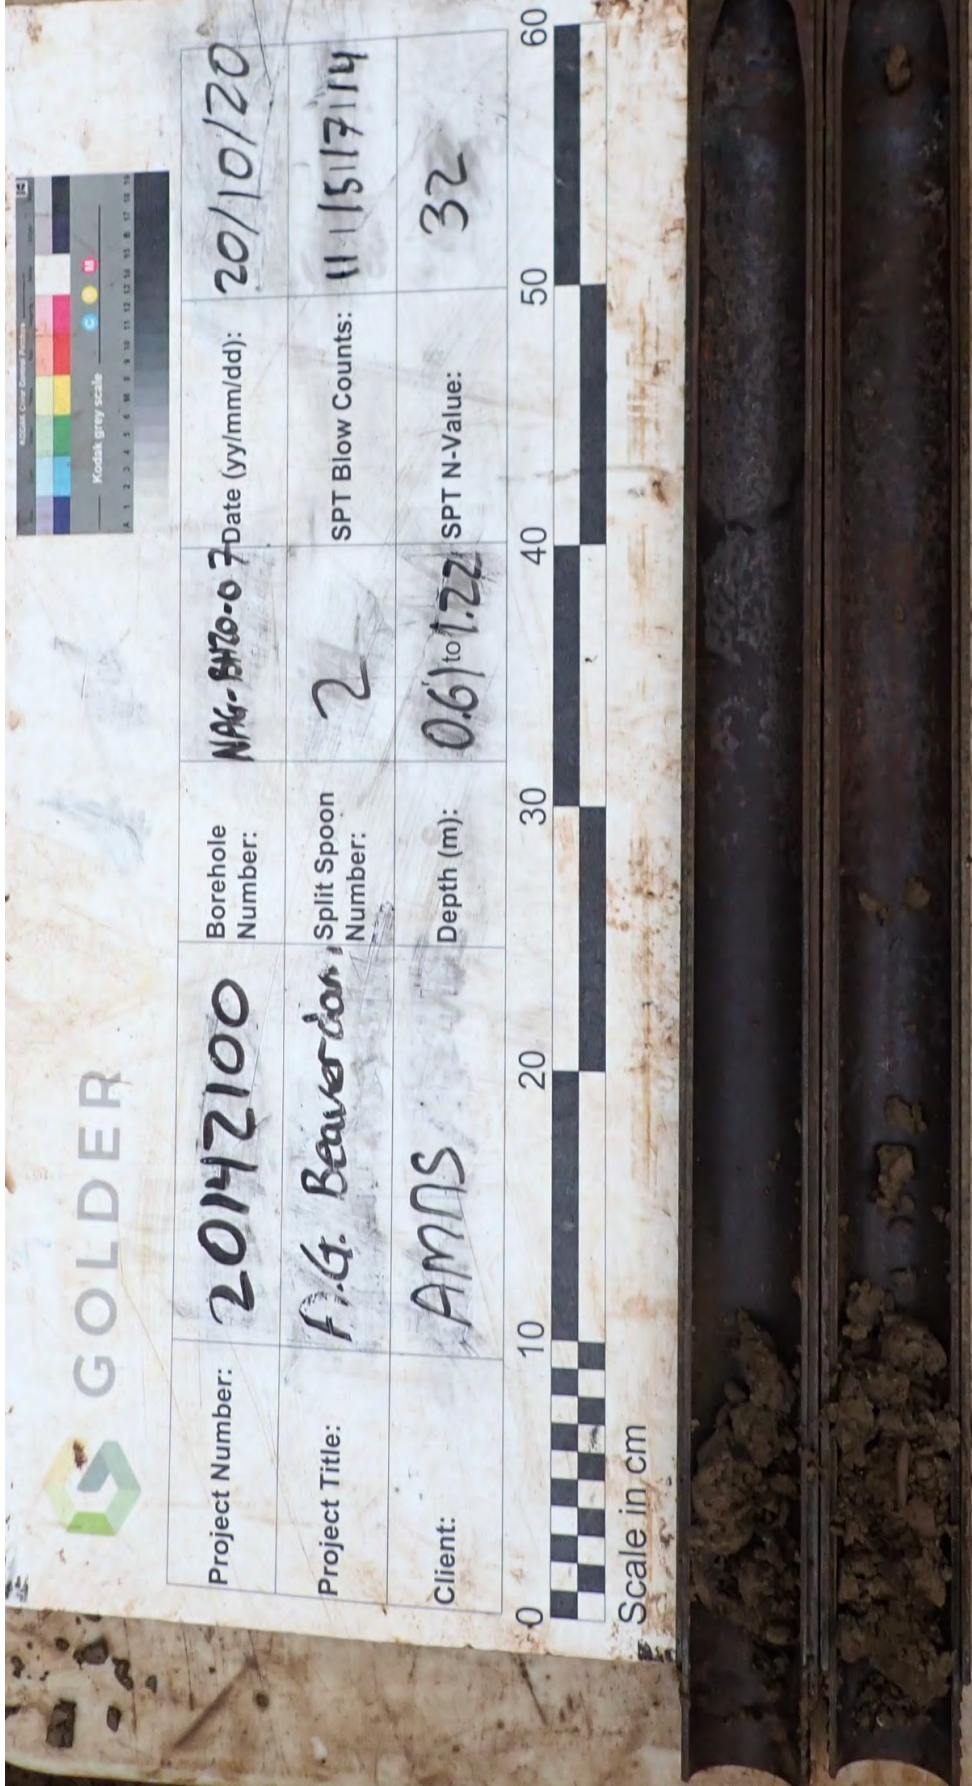
Project Number:	20142100	Borehole Number:	NAG-BH20-07	Date (yy/mm/dd):	20/10/20
Project Title:	F.G. Beaver Dam	Split Spoon Number:	2	SPT Blow Counts:	11   5   7   14
Client:	AMNS	Depth (m):	0.6 to 1.22	SPT N-Value:	32

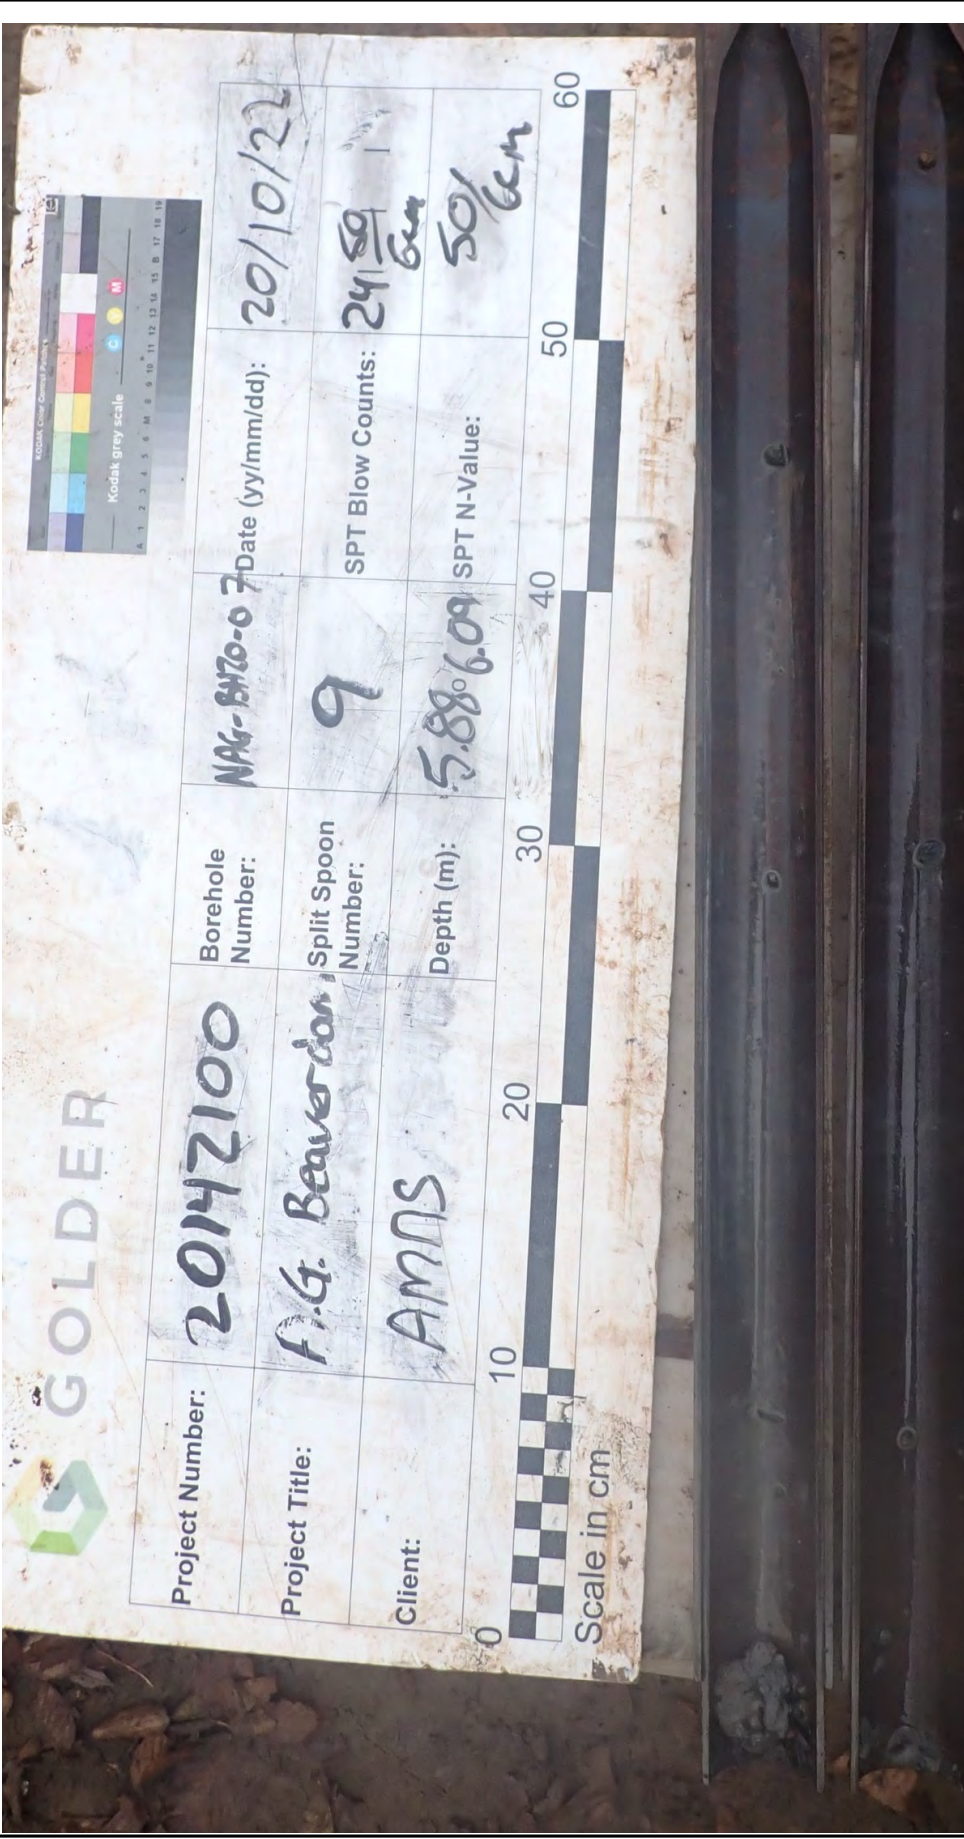
Project Number:	20142100	Borehole Number:	NAG-BH20-07	Date (yy/mm/dd):	20/10/22
Project Title:	F.G. Beaver Dam	Split Spoon Number:	9	SPT Blow Counts:	24 6cm
Client:	AMNS	Depth (m):	5.88	SPT N-Value:	50 6cm

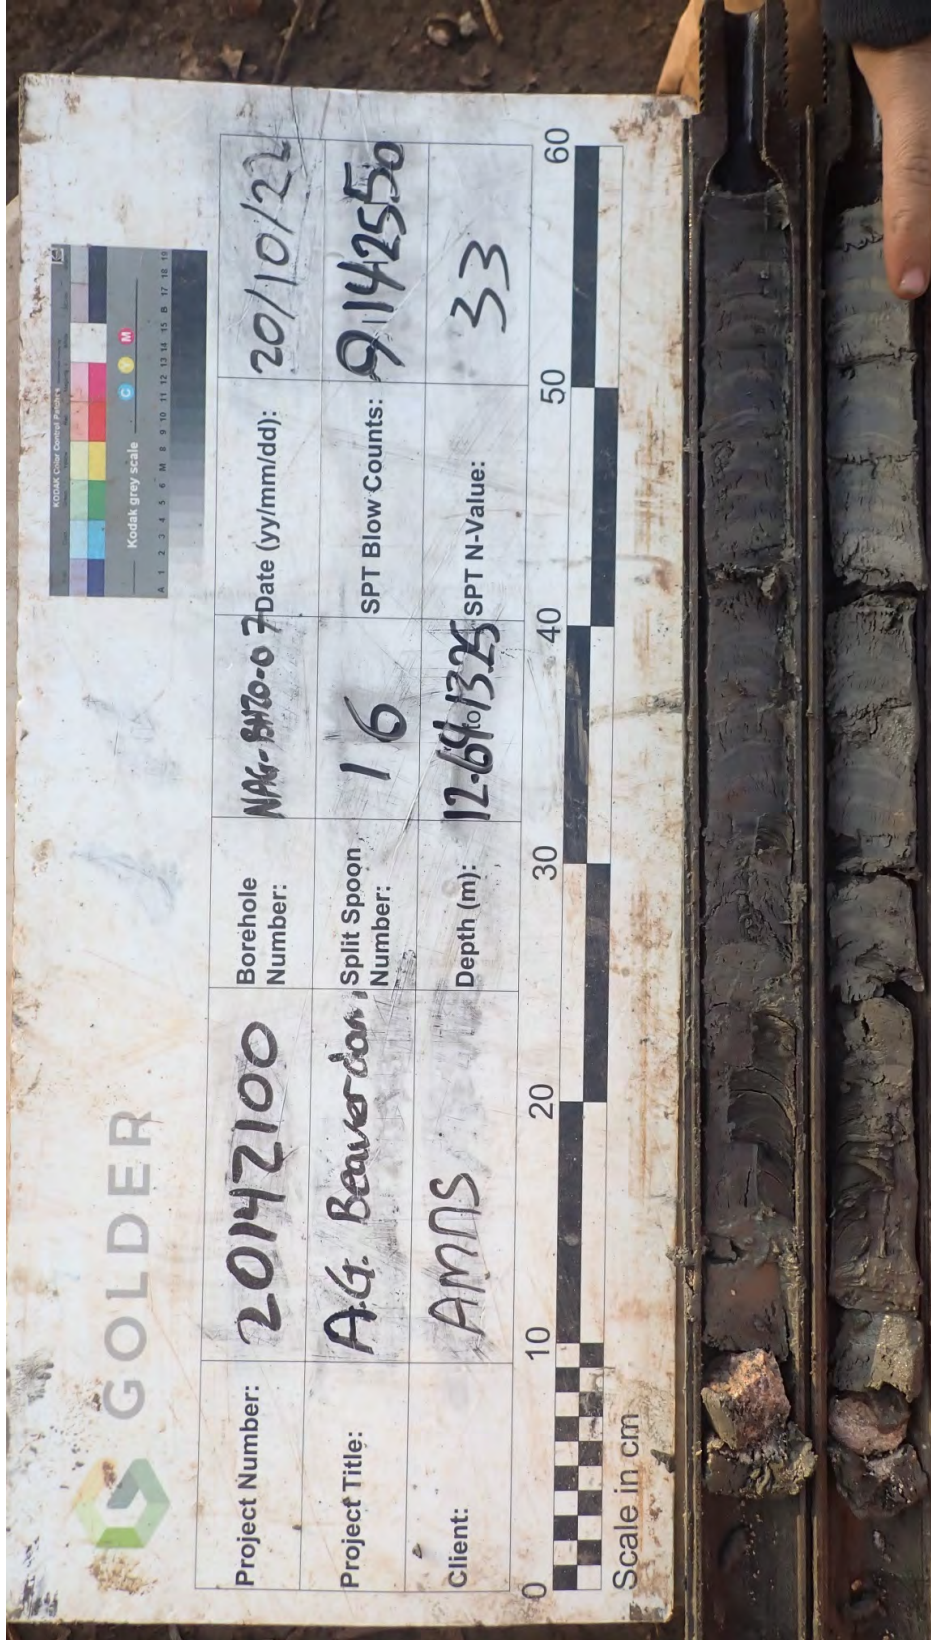
Project No. Control: 20142100 007  
 Rev. 0  
 Figure No. E61

TITLE  
SPLIT SPOON SAMPLE PHOTOGRAPH  
NAG-BH20-07 SS15

Project Number: <b>20142100</b>	Borehole Number: <b>NAG-SH20-07</b>	Date (yy/mm/dd): <b>20/10/22</b>
Project Title: <b>A.G. Beaver Dam</b>	Split Spoon Number: <b>16</b>	SPT Blow Counts: <b>9, 14, 25, 50</b>
Client: <b>AMNS</b>	Depth (m): <b>12.64 to 13.25</b>	SPT N-Value: <b>33</b>

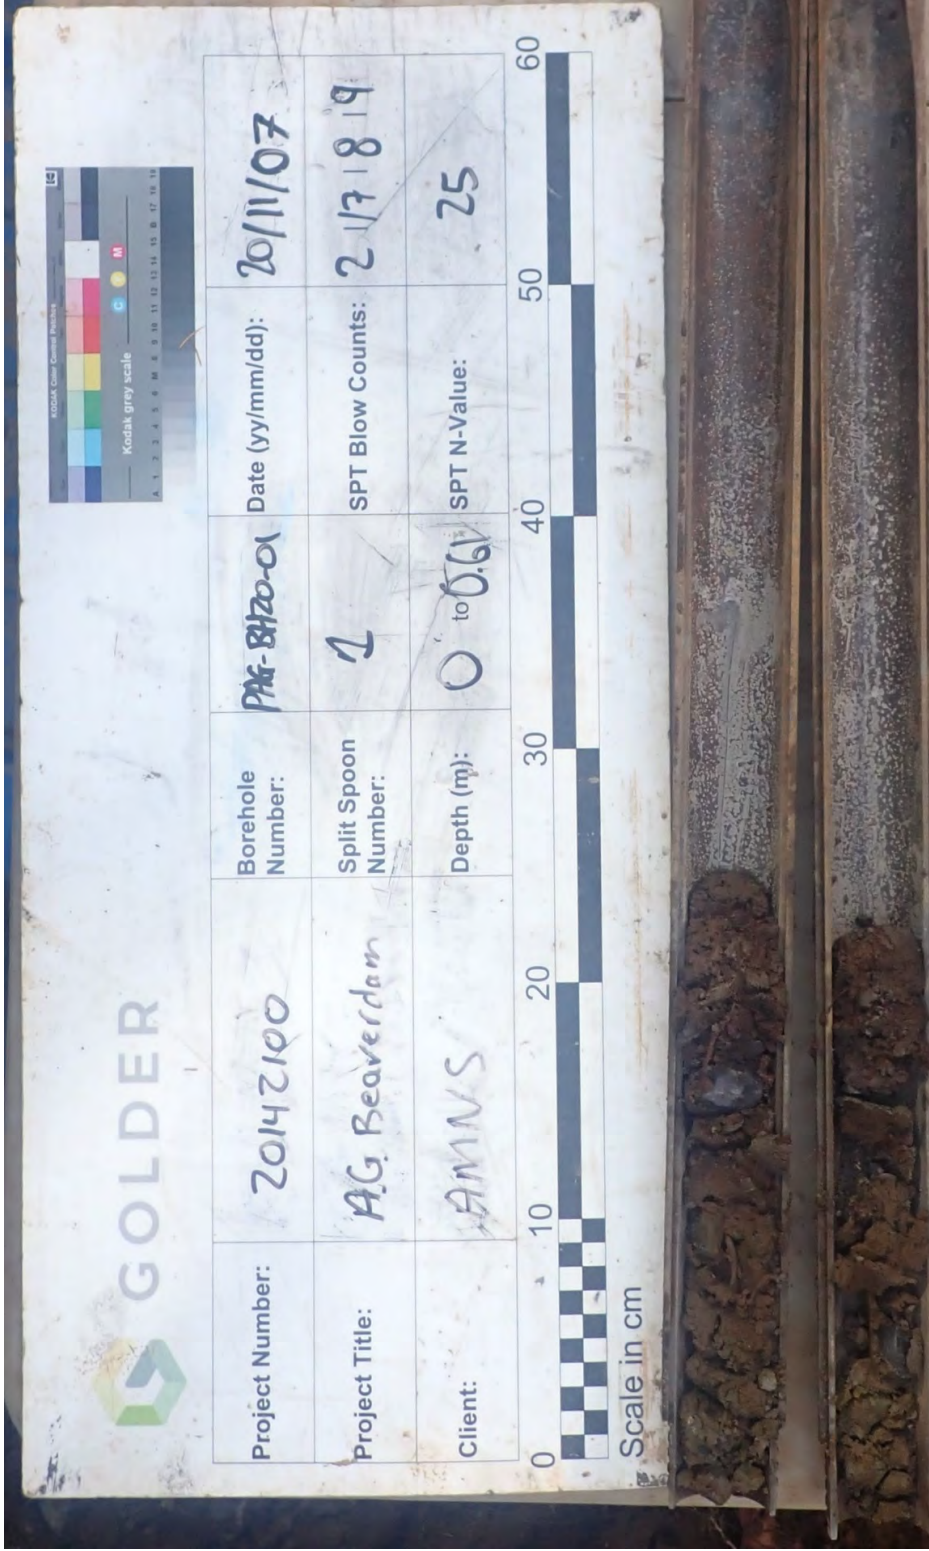
<b>GOLDER</b>	TITLE <b>SPLIT SPOON SAMPLE PHOTOGRAPH</b> <b>NAG-BH20-07 SS16</b>
DATE <b>2020-11-16</b>	Project No. <b>20142100</b>
PREPARED <b>.JB</b>	Control <b>007</b>
DESIGN <b>—</b>	Rev. <b>0</b>
REVIEW <b>—</b>	Figure No. <b>E62</b>
APPROVED <b>—</b>

TITLE  
SPLIT SPOON SAMPLE PHOTOGRAPH  
PAG-BH20-01 SS1

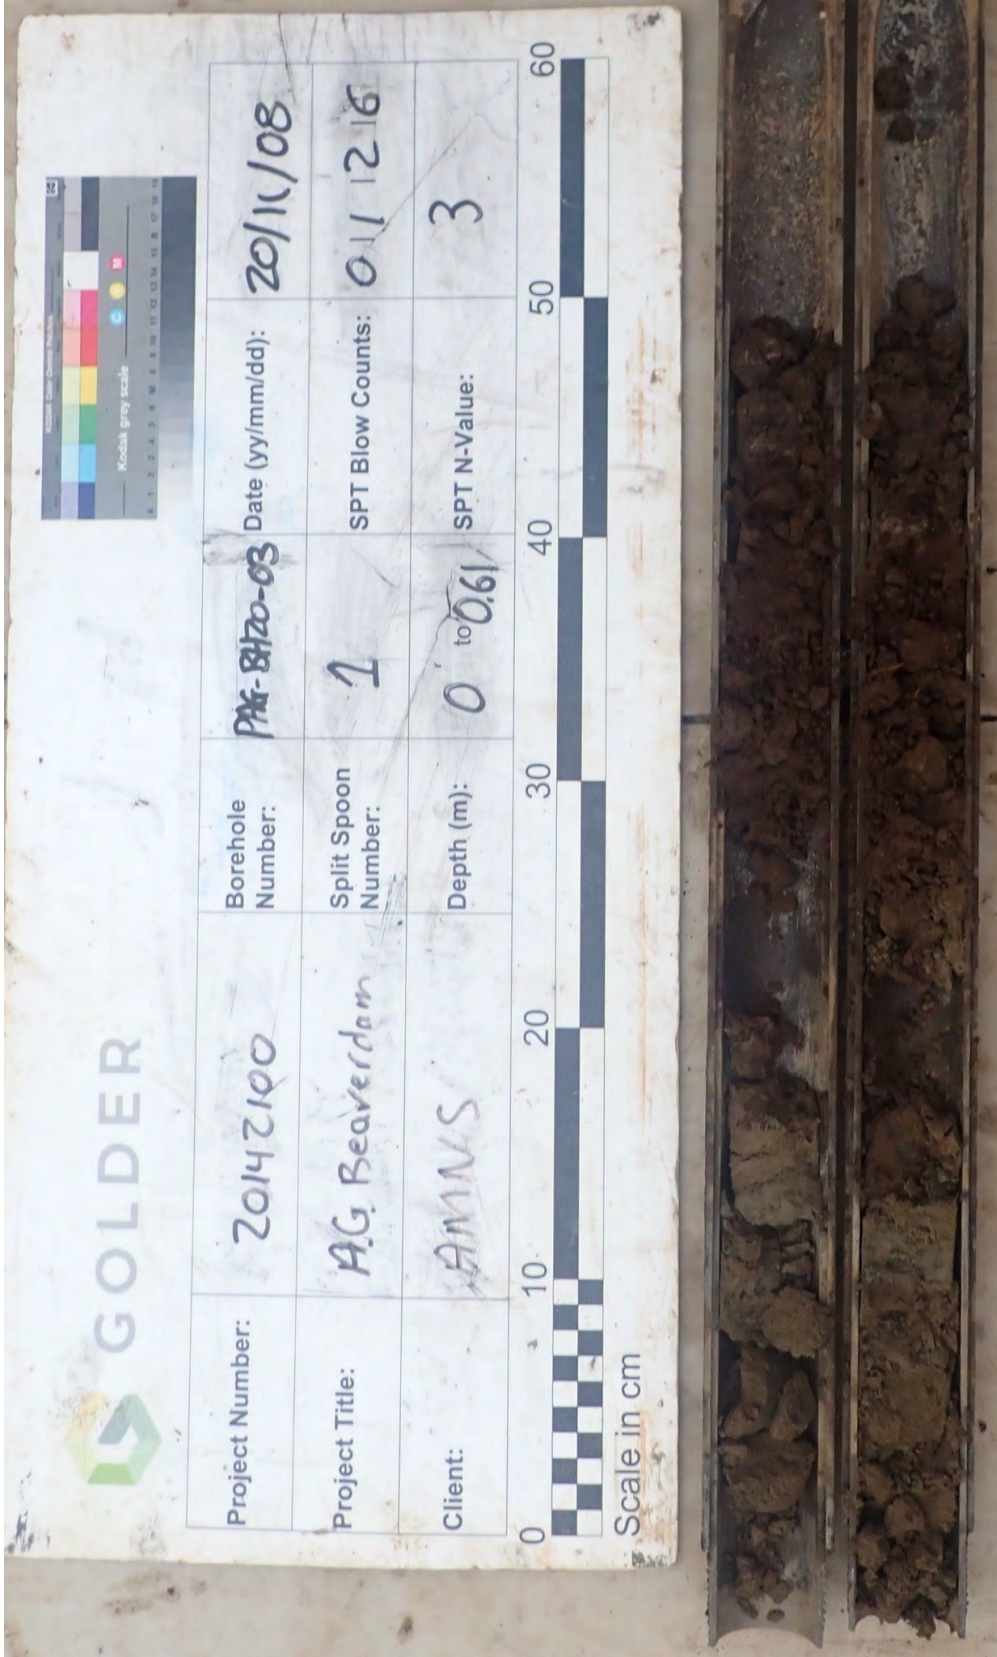
Project No. Control 20142100 007 Rev. 0 Figure No. E65

TITLE  
SPLIT SPOON SAMPLE PHOTOGRAPH  
PAG-BH20-02 SS2
