Geotechnical Investigation: Data Report –  
Beaver Dam Mine, January 15, 2021as  
Completed for the Updated 2021 Beaver Dam Mine EIS

# Geotechnical Investigation: Data Report

## *Beaver Dam Mine*

20142100-004-R-Rev0

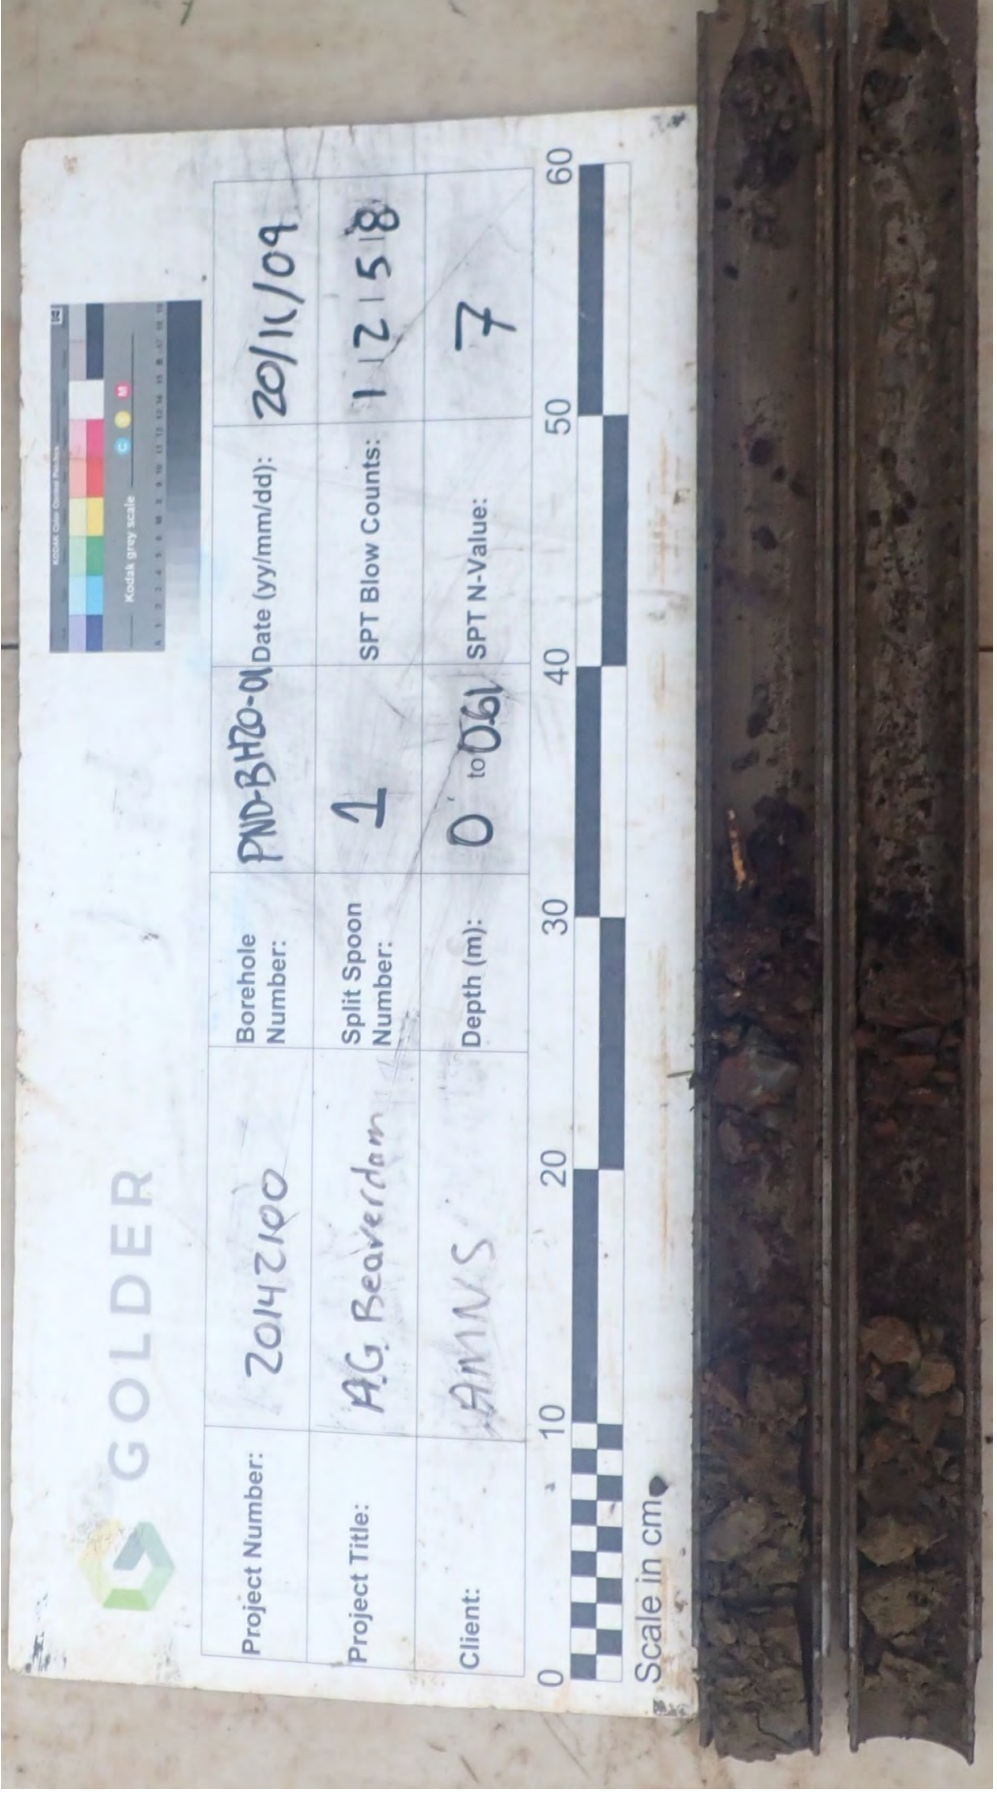
Project Number:	20142100	Borehole Number:	PND-BH20-01	Date (yy/mm/dd):	20/11/09
Project Title:	AG Beaverdam	Split Spoon Number:	1	SPT Blow Counts:	1   2   5   8
Client:	AMNS	Depth (m):	0 to 0.61	SPT N-Value:	7

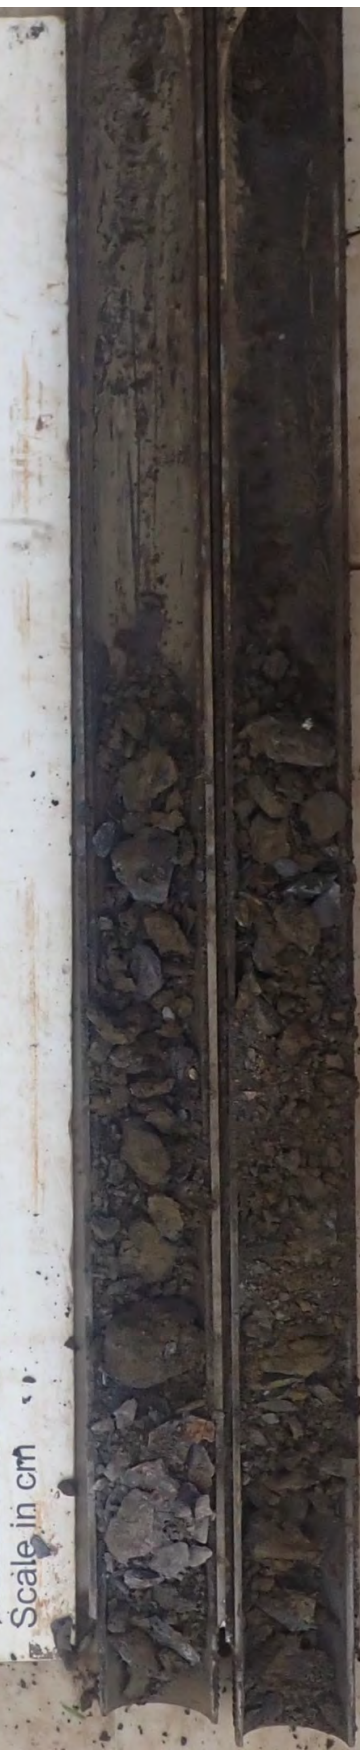
Project Number:	20142100	Borehole Number:	PND-BH20-01	Date (yy/mm/dd):	20/11/09
Project Title:	AG Beaverdam	Split Spoon Number:	2	SPT Blow Counts:	11 17 18 18
Client:	AMNS	Depth (m):	0.61 to 1.77	SPT N-Value:	35

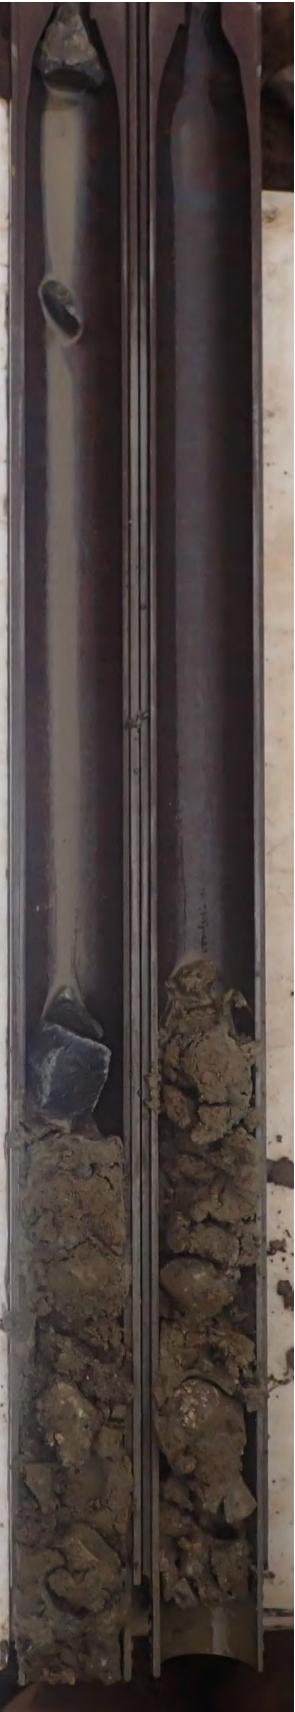
Project Number:	20142100	Borehole Number:	PND-BH20-02	Date (yy/mm/dd):	20/11/06
Project Title:	AG Beaverdam	Split Spoon Number:	3	SPT Blow Counts:	20362717
Client:	AMINS	Depth (m):	1.40 to 2.01	SPT N-Value:	63

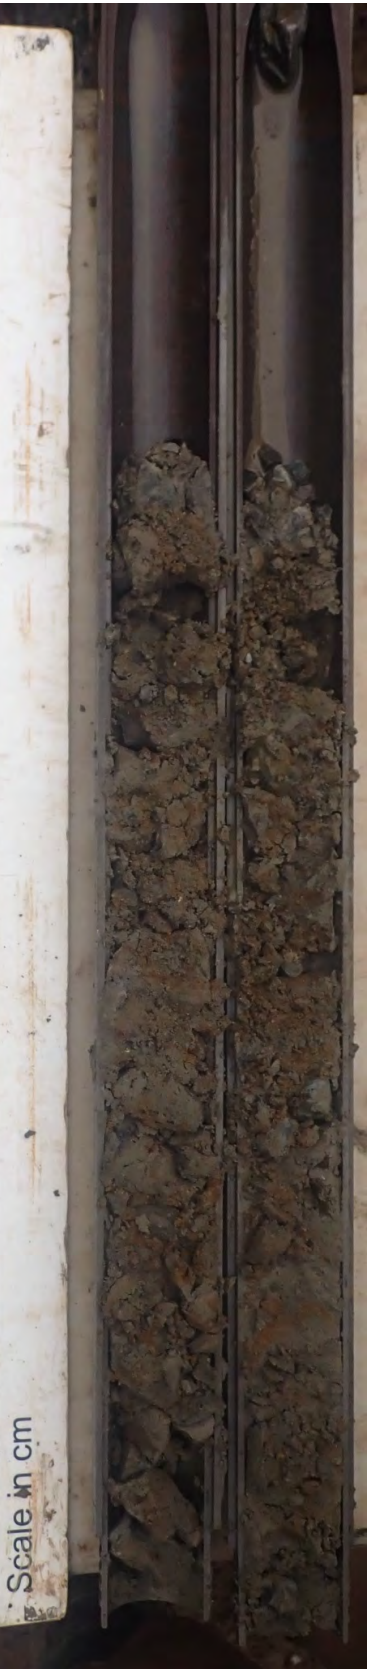
Project Number:	20142100	Borehole Number:	PND-BH20-02	Date (yy/mm/dd):	20/11/06
Project Title:	A.G. Beaverdam	Split Spoon Number:	5	SPT Blow Counts:	28   41   49   50 120
Client:	AMNS	Depth (m):	2.90 to 3.48	SPT N-Value:	90

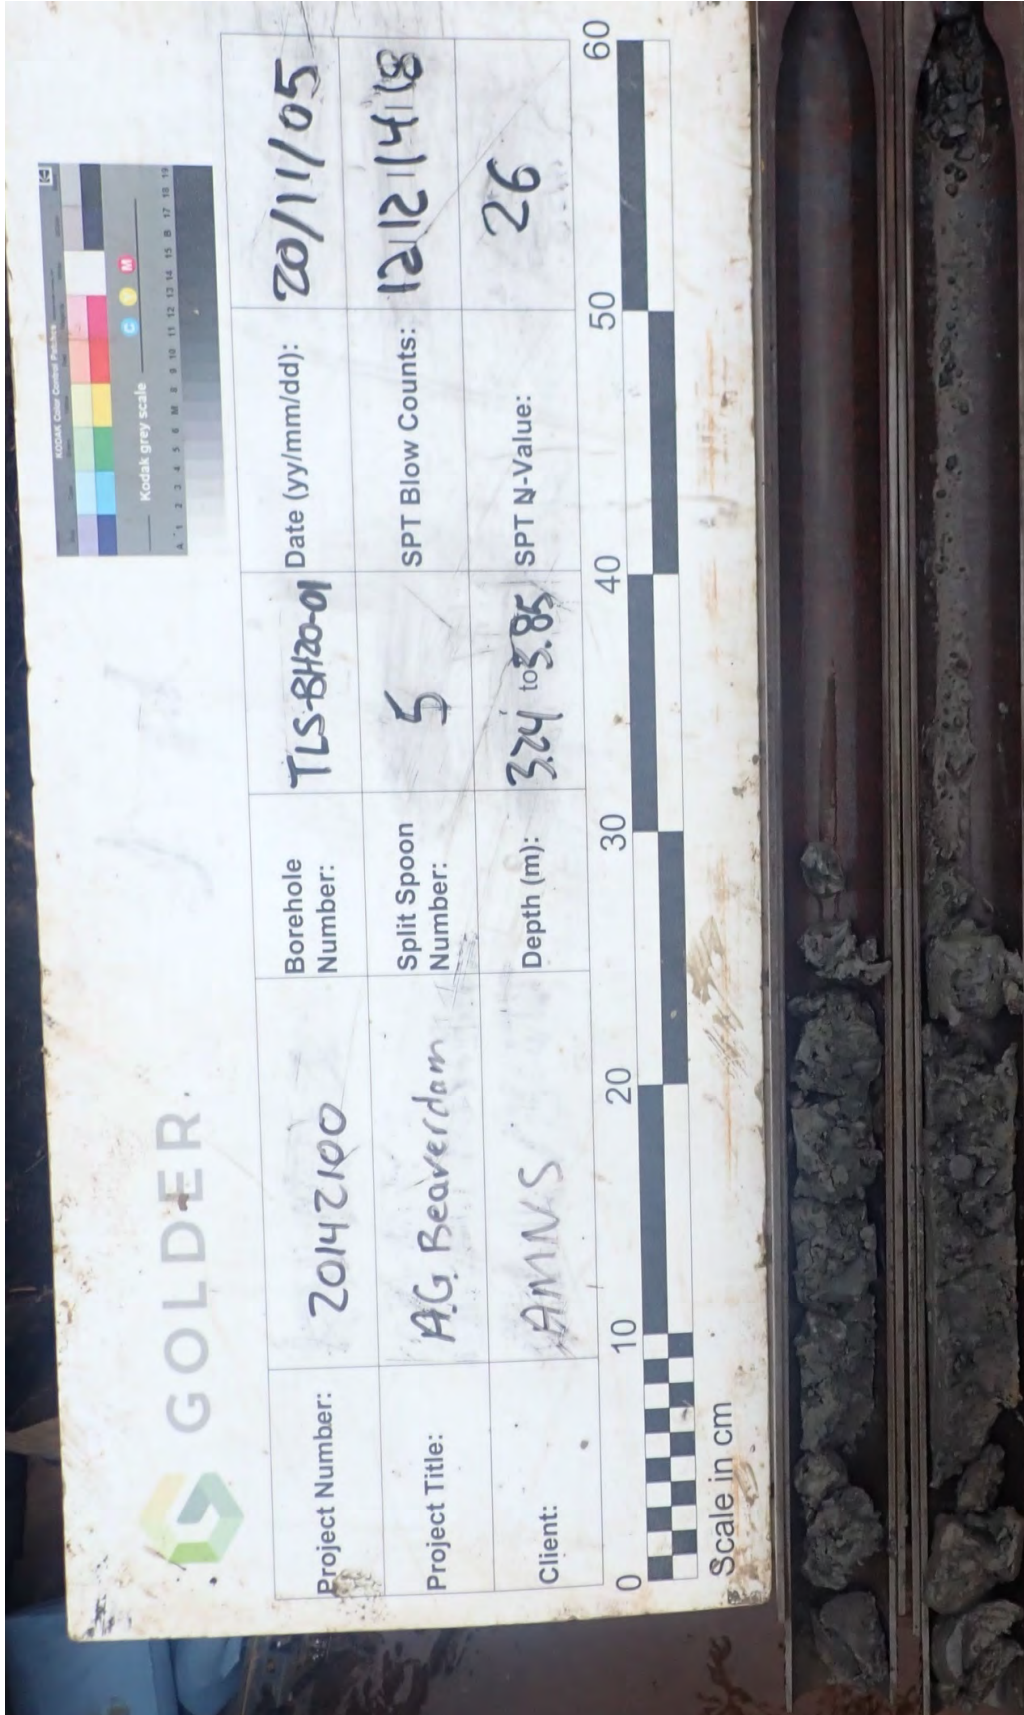
Project Number:	20142100	Borehole Number:	TLS-BH20-01	Date (yy/mm/dd):	20/11/05
Project Title:	AG Beaverdam	Split Spoon Number:	5	SPT Blow Counts:	12/12/14/18
Client:	AMNS	Depth (m):	3.24 to 3.85	SPT N-Value:	26

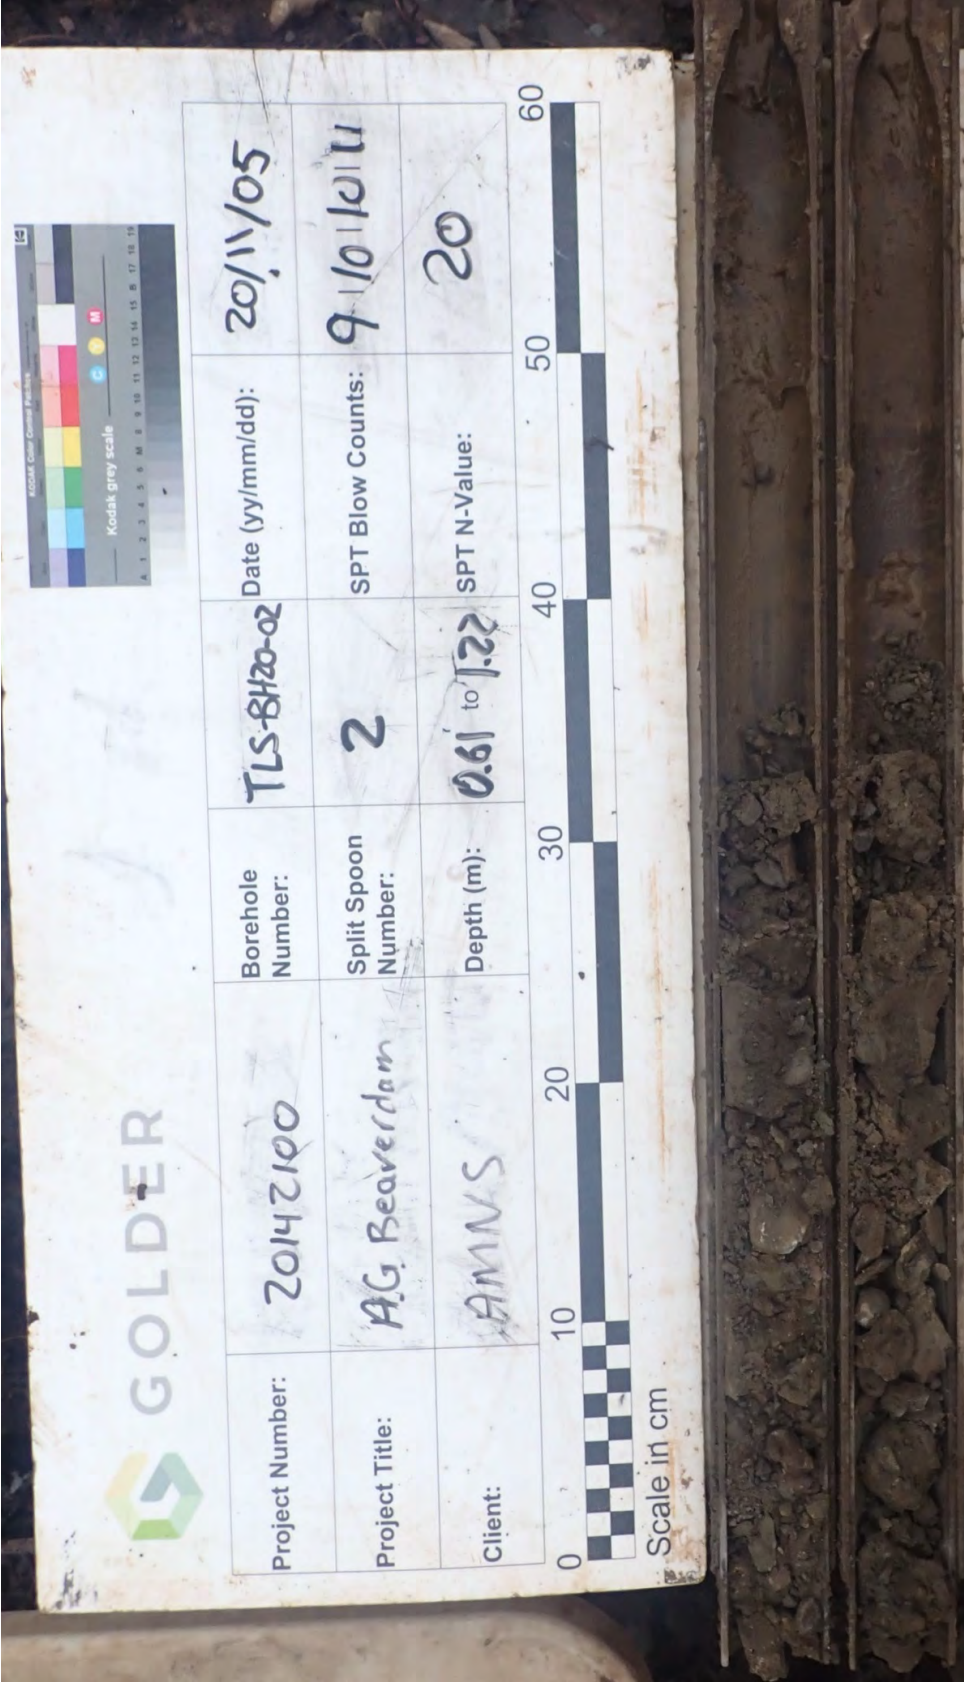
Project No.	Control	Rev.	Figure No.
20142100	007	0	E89

TITLE  
**SPLIT SPOON SAMPLE PHOTOGRAPH**  
**TLS-BH20-02 SS1**

Project Number:	20142100	Borehole Number:	TLS-BH20-02	Date (yy/mm/dd):	20/11/05
Project Title:	A.G. Beaverdam	Split Spoon Number:	2	SPT Blow Counts:	9 10 10 11
Client:	AMNS	Depth (m):	0.61 to 1.22	SPT N-Value:	20

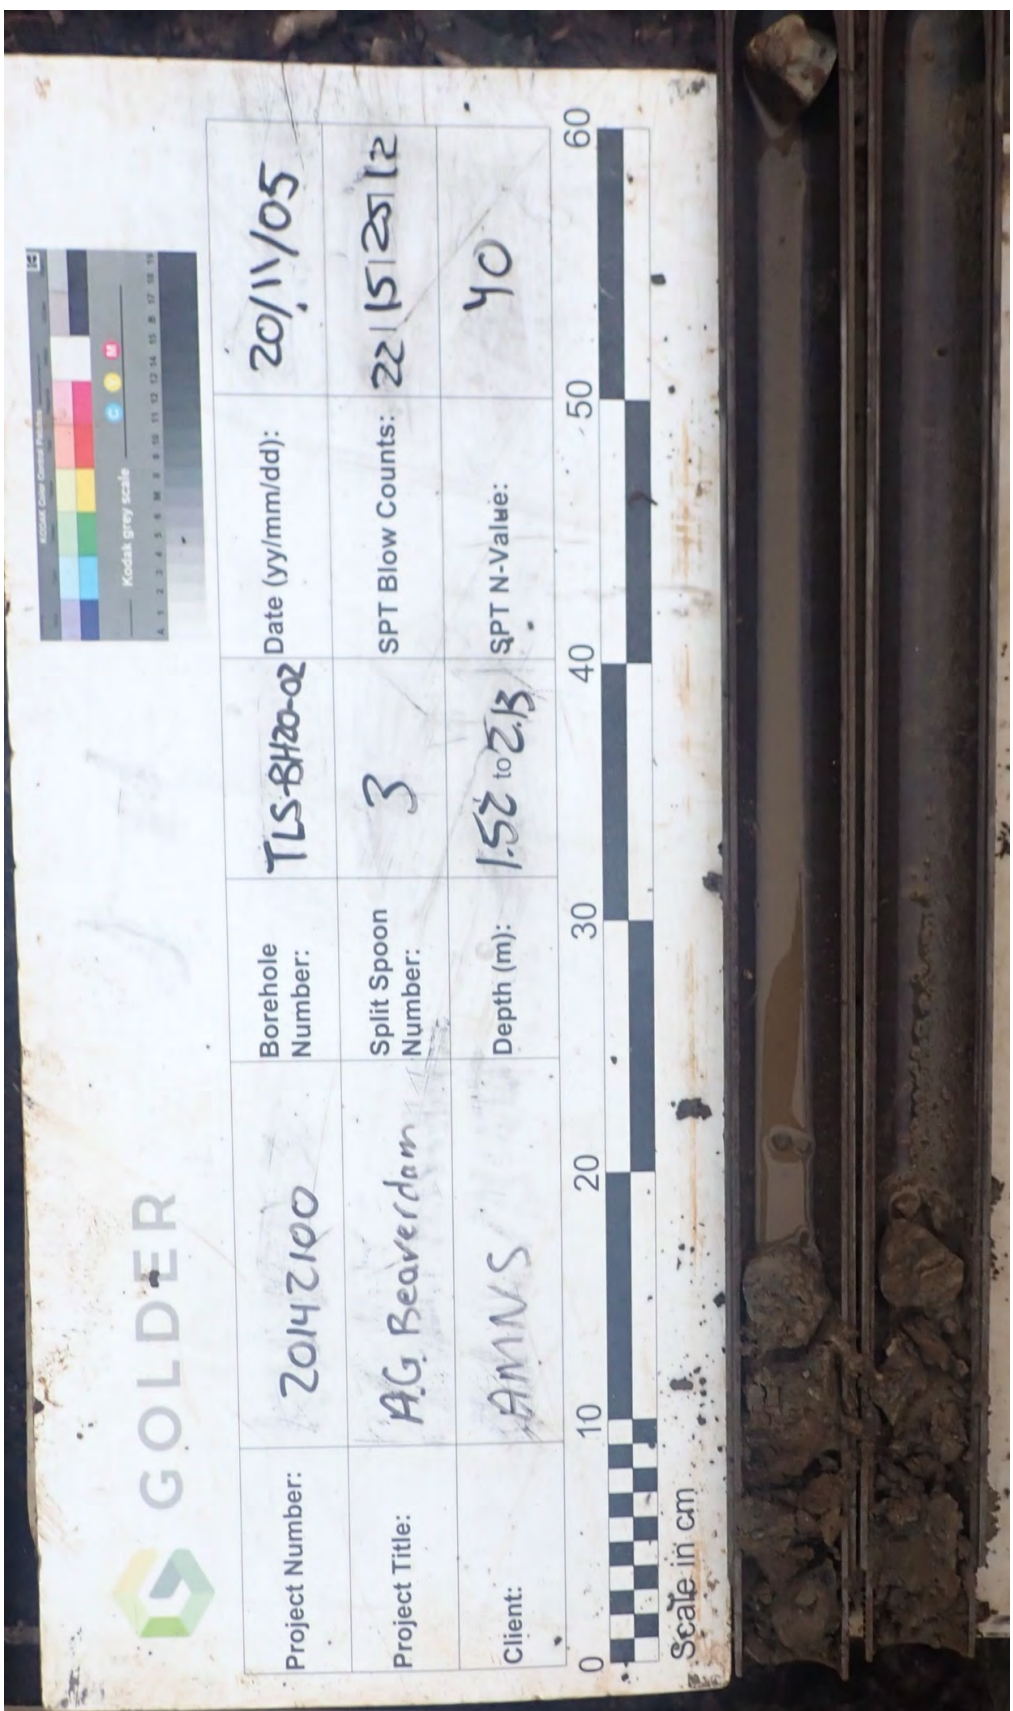
Project Number:	20142100	Borehole Number:	TLS-BH20-02	Date (yy/mm/dd):	20/11/05
Project Title:	AG Beaverdam	Split Spoon Number:	3	SPT Blow Counts:	22   15   28   12
Client:	AMNS	Depth (m):	1.52 to 2.13	SPT N-Value:	40

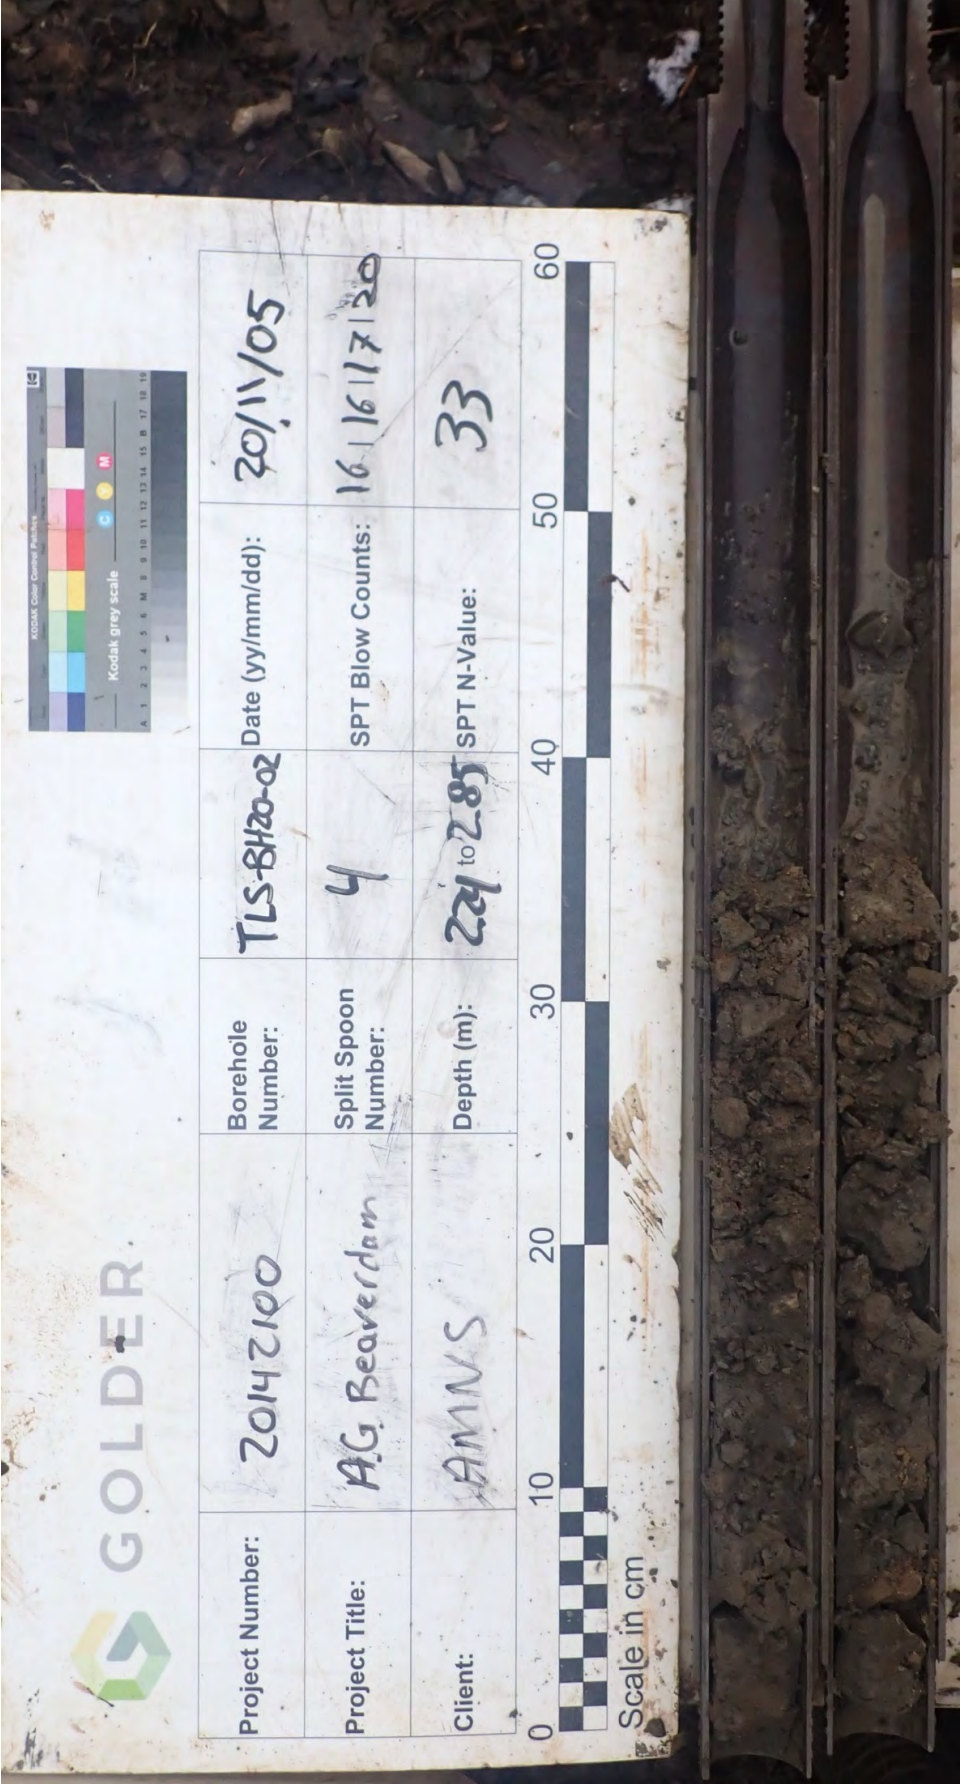
Project Number:	20142100	Borehole Number:	TLS-BH20-02	Date (yy/mm/dd):	20/11/05
Project Title:	AG Beaverdam	Split Spoon Number:	4	SPT Blow Counts:	16   16   17   20
Client:	AMNS	Depth (m):	2.24 to 2.85	SPT N-Value:	33

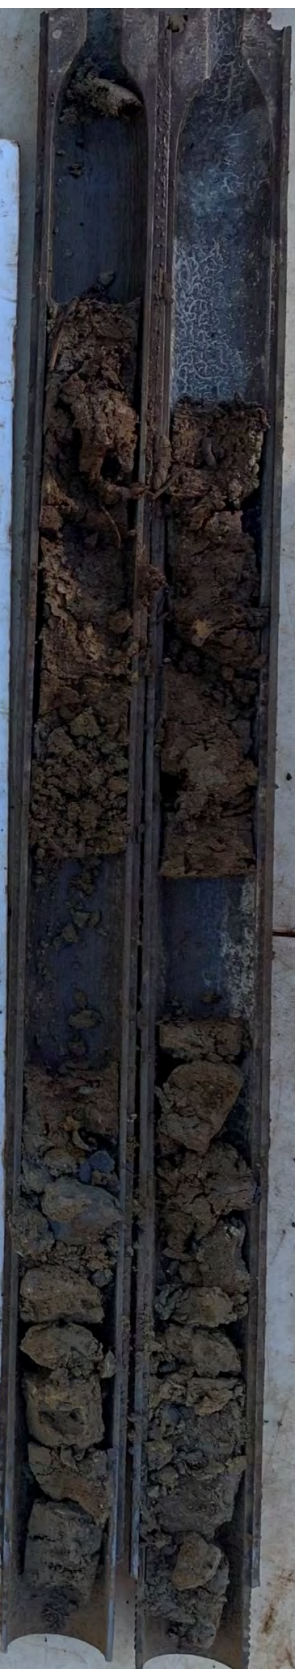
Project Number:	20142100	Borehole Number:	TLS-BH20-03	Date (yy/mm/dd):	20/11/10
Project Title:	AG Beaverdam	Split Spoon Number:	1	SPT Blow Counts:	1 6 8 19
Client:	AMNS	Depth (m):	0 to 0.61	SPT N-Value:	14

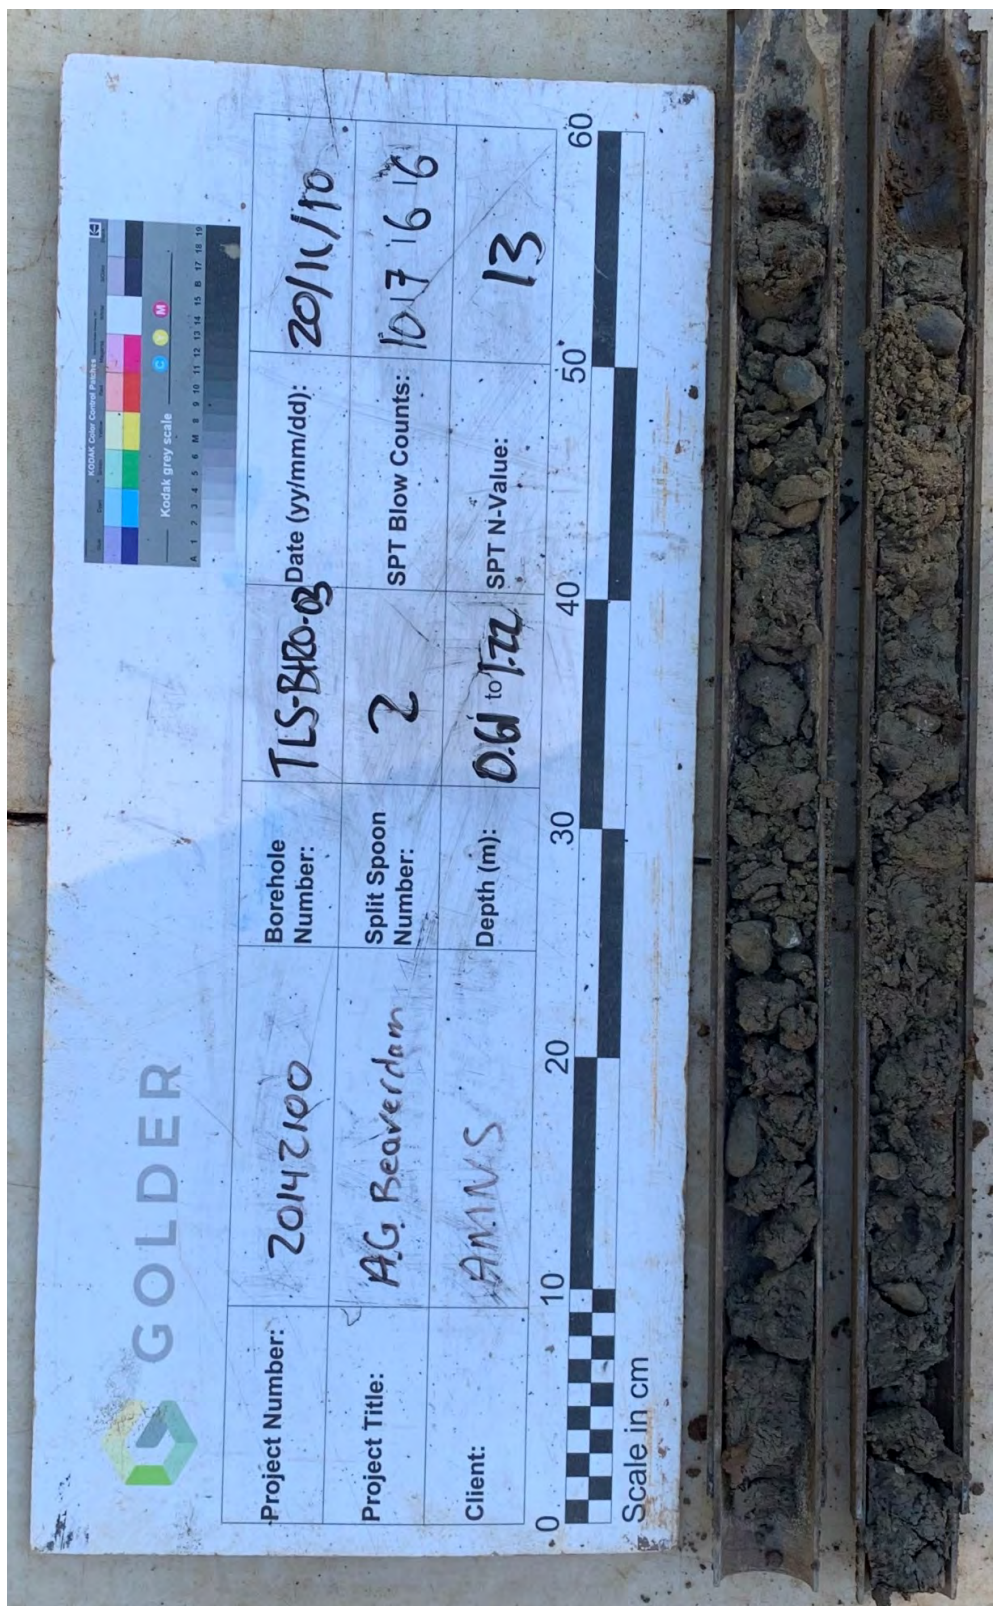
Project Number:	20142100	Borehole Number:	TLS-BH20-03	Date (yy/mm/dd):	20/11/10
Project Title:	A.G. Beaverdam	Split Spoon Number:	2	SPT Blow Counts:	10 17 16 16
Client:	AMMS	Depth (m):	0.61 to 1.72	SPT N-Value:	13

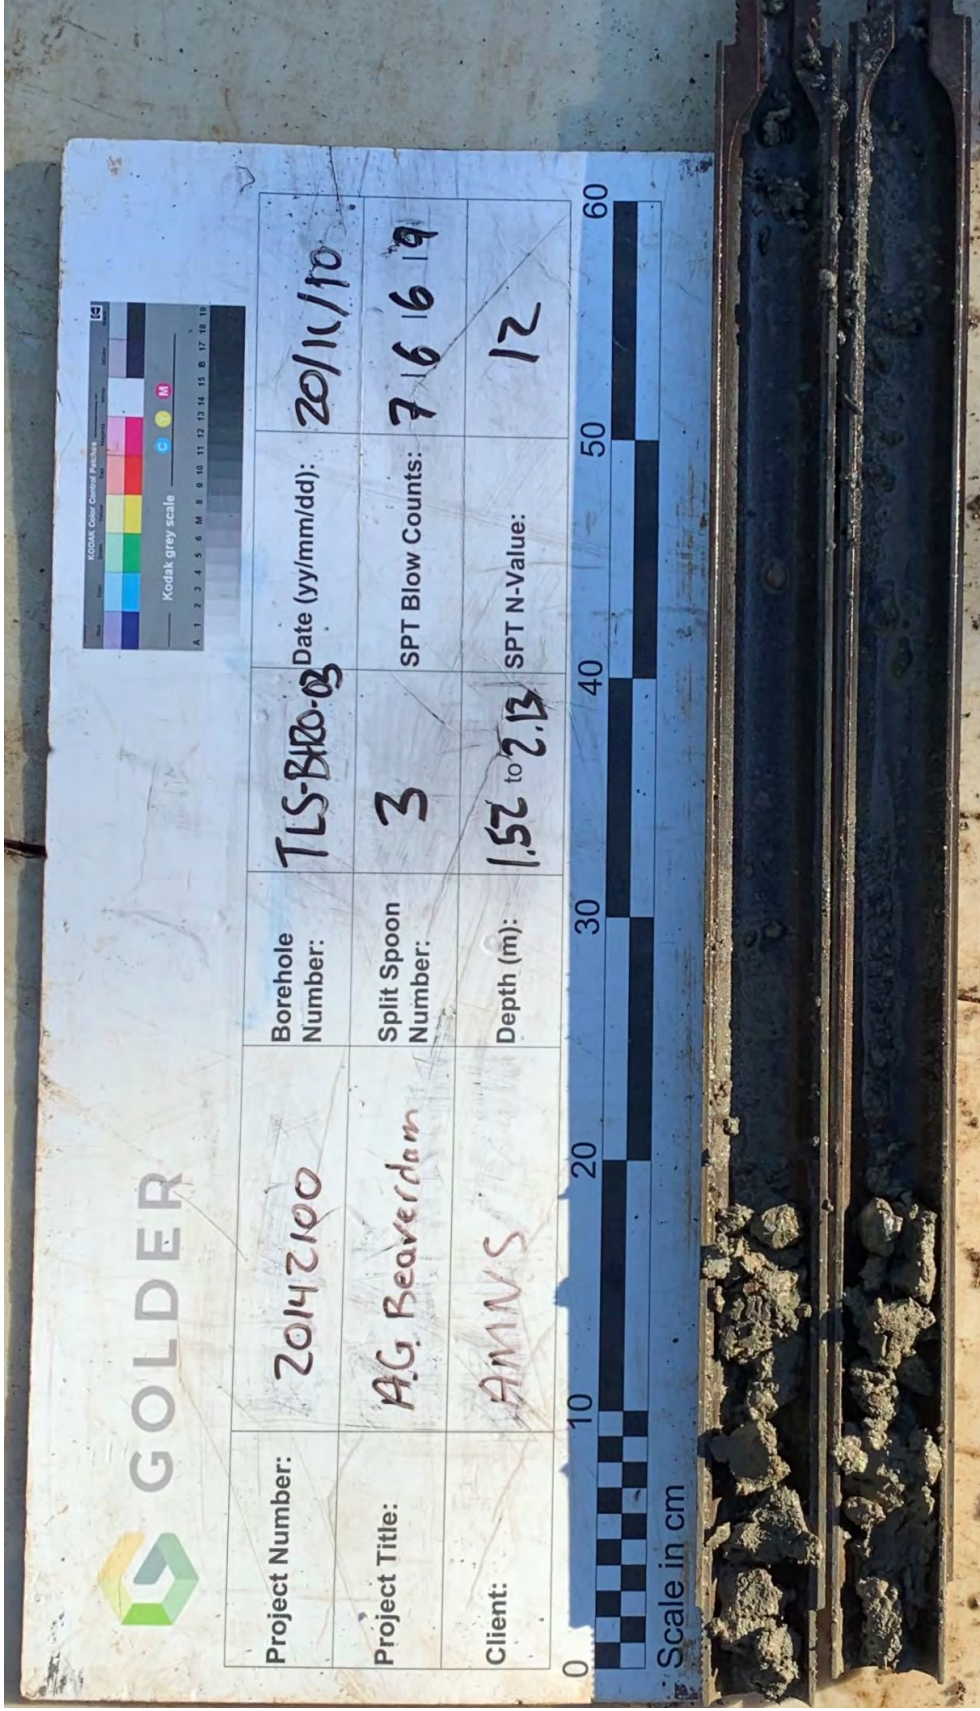
Project Number:	20142100	Borehole Number:	TLS-BH20-03	Date (yy/mm/dd):	20/11/10
Project Title:	A.G. Beaverdam	Split Spoon Number:	3	SPT Blow Counts:	7   6   6   9
Client:	AMNS	Depth (m):	1.52 to 2.13	SPT N-Value:	12

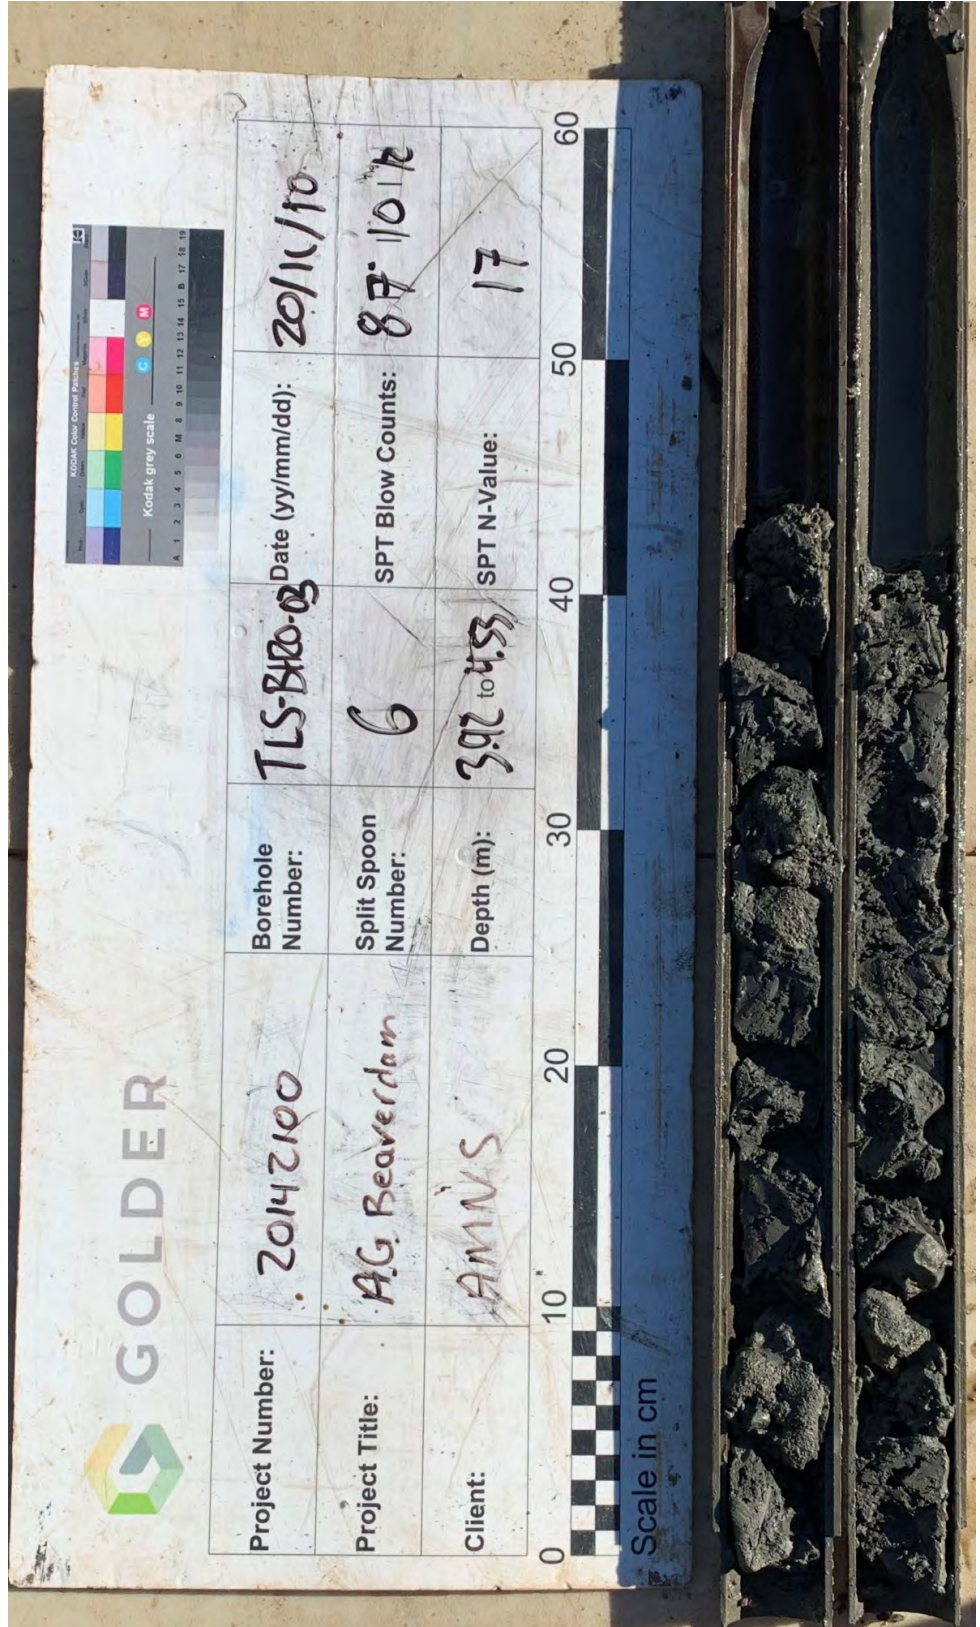
Project Number:	20142100	Borehole Number:	TLS-BH20-03	Date (yy/mm/dd):	20/11/10
Project Title:	A.G. Beaverdam	Split Spoon Number:	6	SPT Blow Counts:	87 110 12
Client:	AMNS	Depth (m):	3.92 to 4.55	SPT N-Value:	17

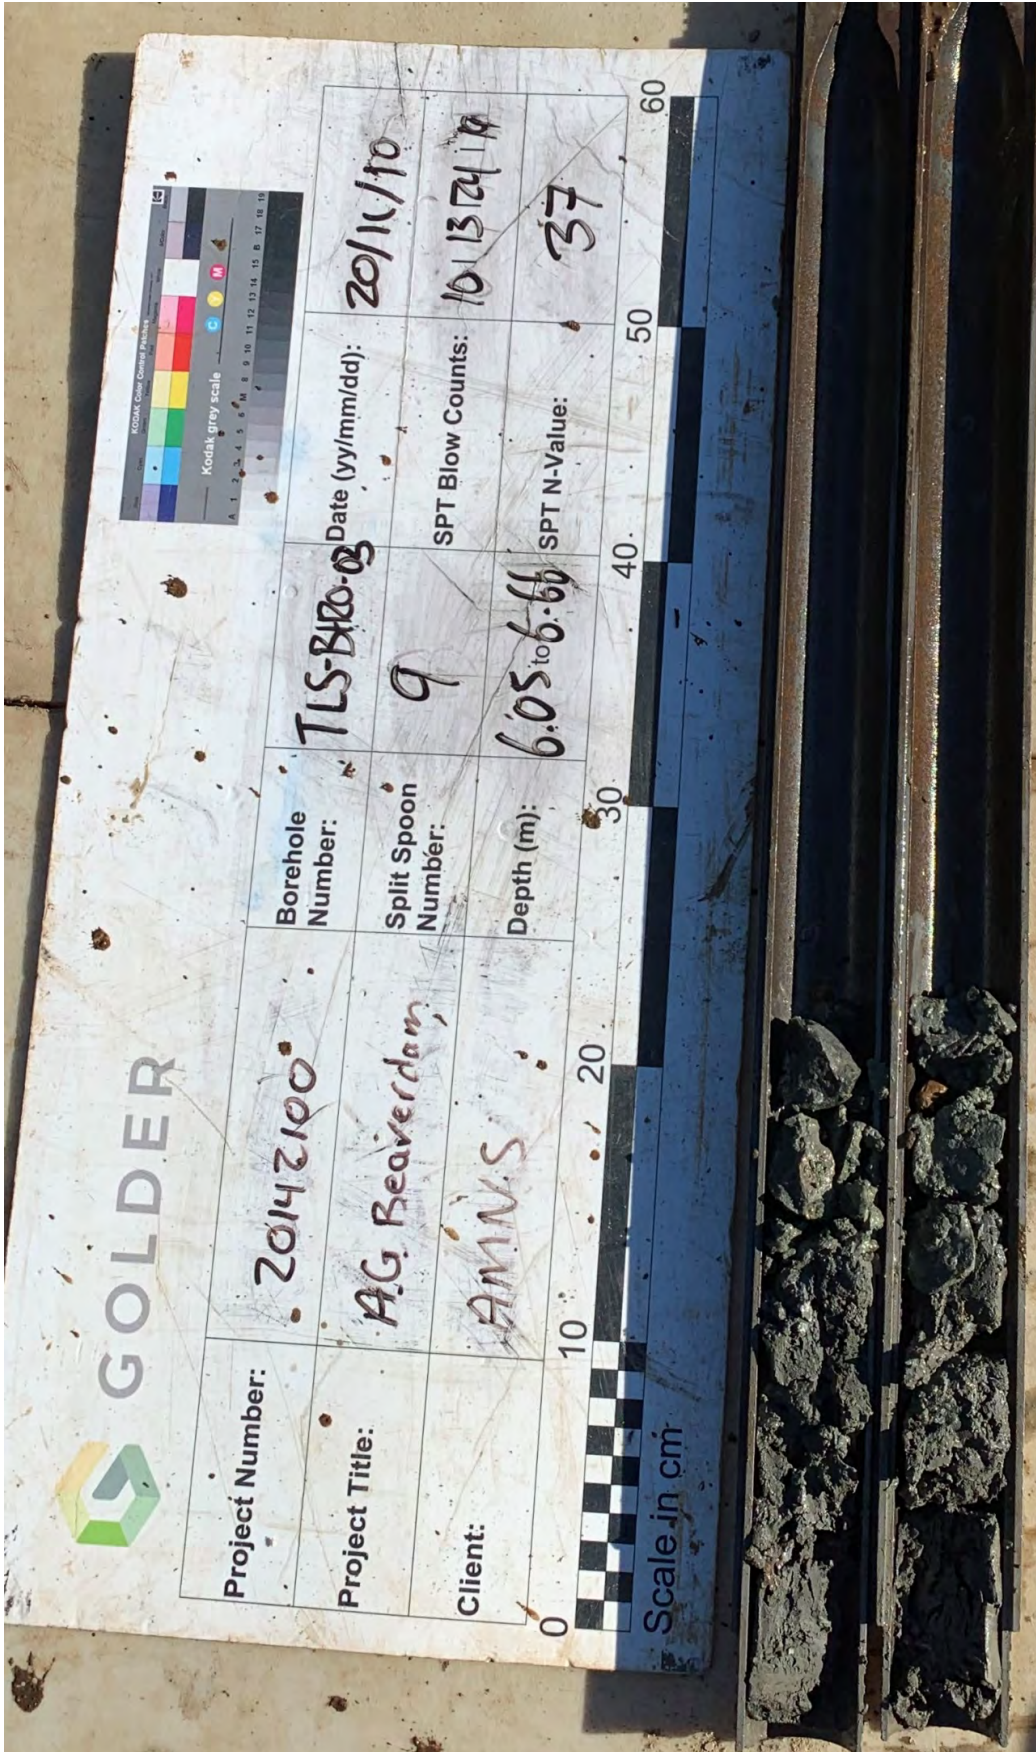
Project Number:	20142100	Borehole Number:	TLS-BH20-03	Date (yy/mm/dd):	20/11/10
Project Title:	AG Beaverdam	Split Spoon Number:	9	SPT Blow Counts:	10   13   24   19
Client:	AMINS	Depth (m):	6.05 to 6.66	SPT N-Value:	37

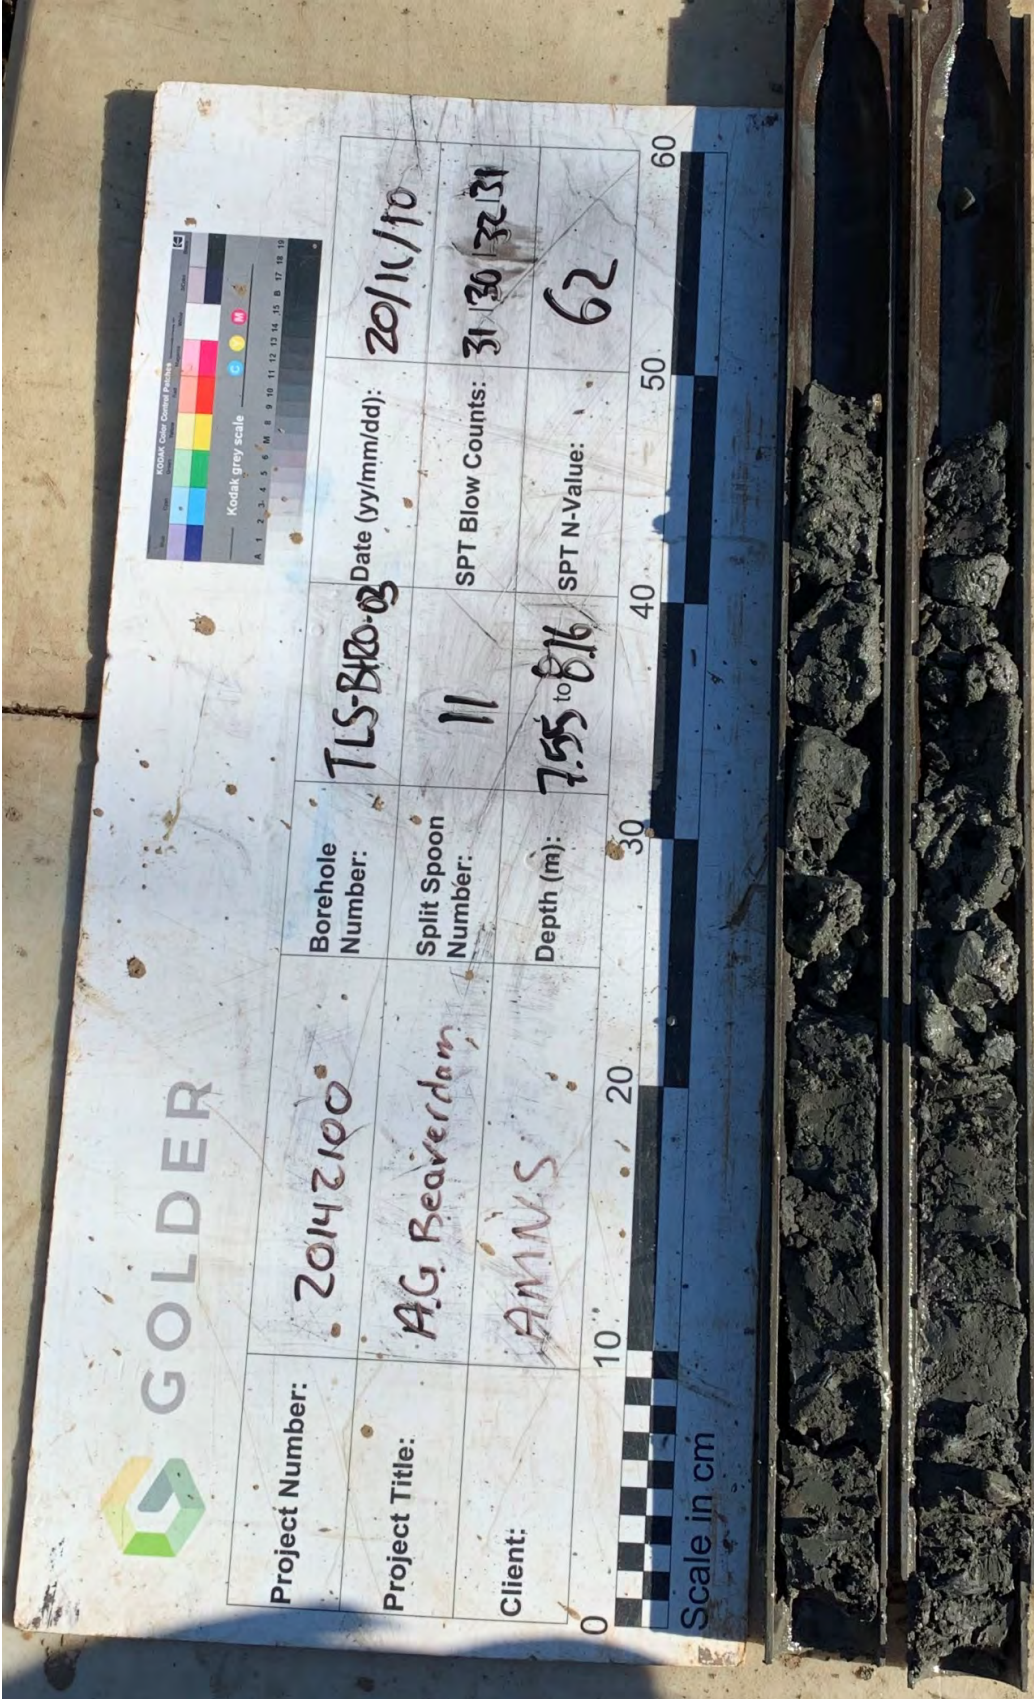
Project Number:	20142100	Borehole Number:	TLS-BH20-04	Date (yy/mm/dd):	20/11/10
Project Title:	A.G. Beaverdam	Split Spoon Number:	1	SPT Blow Counts:	1 3 8 5
Client:	AMNS	Depth (m):	0 to 0.61	SPT N-Value:	11

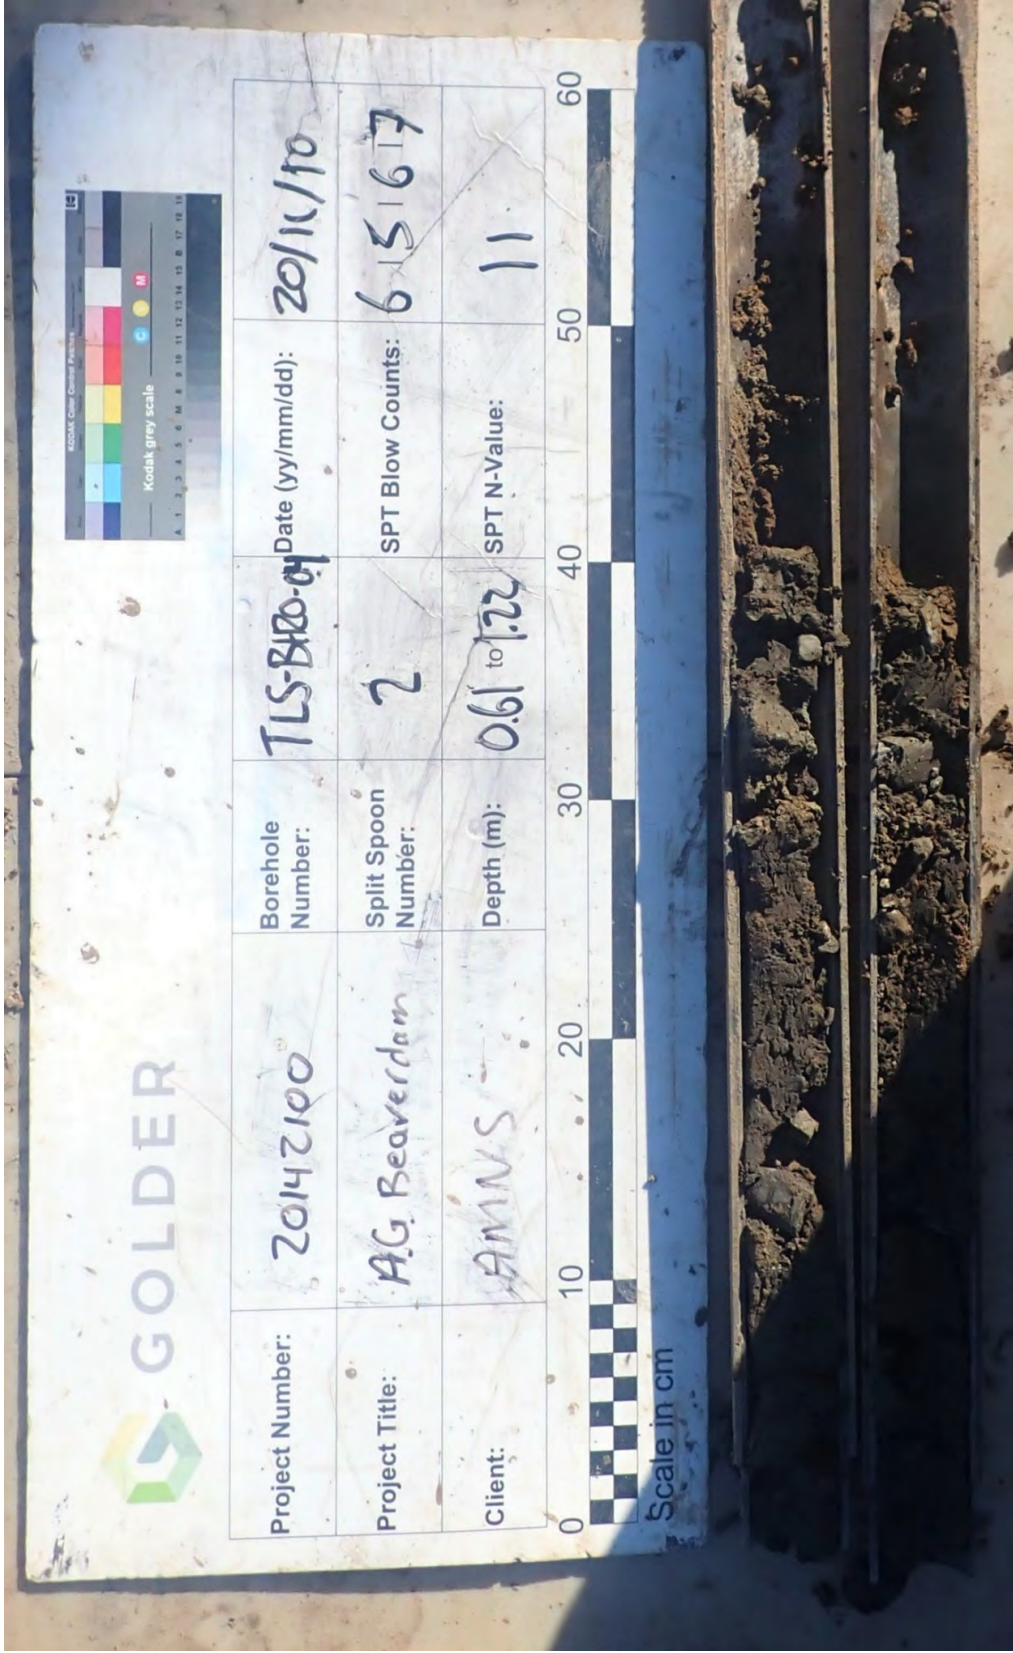
Project Number:	20142100	Borehole Number:	TLS-BH20-04	Date (yy/mm/dd):	20/11/10
Project Title:	A.G. Beaverdam	Split Spoon Number:	2	SPT Blow Counts:	6 15 16 17
Client:	AMNS	Depth (m):	0.61 to 1.22	SPT N-Value:	11

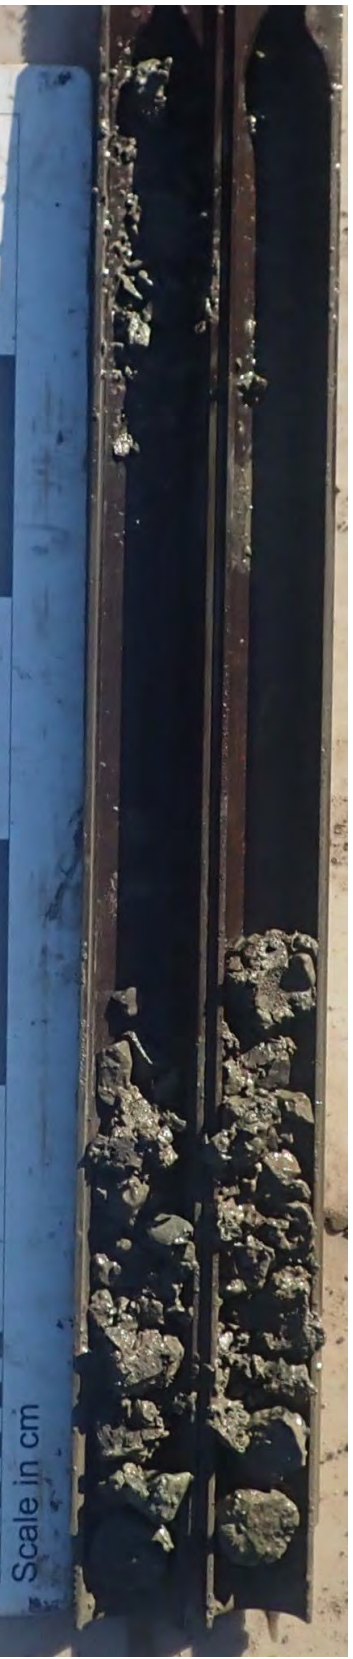
Project Number:	20142100	Borehole Number:	TLS-BH20-04	Date (yy/mm/dd):	20/11/10
Project Title:	A.G. Beaverdam	Split Spoon Number:	4	SPT Blow Counts:	26 16 22 31
Client:	AMNS	Depth (m):	2.0 to 2.90	SPT N-Value:	38

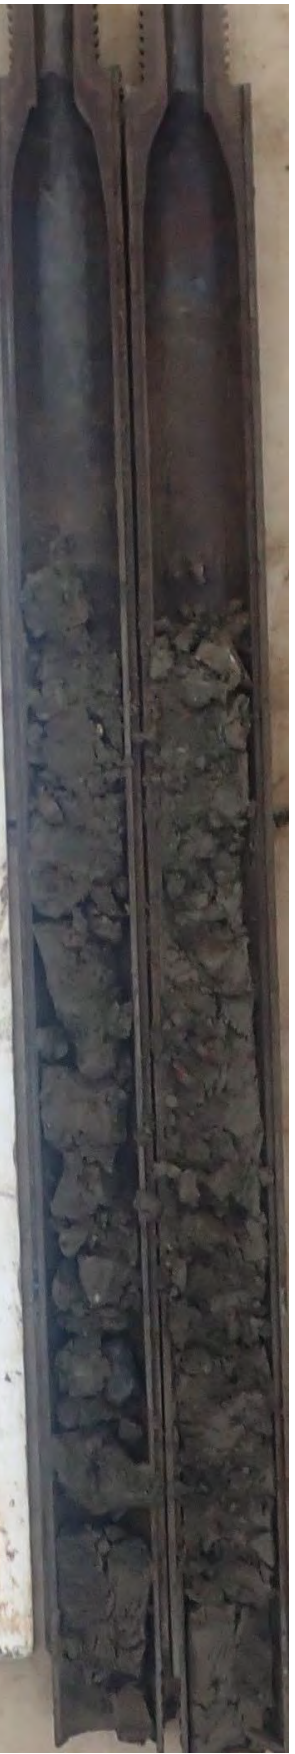
Project Number:	20142100	Borehole Number:	TLS-BH20-05	Date (yy/mm/dd):	20/11/11
Project Title:	AG, Beaverdam	Split Spoon Number:	2	SPT Blow Counts:	7, 7, 6, 1, 8
Client:	AMNS	Depth (m):	0.61 to 1.22	SPT N-Value:	13
