Geotechnical Investigation: Data Report –  
Beaver Dam Mine, January 15, 2021as  
Completed for the Updated 2021 Beaver Dam Mine EIS

# Geotechnical Investigation: Data Report

## *Beaver Dam Mine*

20142100-004-R-Rev0

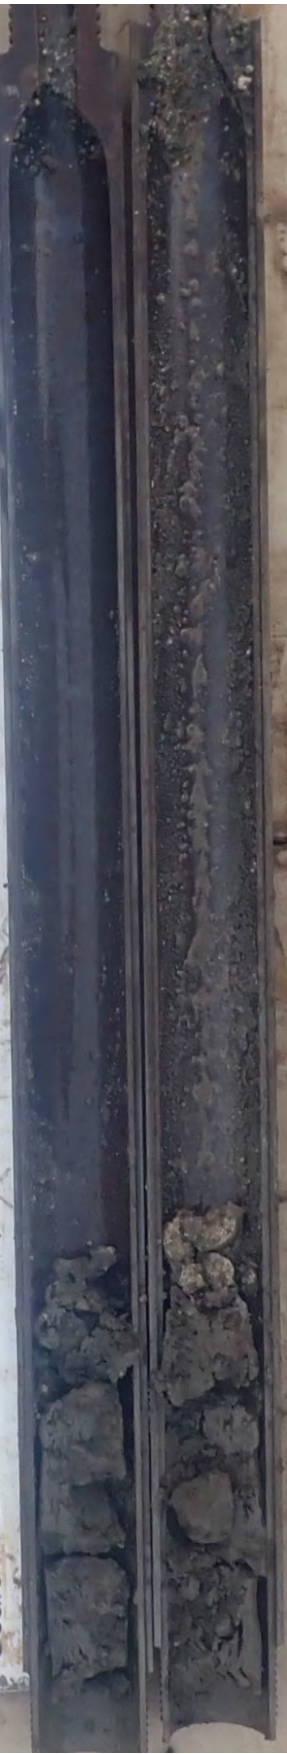
Project Number:	20142100	Borehole Number:	TL5-BH20-05	Date (yy/mm/dd):	20/11/11
Project Title:	A.G. Beaverdam	Split Spoon Number:	3	SPT Blow Counts:	9 13 7 10
Client:	AMNS	Depth (m):	1.52 to 2.13	SPT N-Value:	14

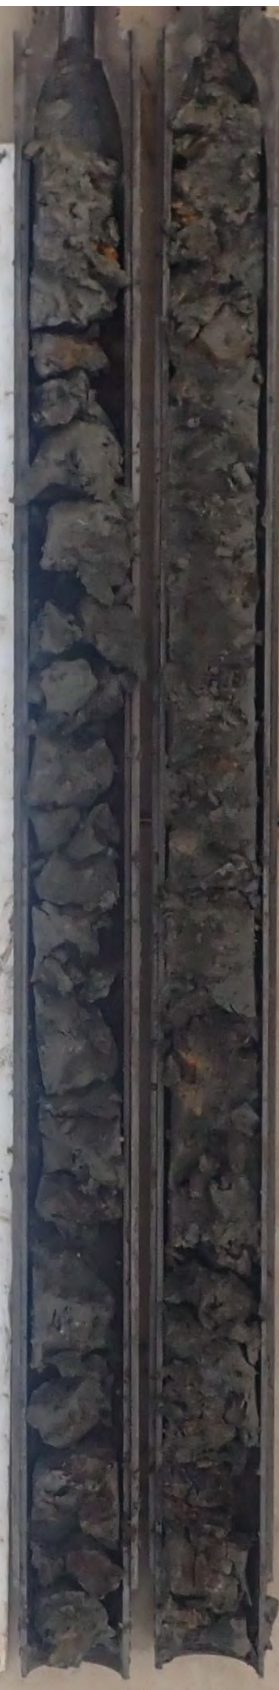
Project Number:	20142100	Borehole Number:	TL5-BH20-05	Date (yy/mm/dd):	20/11/11
Project Title:	AG, Beaverdam	Split Spoon Number:	5	SPT Blow Counts:	20   26   36   50 130a
Client:	AMNS	Depth (m):	3.70 to 3.79	SPT N-Value:	62

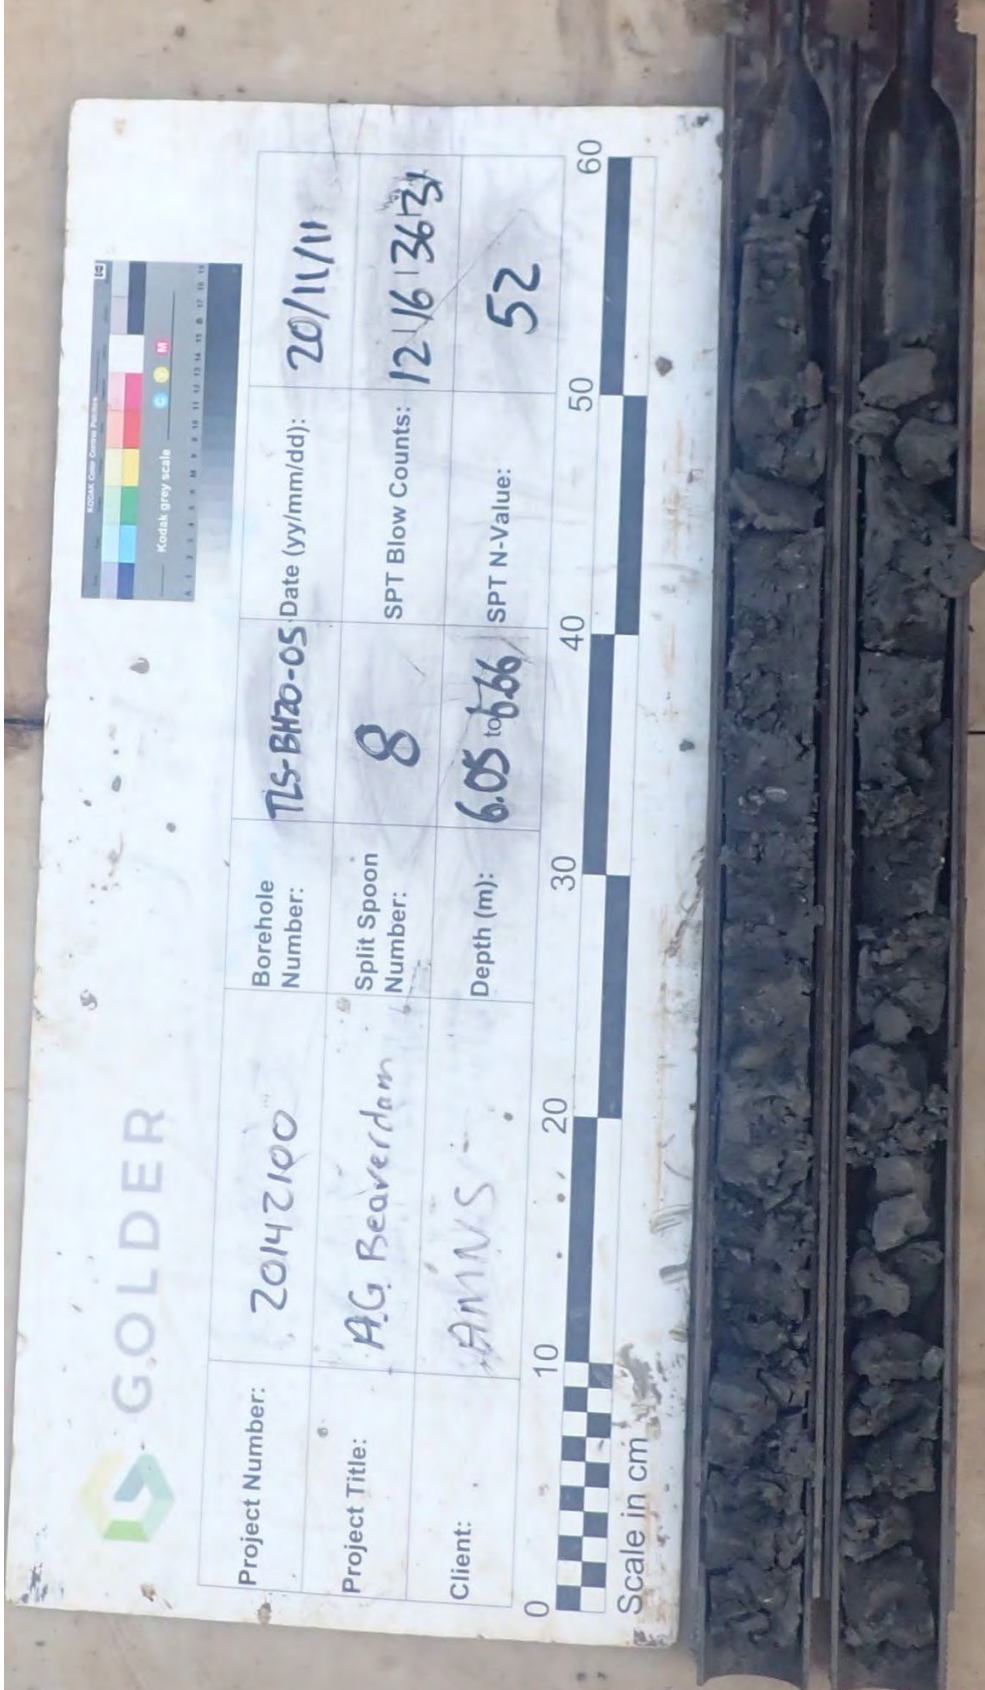
Project Number:	20142100	Borehole Number:	TLS-BH20-05	Date (yy/mm/dd):	20/11/11
Project Title:	AG Beaverdam	Split Spoon Number:	8	SPT Blow Counts:	12/16/36/3
Client:	AMNS	Depth (m):	6.05 to 6.66	SPT N-Value:	52

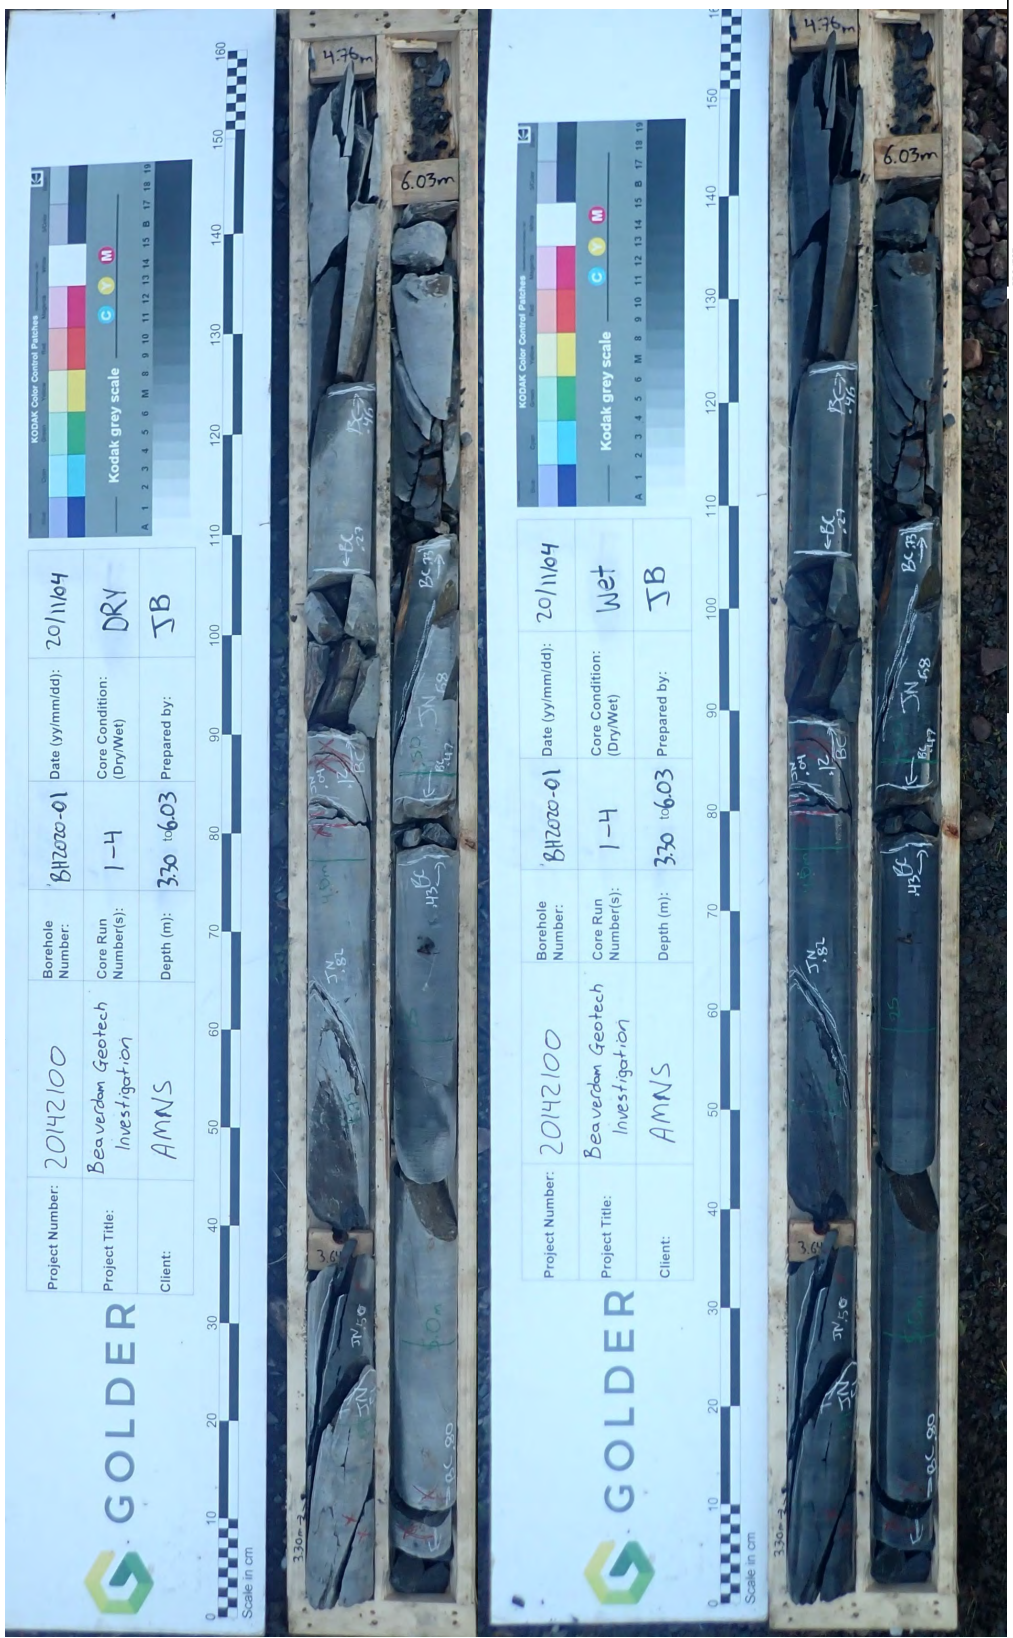
Project Number:	20142100	Borehole Number:	BH2020-01	Date (yy/mm/dd):	20/11/04
Project Title:	Beaverdam Geotech Investigation	Core Run Number(s):	1-4	Core Condition: (Dry/Wet)	DRY
Client:	AMNS	Depth (m):	3.30 to 6.03	Prepared by:	JB

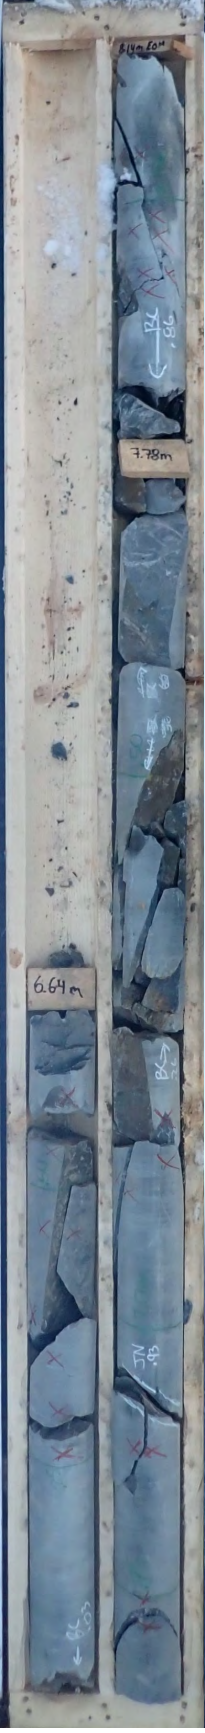
Project Number:	2042100	Borehole Number:	BH2020-01	Date (yy/mm/dd):	20/11/04
Project Title:	Beaverdam Geotech Investigation	Core Run Number(s):	5-7	Core Condition: (Dry/Wet)	DRY
Client:	AMNS	Depth (m):	6.64 to 8.19	Prepared by:	JB

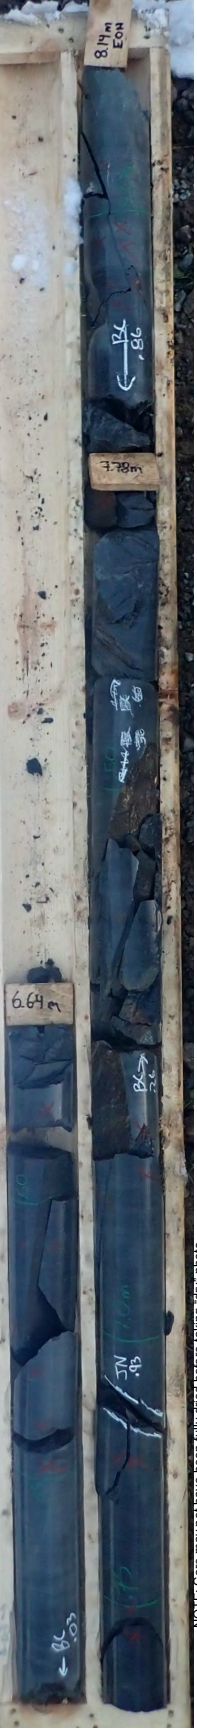
Project Number:	2042100	Borehole Number:	BH2020-01	Date (yy/mm/dd):	20/11/04
Project Title:	Beaverdam Geotech Investigation	Core Run Number(s):	5-7	Core Condition: (Dry/Wet)	Wet
Client:	AMNS	Depth (m):	6.03 to 8.19	Prepared by:	JB

NOTE: Core may not have been fully oriented before taking dry photo.

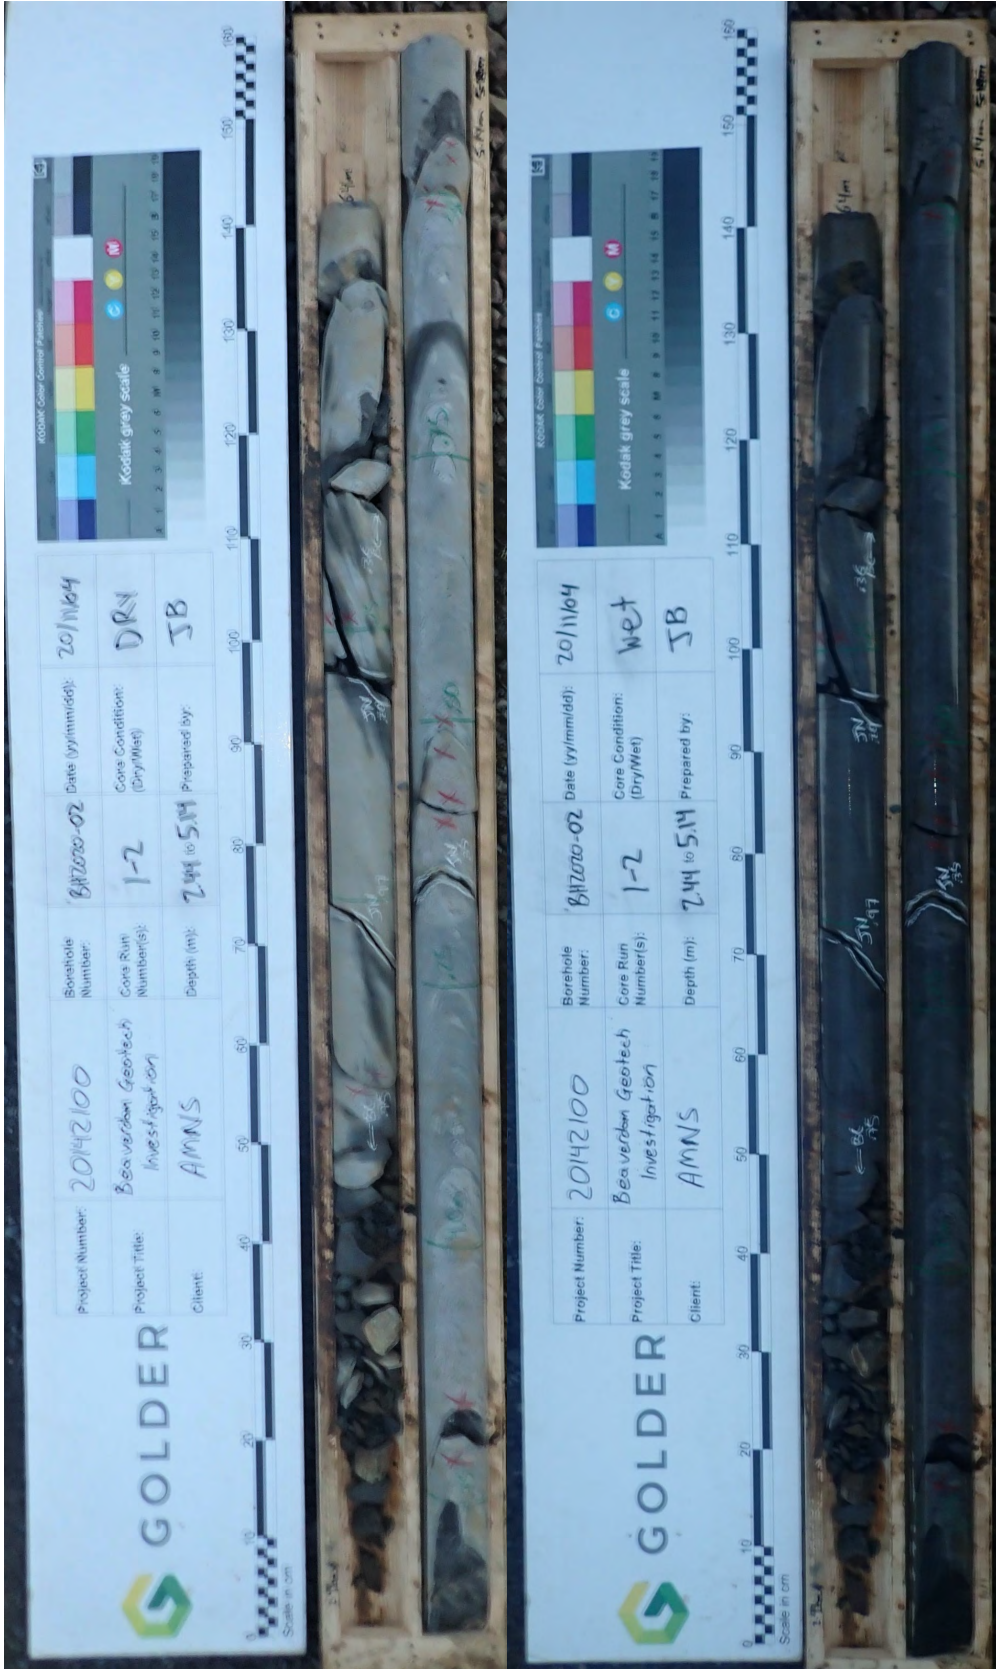
Project Number:	20142100	Borehole Number:	BH2020-02	Date (yy/mm/dd):	20/11/04
Project Title:	Bea verden Geotech Investigation	Core Run Number(s):	1-2	Core Condition: (Dry/Wet)	DRY
Client:	AMNS	Depth (m):	2.44 to 5.14	Prepared by:	JB

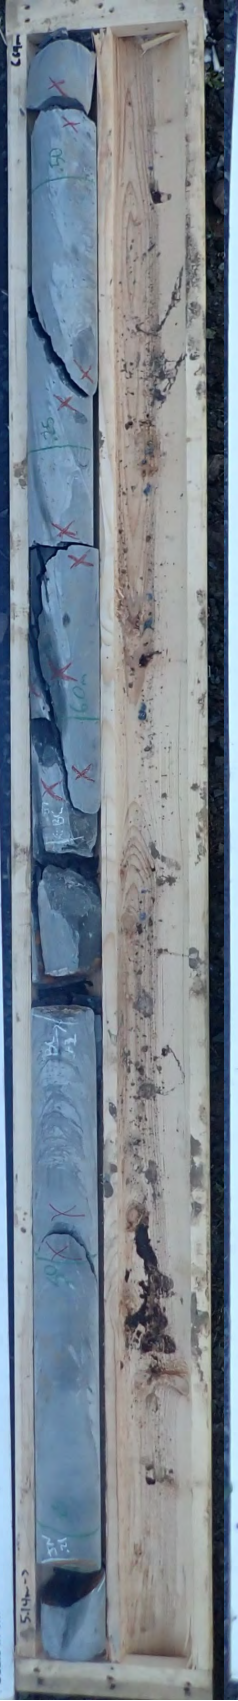
Project Number:	20142100	Borehole Number:	BH2020-02	Date (yy/mm/dd):	20/11/04
Project Title:	Beaverdam Geotech Investigation	Core Run Number(s):	3	Core Condition: (Dry/Wet)	DRY
Client:	AMNS	Depth (m):	5.14 to 6.84	Prepared by:	JB

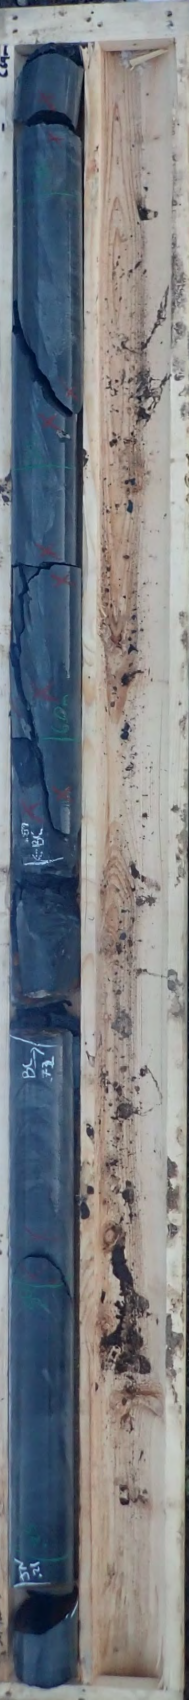
Project Number:	20142100	Borehole Number:	BH2020-02	Date (yy/mm/dd):	20/11/04
Project Title:	Beaverdam Geotech Investigation	Core Run Number(s):	3	Core Condition: (Dry/Wet)	Wet
Client:	AMNS	Depth (m):	5.14 to 6.84	Prepared by:	JB

NOTE: Core may not have been fully dried before taking "dry" photo.

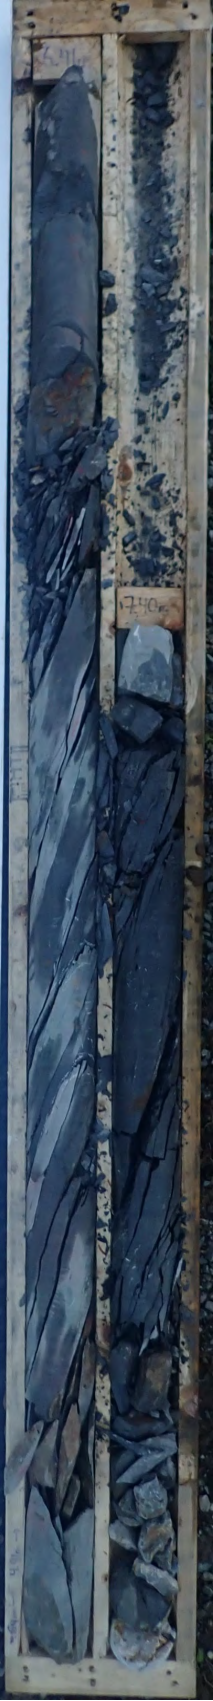
Project Number:	20142100	Borehole Number:	BH2020-03	Date (yy/mm/dd):	20/11/02
Project Title:	Beaverdam Geotech Investigation	Core Run Number(s):	1-2	Core Condition: (Dry/Wet)	DRY
Client:	AMNS	Depth (m):	4.91 to 7.40	Prepared by:	JB

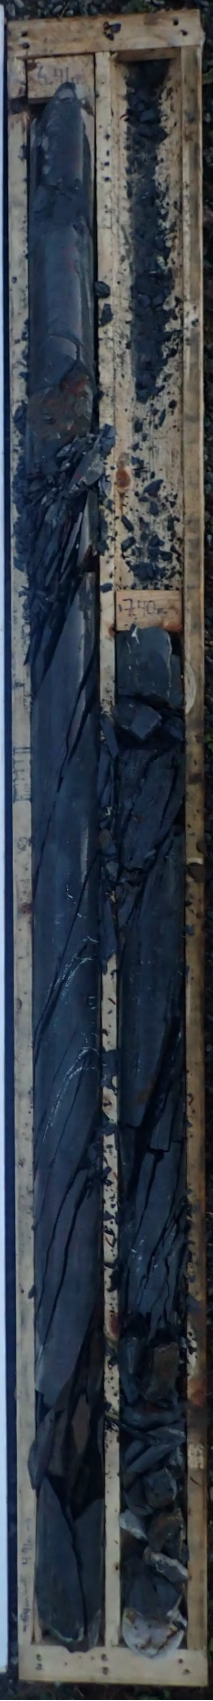
Project Number:	20142100	Borehole Number:	BH2020-03	Date (yy/mm/dd):	20/11/02
Project Title:	Beaverdam Geotech Investigation	Core Run Number(s):	1-2	Core Condition: (Dry/Wet)	Wet
Client:	AMNS	Depth (m):	4.91 to 7.40	Prepared by:	JB

NOTE: Core may not have been fully dried before taking "dry" photo.

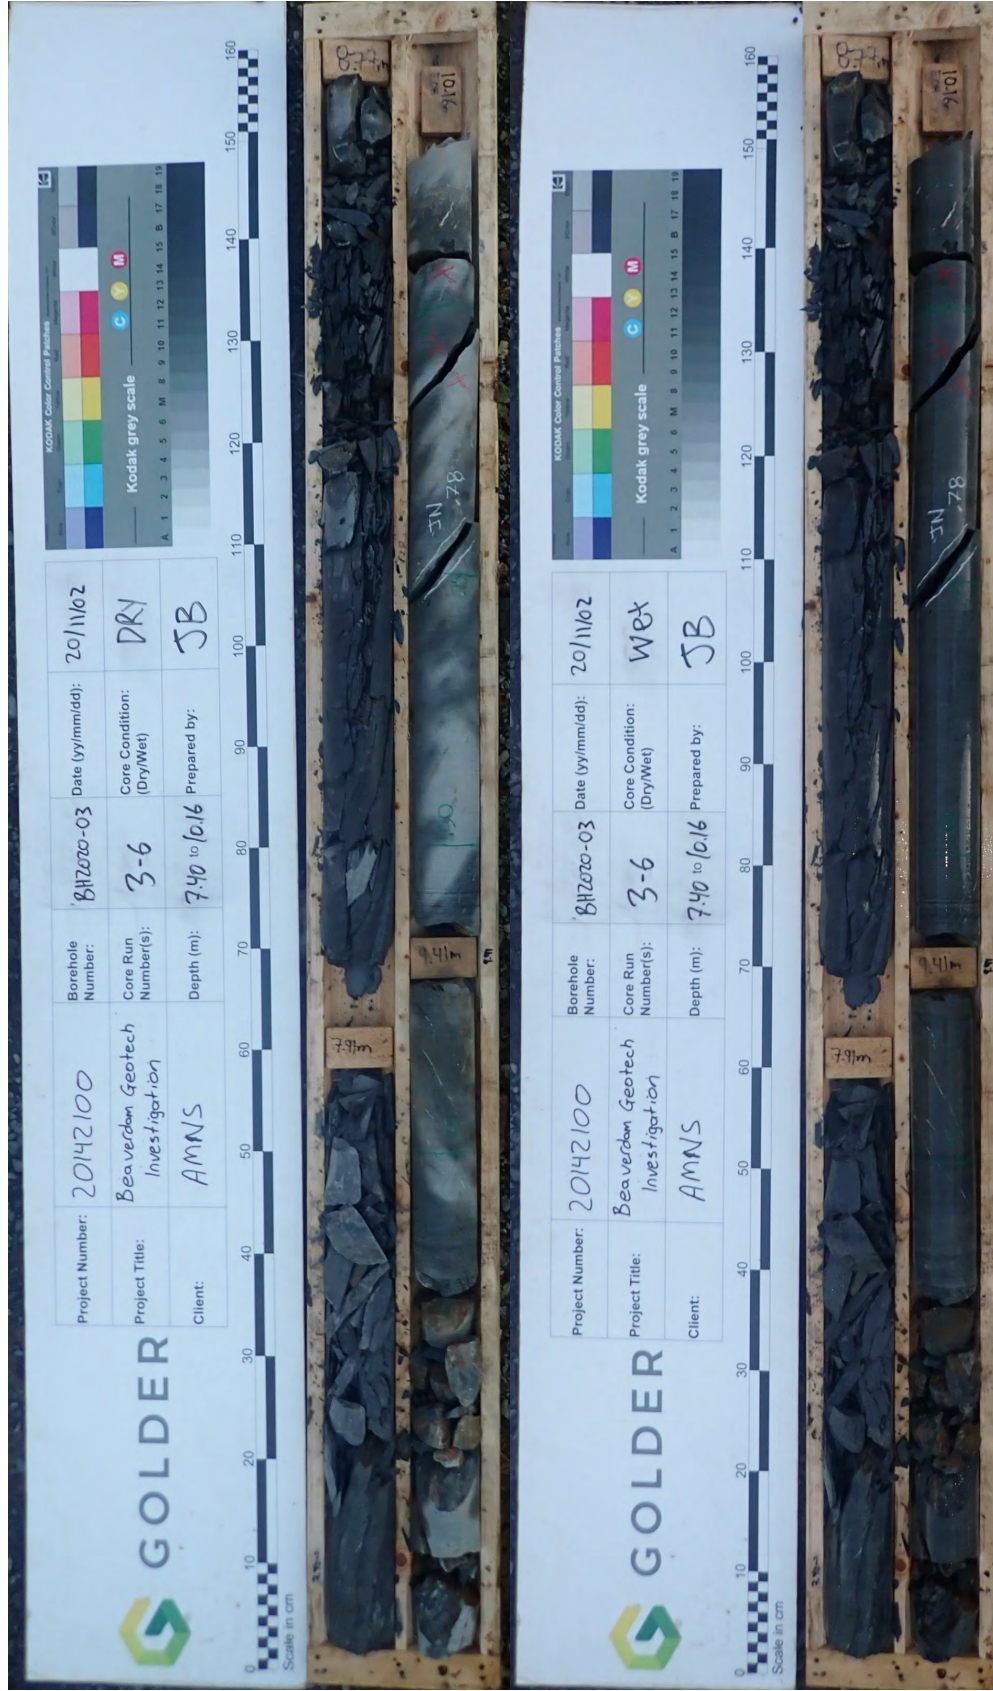
Project Number:	20142100	Borehole Number:	BH2020-03	Date (yy/mm/dd):	20/11/02
Project Title:	Beaverdam Geotech Investigation	Core Run Number(s):	3-6	Core Condition: (Dry/Wet):	DRY
Client:	AMNS	Depth (m):	7.40 to 10.16	Prepared by:	JB

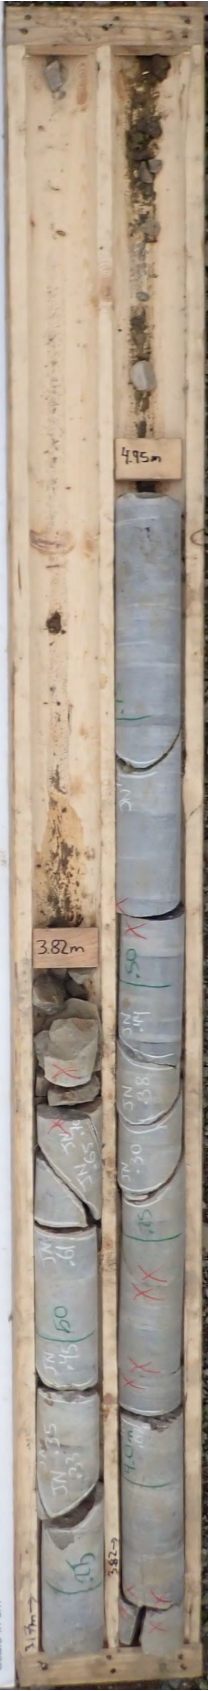
Project Number:	20142100	Borehole Number:	LGS-BH20-01	Date (yy/mm/dd):	20/10/29
Project Title:	Beaverdam Geotech Investigation	Core Run Number(s):	1-2	Core Condition: (Dry/Wet)	DRY
Client:	AMNS	Depth (m):	3.17 to 4.95	Prepared by:	JB

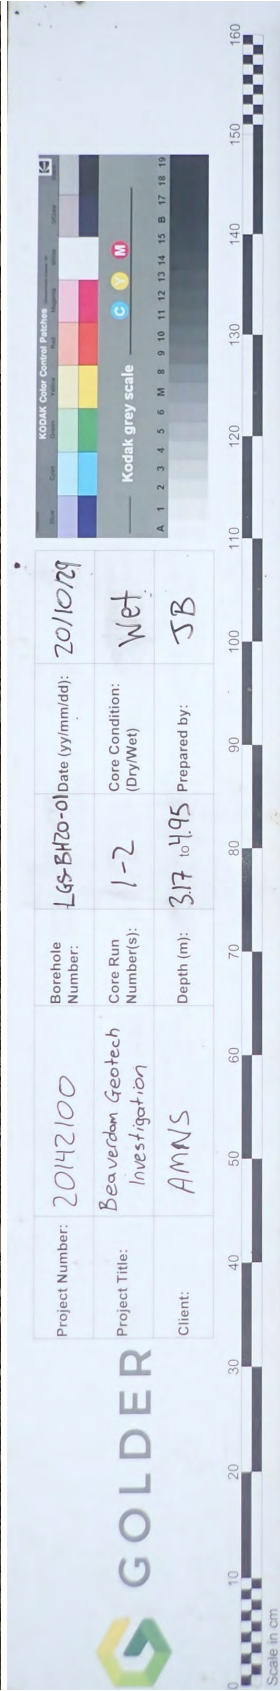
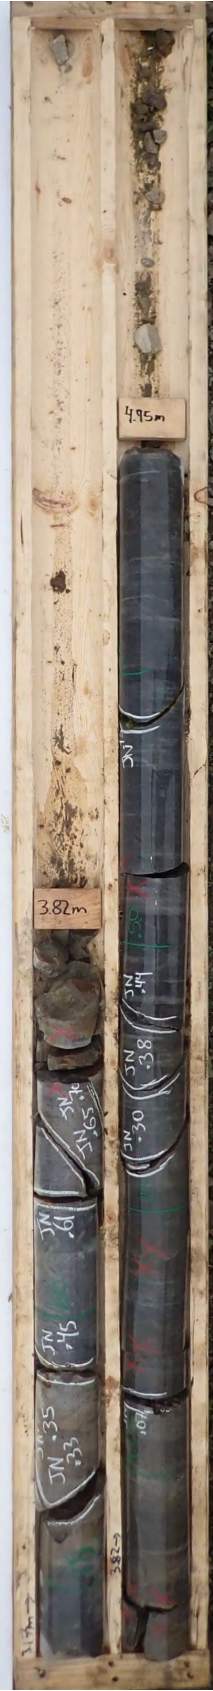
Project Number:	20142100	Borehole Number:	LGS-BH20-01	Date (yy/mm/dd):	20/10/29
Project Title:	Beaverdam Geotech Investigation	Core Run Number(s):	1-2	Core Condition: (Dry/Wet)	Wet
Client:	AMNS	Depth (m):	3.17 to 4.95	Prepared by:	JB

NOTE: Core may not have been fully dried before taking "dry" photo.

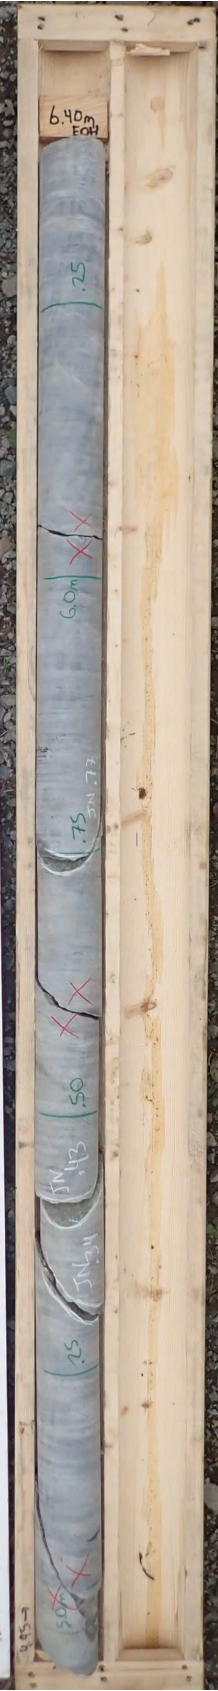
Project Number:	20142100	Borehole Number:	LGS-BH20-01	Date (yy/mm/dd):	20/10/20
Project Title:	Beaverdam Geotech Investigation	Core Run Number(s):	3	Core Condition: (Dry/Wet)	DRY
Client:	AMNS	Depth (m):	495 to 6.40	Prepared by:	JB

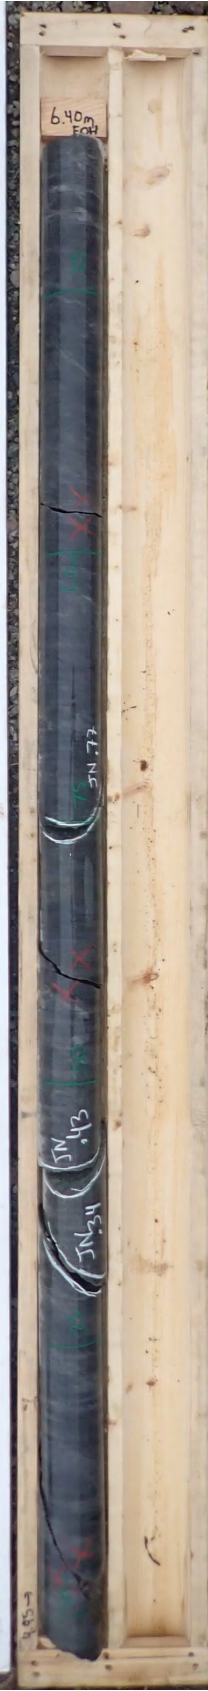
Project Number:	20142100	Borehole Number:	LGS-BH20-01	Date (yy/mm/dd):	20/10/20
Project Title:	Beaverdam Geotech Investigation	Core Run Number(s):	3	Core Condition: (Dry/Wet)	Wet
Client:	AMNS	Depth (m):	495 to 6.40	Prepared by:	JB

NOTE: Core may not have been fully dried before taking "dry" photo.

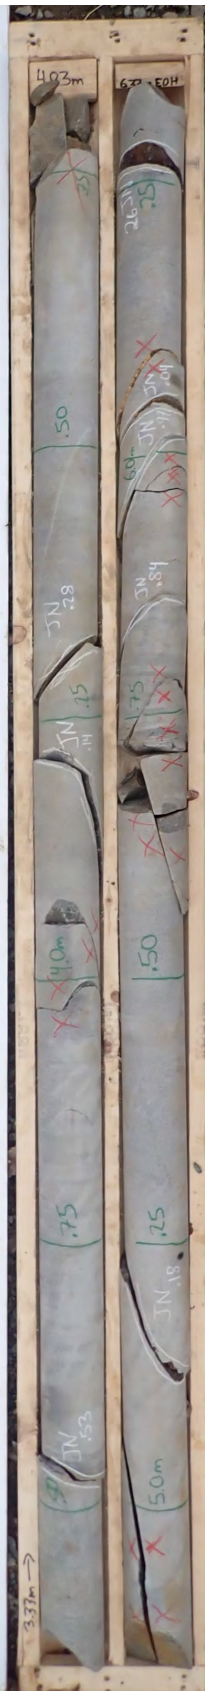
Project Number:	20142100	Borehole Number:	LGS-BH20-03	Date (yy/mm/dd):	20/10/28
Project Title:	Beaverdam Geotech Investigation	Core Run Number(s):	1-2	Core Condition: (Dry/Wet)	DRY
Client:	AMNS	Depth (m):	333 to 633	Prepared by:	JB

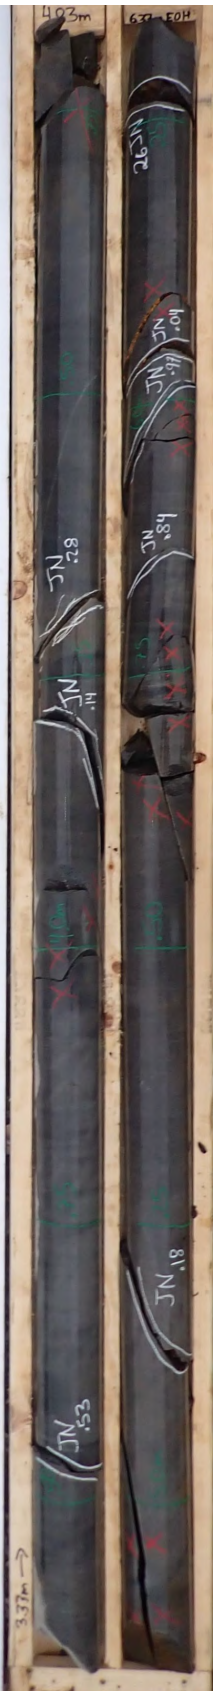
FIGURE NO.: P9

Project Number:	20142100	Borehole Number:	LGS-BH20-03	Date (yy/mm/dd):	20/10/28
Project Title:	Beaverdam Geotech Investigation	Core Run Number(s):	1-2	Core Condition: (Dry/Wet)	WET
Client:	AMNS	Depth (m):	333 to 633	Prepared by:	JB

NOTE: Core may not have been fully dried before taking "dry" photo.

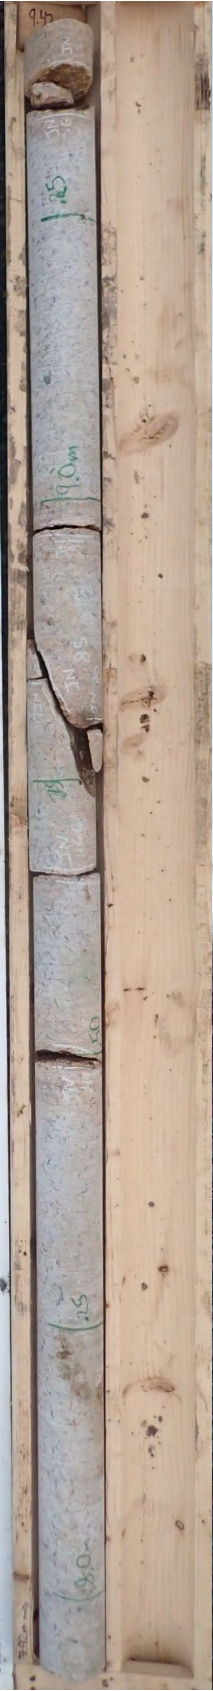
Project Number:	20142100	Borehole Number:	NAG BH2001	Date (yy/mm/dd):	20/10/25
Project Title:	Beaverdam Geotech Investigation	Core Run Number(s):	3	Core Condition: (Dry/Wet)	DRY
Client:	AMNS	Depth (m):	7.92 to 9.42	Prepared by:	JB

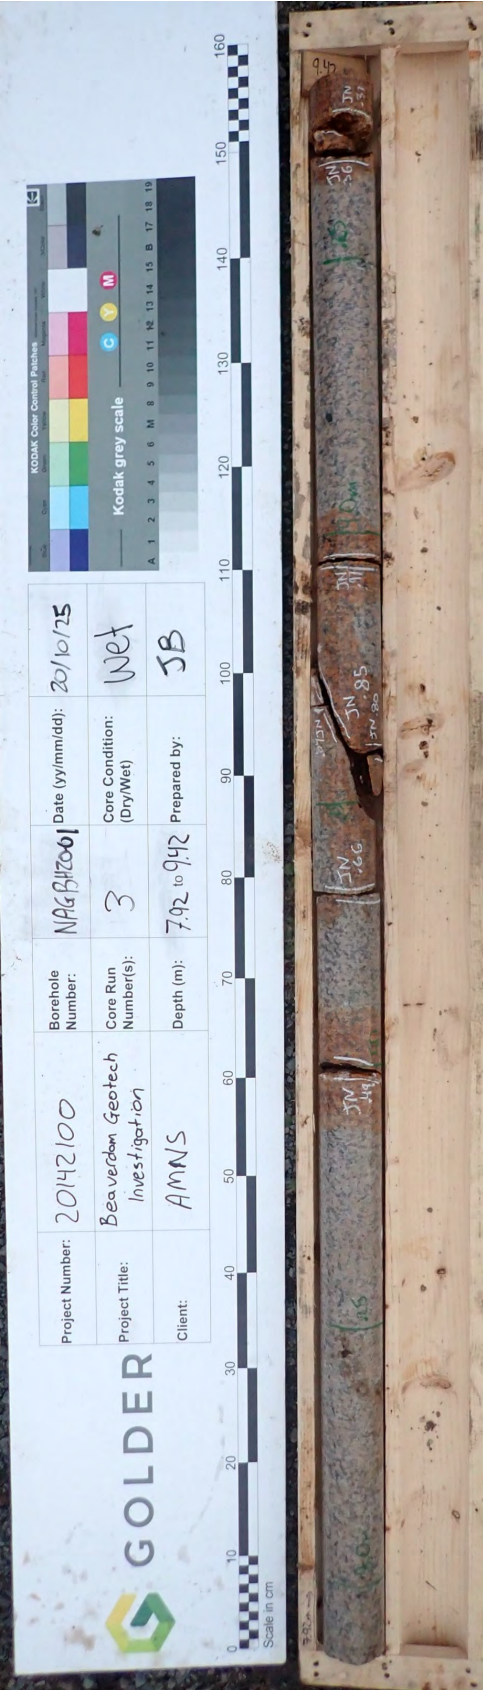
Project Number:	20142100	Borehole Number:	NAG BH2001	Date (yy/mm/dd):	20/10/25
Project Title:	Beaverdam Geotech Investigation	Core Run Number(s):	3	Core Condition: (Dry/Wet)	WET
Client:	AMNS	Depth (m):	7.92 to 9.42	Prepared by:	JB

NOTE: Core may not have been fully dried before taking "dry" photo.

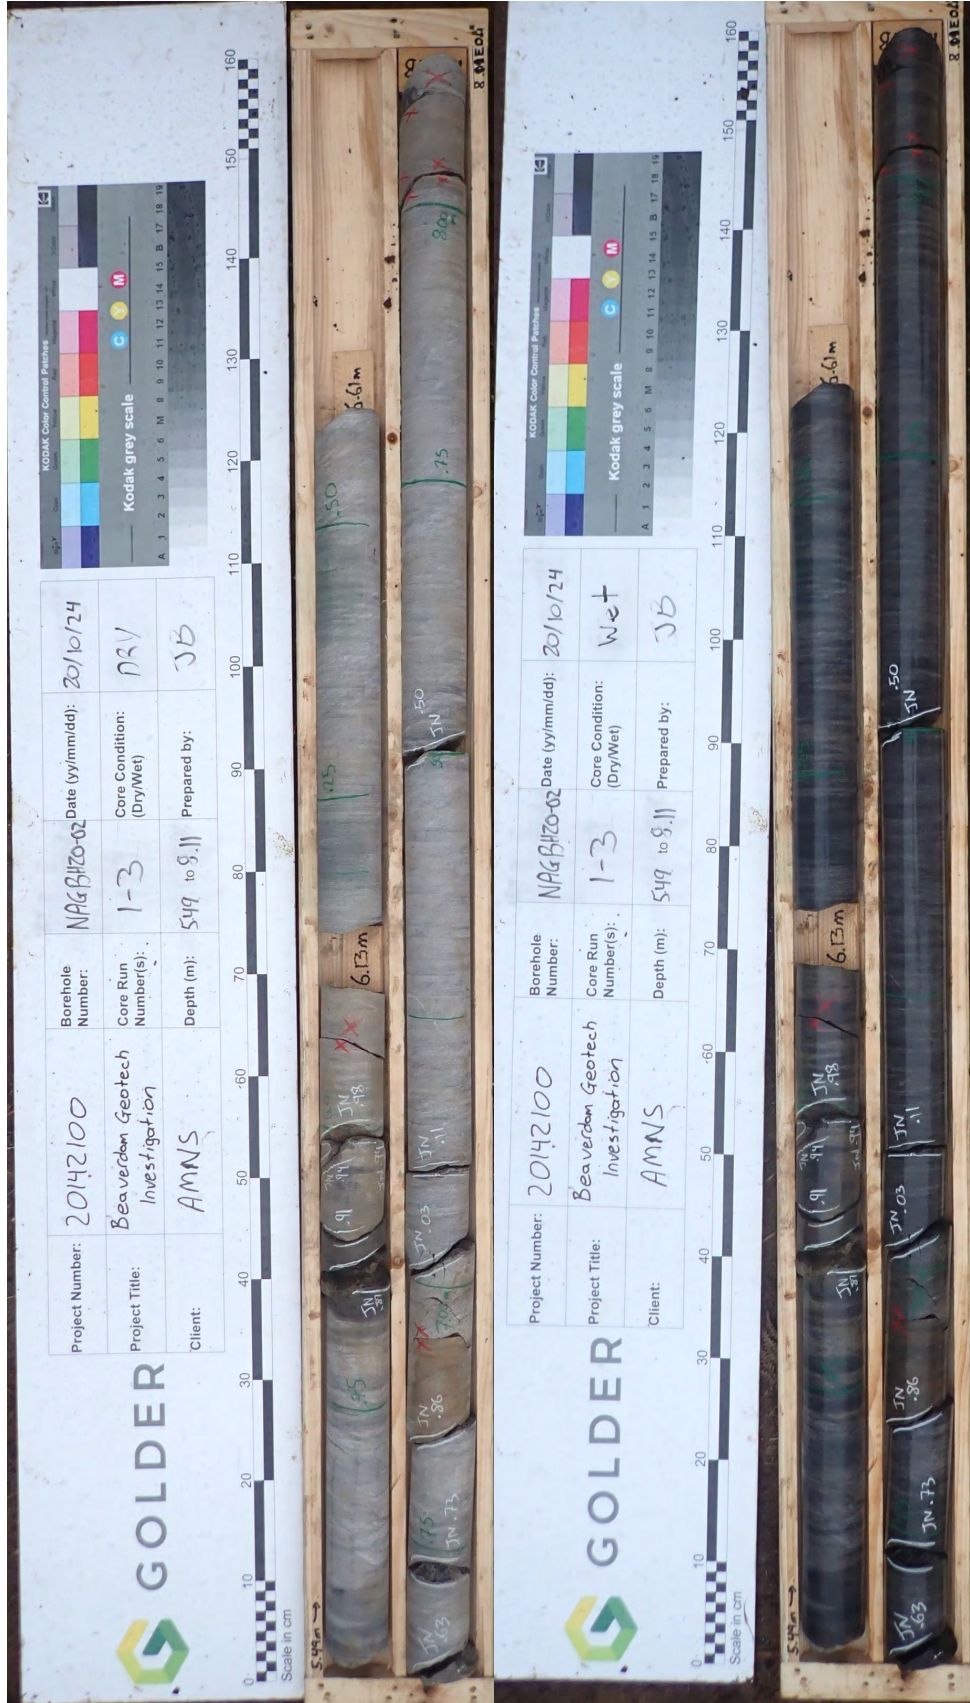
Project Number:	20142100	Borehole Number:	NAG B120-02	Date (yy/mm/dd):	20/10/24
Project Title:	Beaverdam Geotech Investigation	Core Run Number(s):	1-3	Core Condition: (Dry/Wet)	DRY
Client:	AMNS	Depth (m):	549 to 9.11	Prepared by:	JB

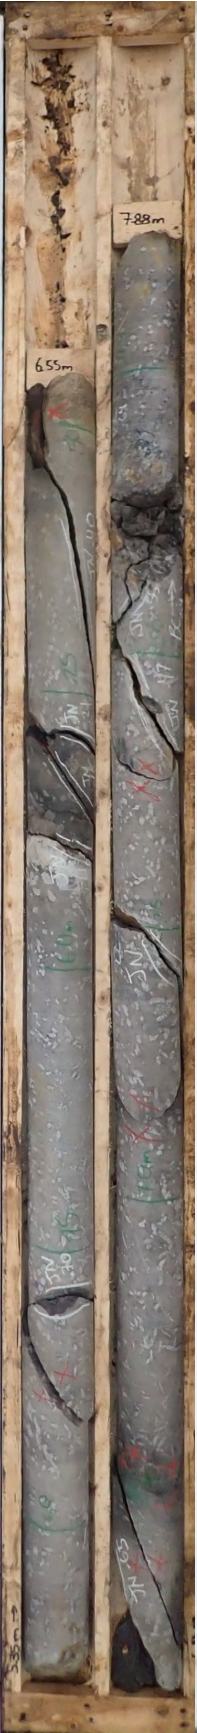
Project Number:	20142100	Borehole Number:	NAG-BH20-03	Date (yy/mm/dd):	20/10/26
Project Title:	Beaverdam Geotech Investigation	Core Run Number(s):	1-2	Core Condition: (Dry/Wet)	DRY
Client:	AMNS	Depth (m):	5.35 to 7.88	Prepared by:	JB

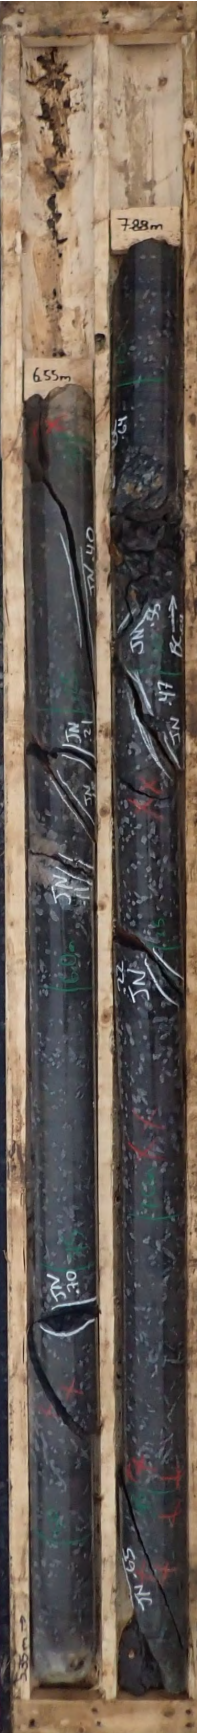
Project Number:	20142100	Borehole Number:	NAG-BH20-03	Date (yy/mm/dd):	20/10/26
Project Title:	Beaverdam Geotech Investigation	Core Run Number(s):	1-2	Core Condition: (Dry/Wet)	WET
Client:	AMNS	Depth (m):	5.35 to 7.88	Prepared by:	JB

NOTE: Core may not have been fully dried before taking "dry" photo.

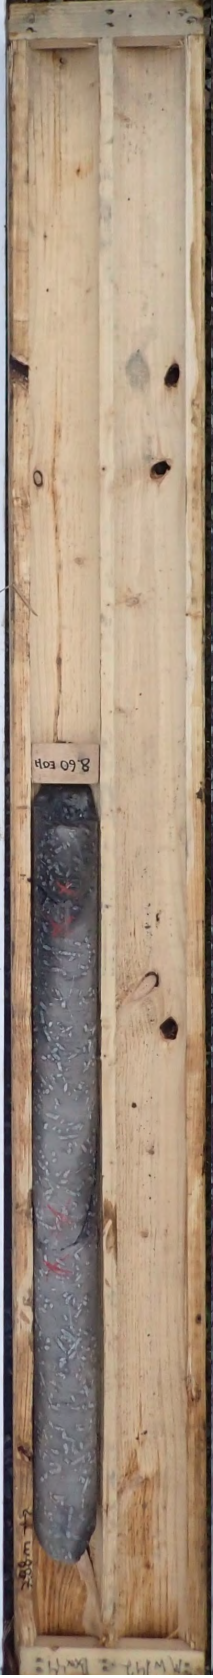
Project Number:	20142100	Borehole Number:	NAGB120-03	Date (yymm/dd):	20/10/26
Project Title:	Beaverdam Geotech Investigation	Core Run Number(s):	3	Core Condition: (Dry/Wet)	DRY
Client:	AMNS	Depth (m):	788 to 863	Prepared by:	JB

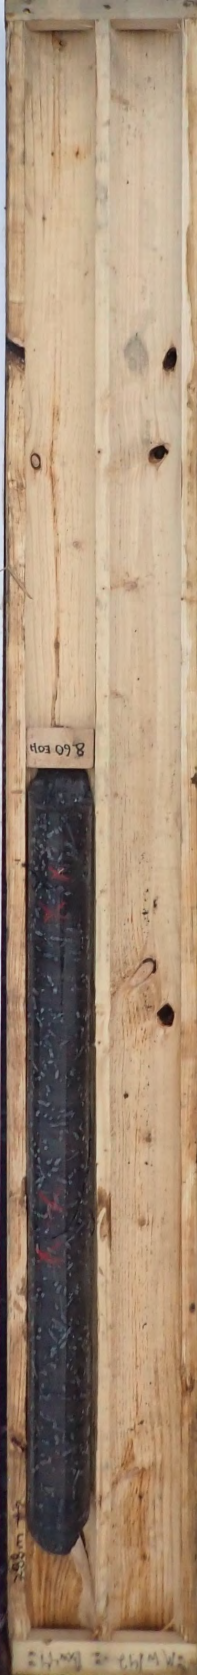
Project Number:	20142100	Borehole Number:	NAGB120-03	Date (yymm/dd):	20/10/26
Project Title:	Beaverdam Geotech Investigation	Core Run Number(s):	3	Core Condition: (Dry/Wet)	Wet
Client:	AMNS	Depth (m):	788 to 863	Prepared by:	JB

NOTE: Core may not have been fully dried before taking "dry" photo.

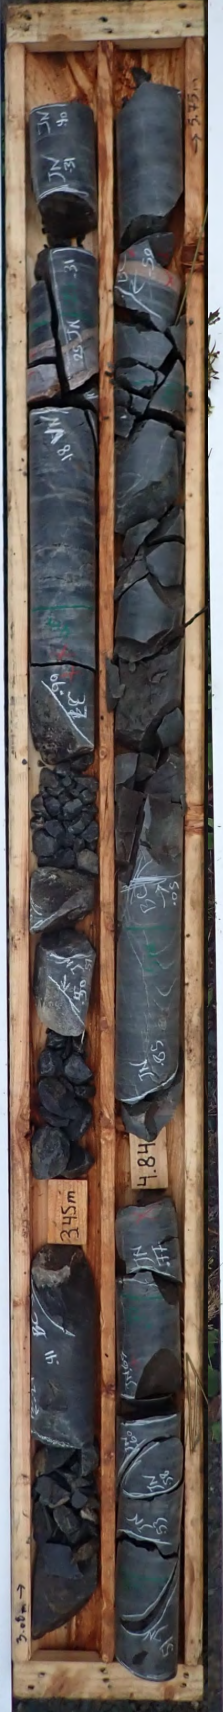
Project Number:	20142100	Borehole Number:	M/G BH20-01	Date (yy/mm/dd):	20/10/21
Project Title:	BD Geotech. Investigation	Core Run Number(s):	1-3	Core Condition: (Dry/Wet)	Wet
Client:	AMNS	Depth (m):	3.08 to 5.15	Prepared by:	JB/MA

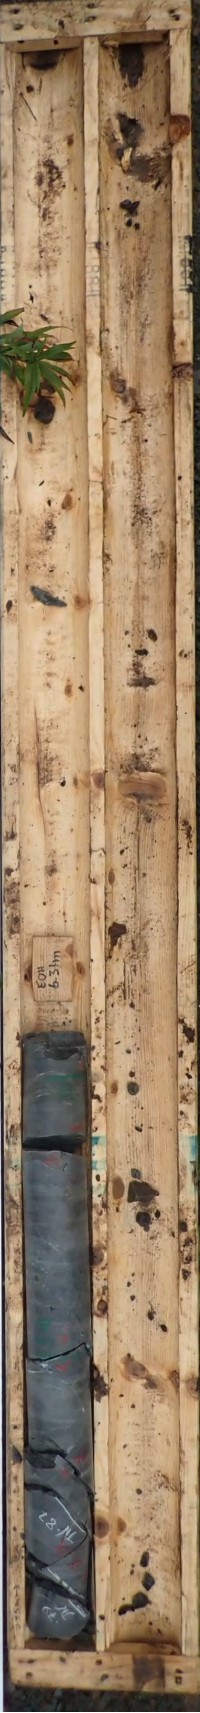
Project Number:	20142100	Borehole Number:	M/G BH20-01	Date (yy/mm/dd):	20/10/21
Project Title:	BD Geotech. Investigation	Core Run Number(s):	3	Core Condition: (Dry/Wet)	Wet
Client:	AMNS	Depth (m):	5.35 to 6.31	Prepared by:	JB/MA

NOTE: Dry photos could not be obtained

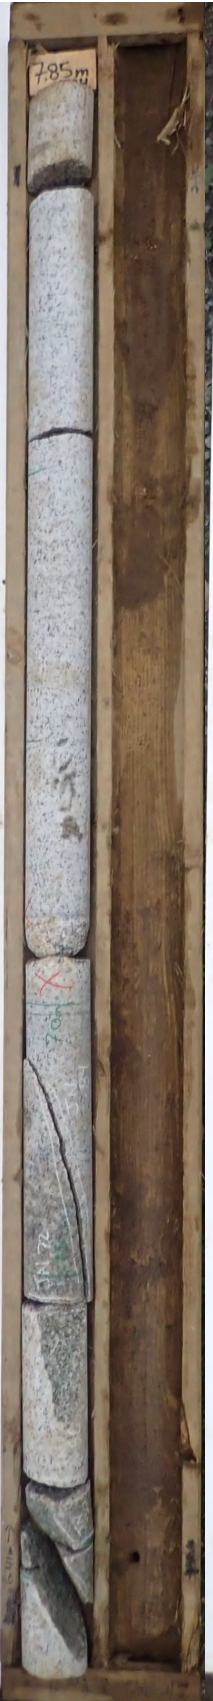
Project Number:	20142100	Borehole Number:	NAG-BH20-05	Date (yy/mm/dd):	20/10/27
Project Title:	Beaverdam Geotech Investigation	Core Run Number(s):	3	Core Condition: (Dry/Wet)	DRY
Client:	AMNS	Depth (m):	641 to 785	Prepared by:	JB

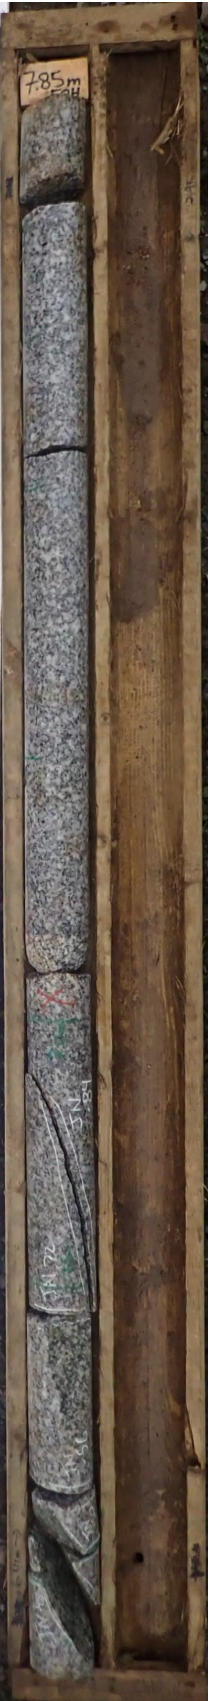
Project Number:	20142100	Borehole Number:	NAG-BH20-05	Date (yy/mm/dd):	20/10/27
Project Title:	Beaverdam Geotech Investigation	Core Run Number(s):	3	Core Condition: (Dry/Wet)	WET
Client:	AMNS	Depth (m):	641 to 785	Prepared by:	JB

NOTE: Core may not have been fully dried before taking "dry" photo.

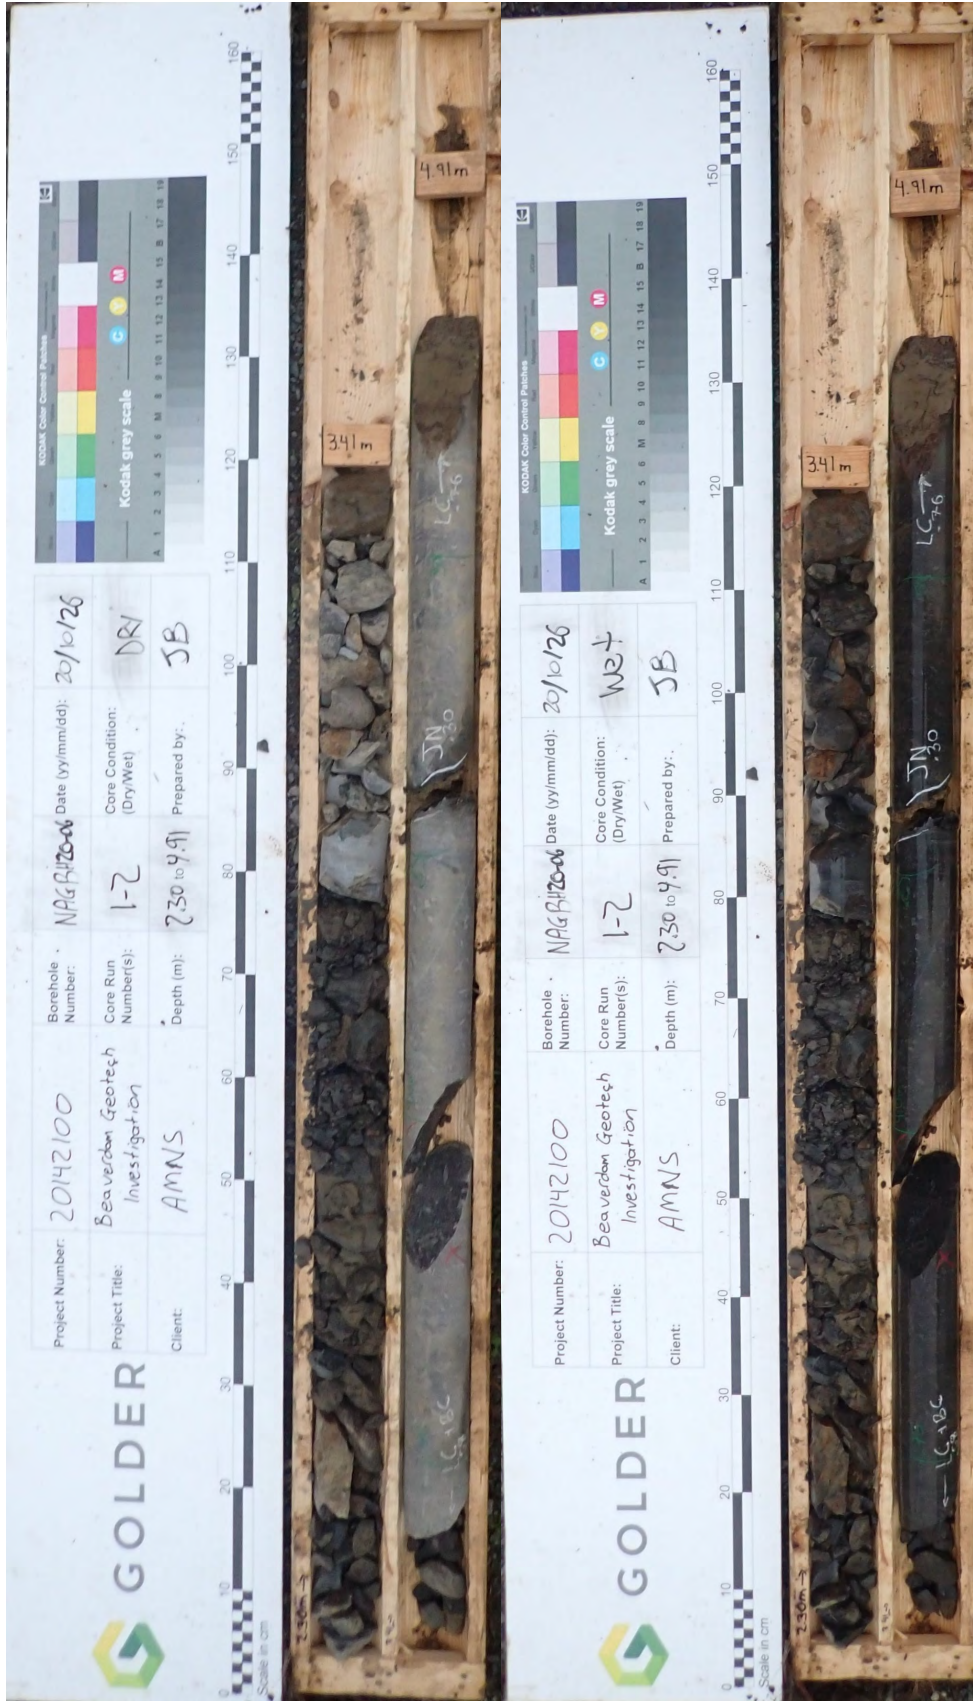
Project Number:	20142100	Borehole Number:	NAG-BH-20-06	Date (yy/mm/dd):	20/10/26
Project Title:	Beaverdam Geotech Investigation	Core Run Number(s):	1-2	Core Condition: (Dry/Wet)	DRY
Client:	AMNS	Depth (m):	2.30 to 4.91	Prepared by:	JB

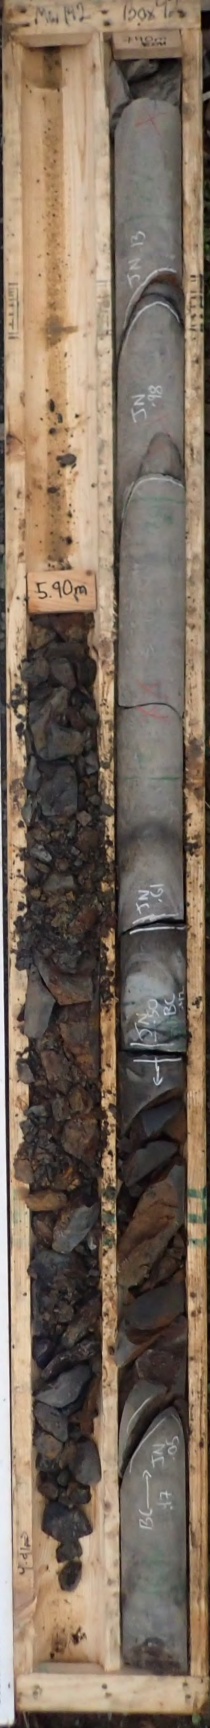
Project Number:	20142100	Borehole Number:	NAG-BH20-06	Date (yy/mm/dd):	20/10/26-27
Project Title:	Beaverdam Geotech Investigation	Core Run Number(s):	34	Core Condition: (Dry/Wet)	DRY
Client:	AMNS	Depth (m):	491 to 740	Prepared by:	JB

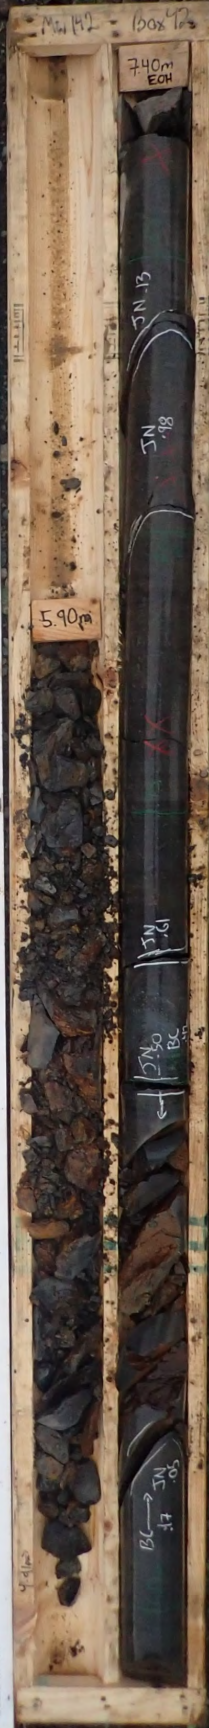
Project Number:	20142100	Borehole Number:	NAG-BH20-06	Date (yy/mm/dd):	20/10/26-27
Project Title:	Beaverdam Geotech Investigation	Core Run Number(s):	34	Core Condition: (Dry/Wet)	Wet
Client:	AMNS	Depth (m):	491 to 740	Prepared by:	JB

NOTE: Core may not have been fully dried before taking "dry" photo.
