Geotechnical Investigation: Data Report –  
Beaver Dam Mine, January 15, 2021as  
Completed for the Updated 2021 Beaver Dam Mine EIS

# Geotechnical Investigation: Data Report

## *Beaver Dam Mine*

20142100-004-R-Rev0

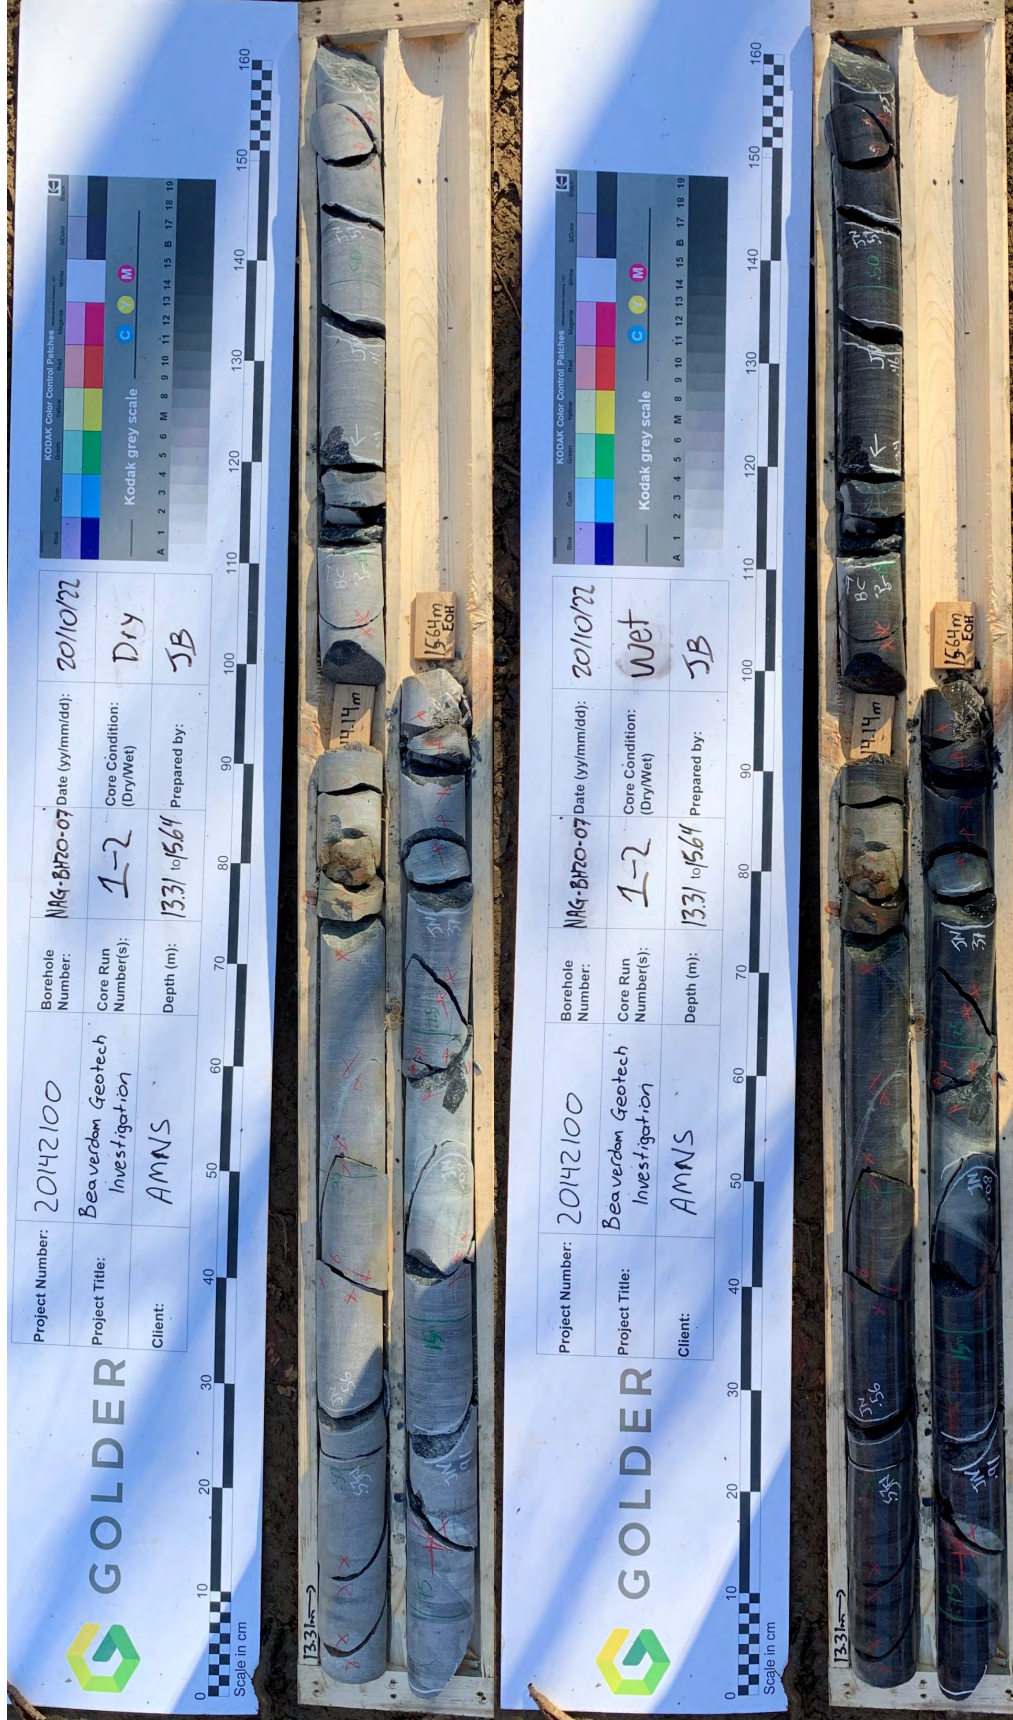
Project Number:	20142100	Borehole Number:	NAQ-BH20-07	Date (yy/mm/dd):	20/10/22
Project Title:	Beaverdam Geotech Investigation	Core Run Number(s):	1-2	Core Condition: (Dry/Wet)	Dry
Client:	AMNS	Depth (m):	133 to 156.4	Prepared by:	JB

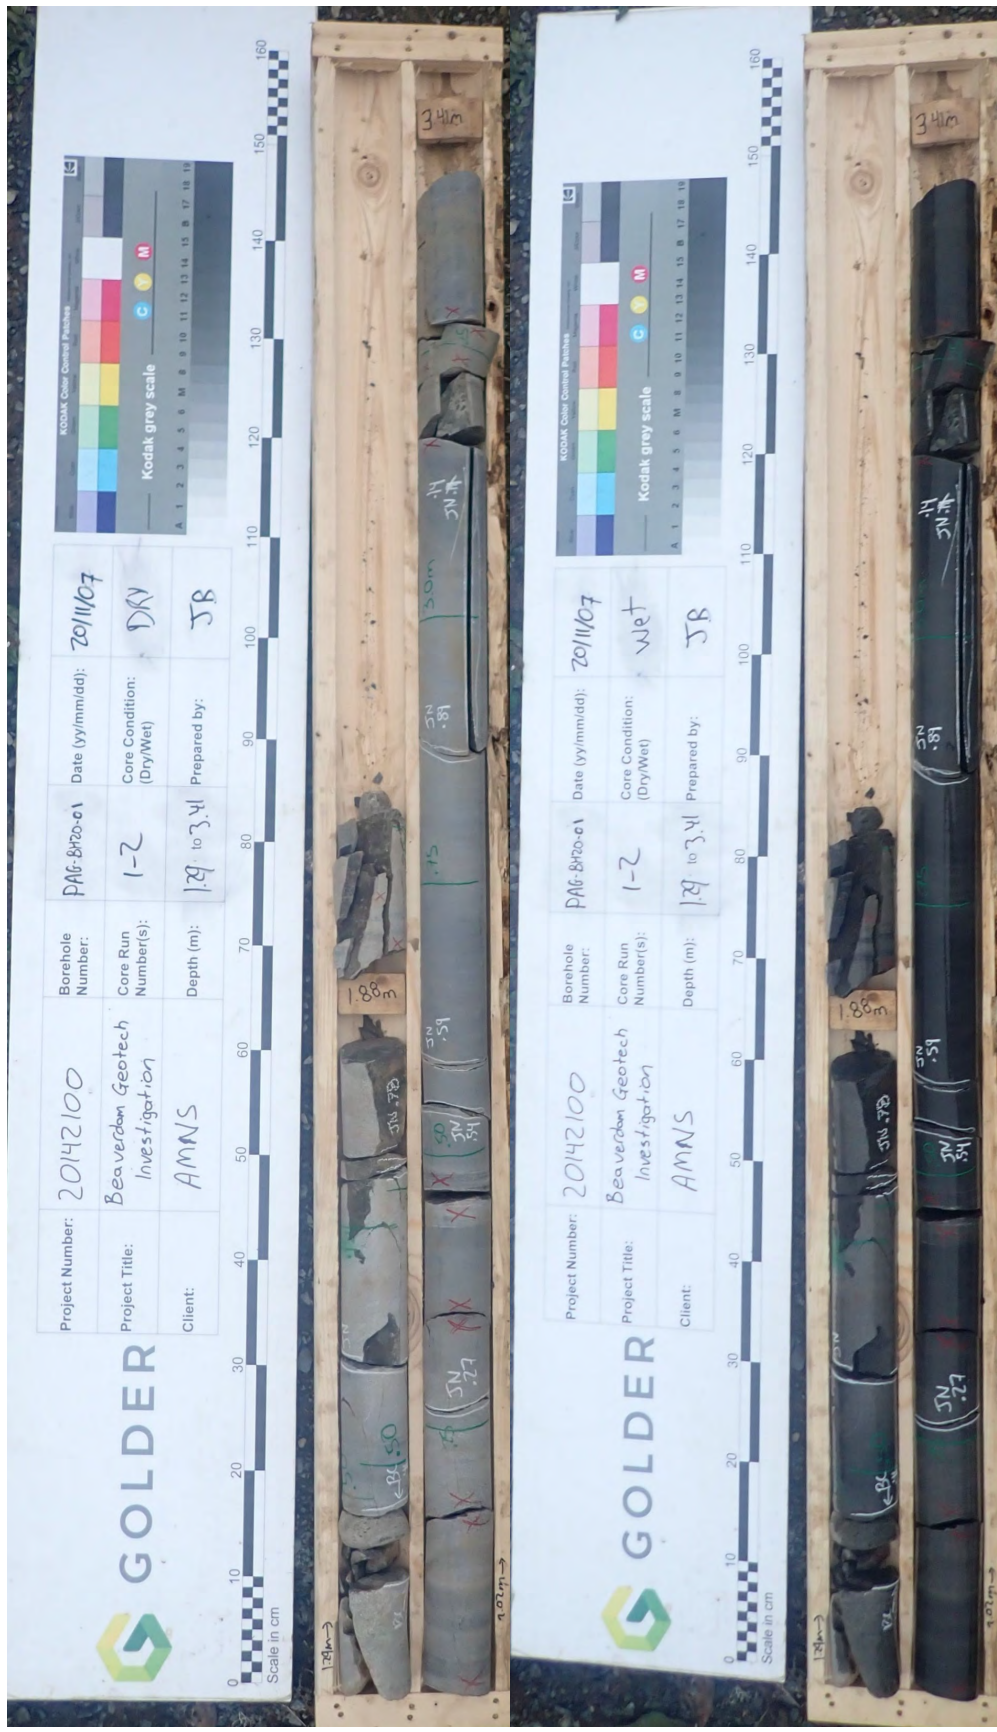
Project Number:	20142100	Borehole Number:	PAG-BH20-01	Date (yy/mm/dd):	20/11/07
Project Title:	Beaverdam Geotech Investigation	Core Run Number(s):	1-2	Core Condition: (Dry/Wet)	DN
Client:	AMNS	Depth (m):	129 to 3.4	Prepared by:	JB

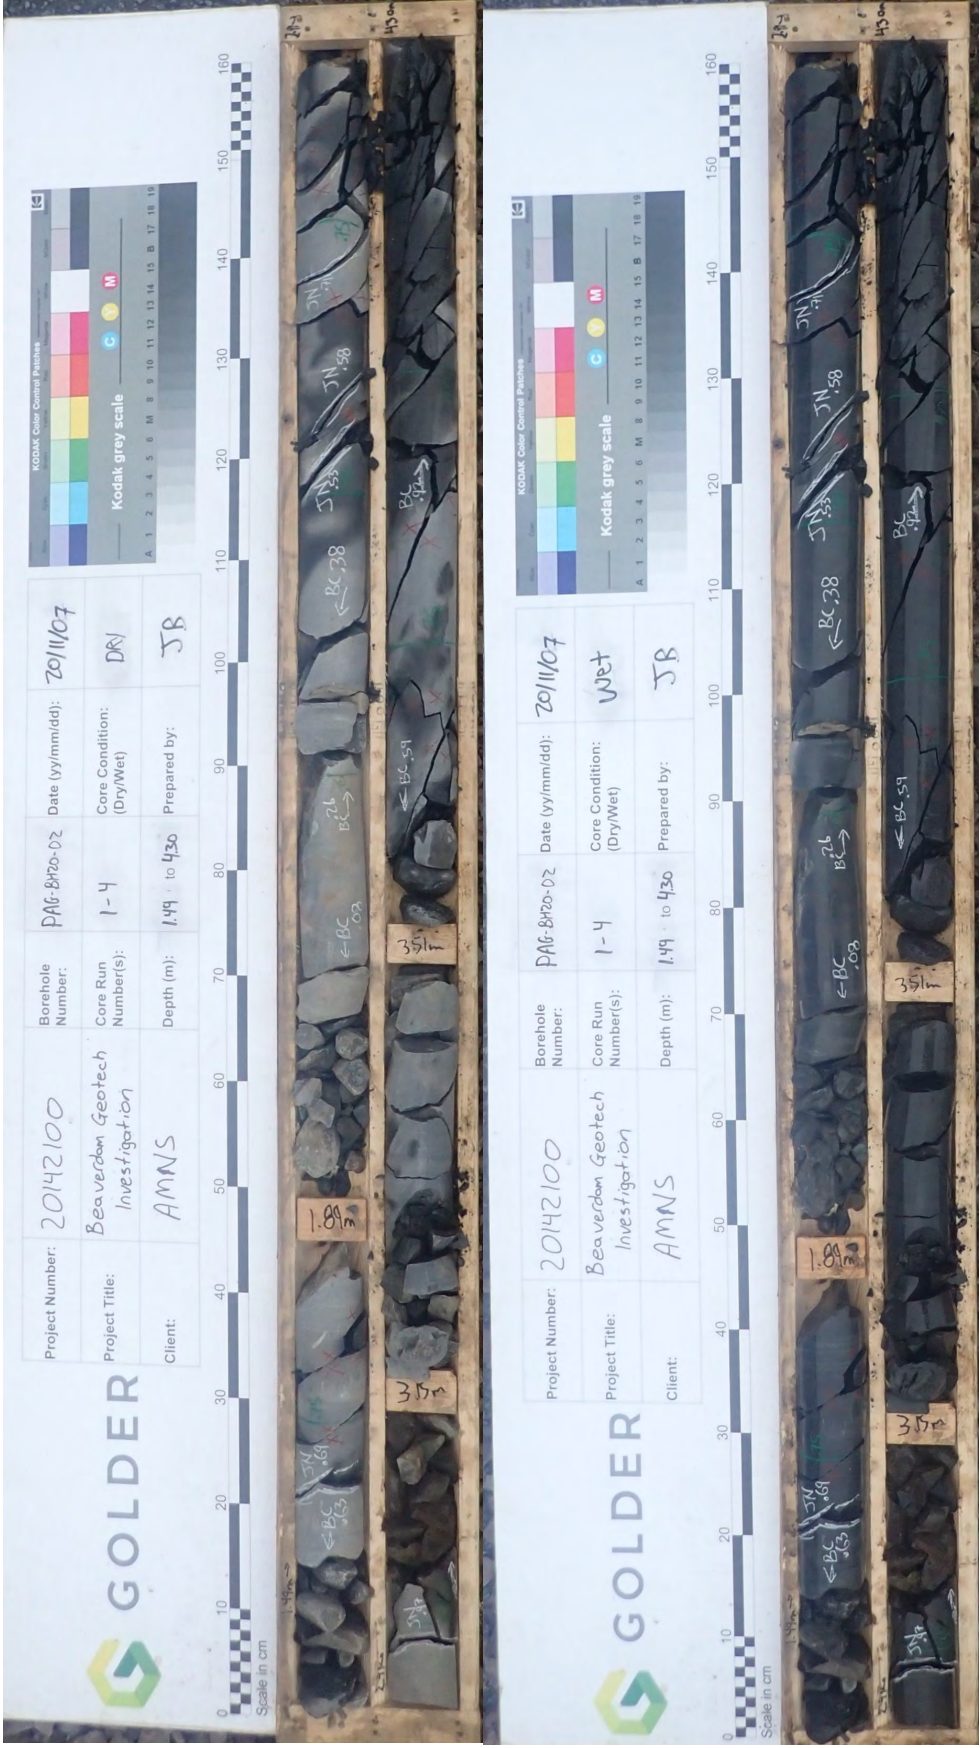
Project Number:	20142100	Borehole Number:	PAG-BH20-02	Date (yy/mm/dd):	20/11/07
Project Title:	Beaverdam Geotech Investigation	Core Run Number(s):	1-4	Core Condition: (Dry/Wet)	DRY
Client:	AMNS	Depth (m):	1.49 to 4.30	Prepared by:	JB

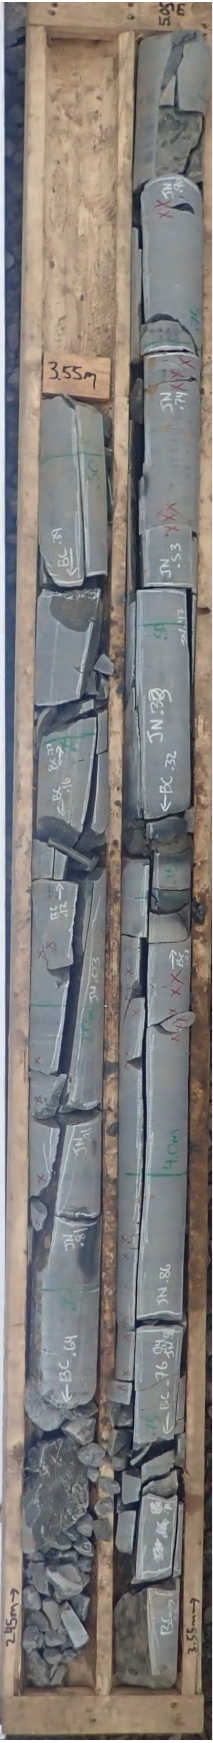
Project Number:	20142100	Borehole Number:	PAG-BH20-03	Date (y/m/d):	20/11/08
Project Title:	Beaverdam Geotech Investigation	Core Run Number(s):	1-2	Core Condition: (Dry/Wet)	DRY
Client:	AMNS	Depth (m):	245 to 505	Prepared by:	JB

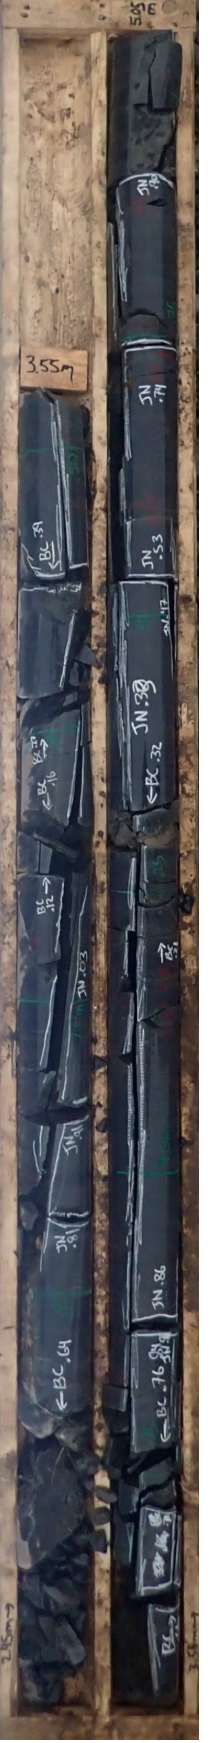
Project Number:	20142100	Borehole Number:	PAG-BH20-03	Date (y/m/d):	20/11/08
Project Title:	Beaverdam Geotech Investigation	Core Run Number(s):	1-2	Core Condition: (Dry/Wet)	Wet
Client:	AMNS	Depth (m):	245 to 505	Prepared by:	JB

NOTE: Core may not have been fully dried before taking "dry" photo.

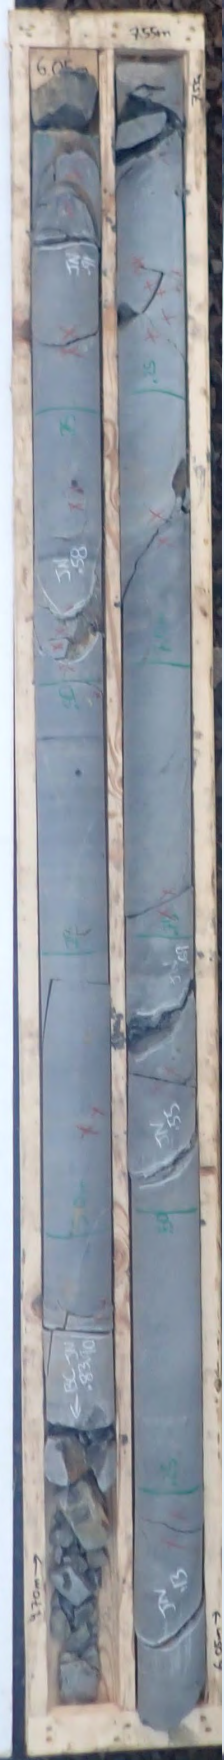
Project Title: Beaverdam Geotech Investigation  
 Core Run Number(s): 1-2  
 Core Condition: (Dry/Wet): DRY

Client: AMNS  
 Depth (m): 4.70 to 7.55  
 Prepared by: JB

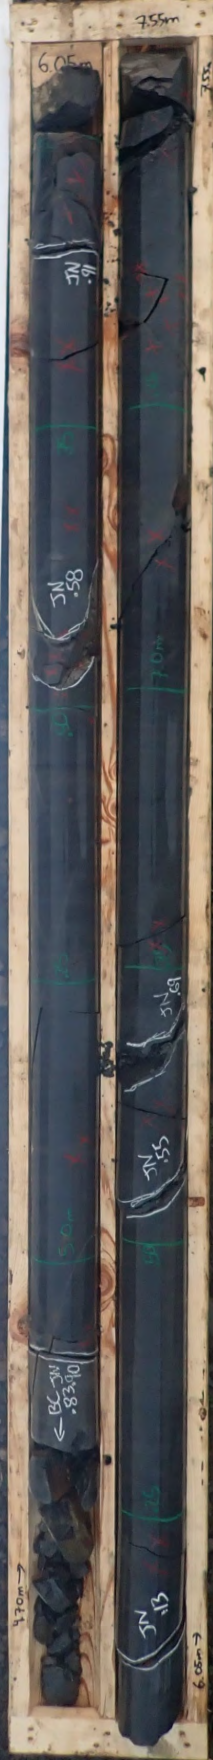
Project Number: 20142100  
 Borehole Number: PND-BH20-01  
 Date (yy/mm/dd): 20/11/04

Project Title: Beaverdam Geotech Investigation  
 Core Run Number(s): 1-2  
 Core Condition: (Dry/Wet): Wet

Client: AMNS  
 Depth (m): 4.70 to 7.55  
 Prepared by: JB

NOTE: Core may not have been fully dried before taking "dry" photo.

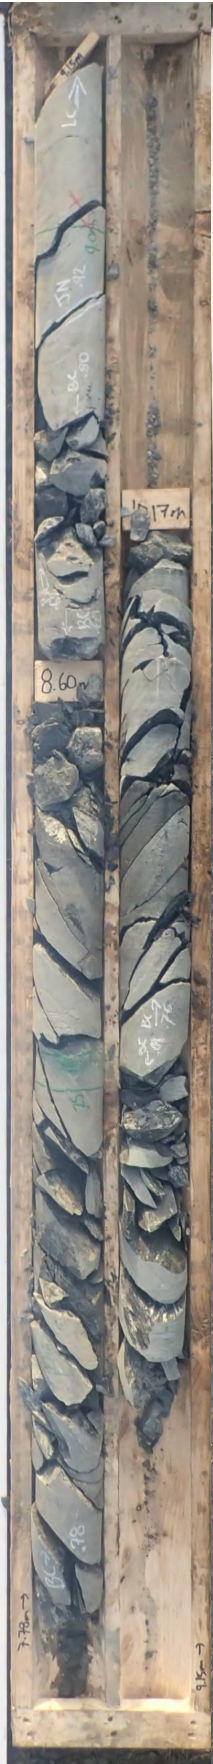
Project Number:	20142100	Borehole Number:	PND-BH20-02	Date (yy/mm/dd):	20/11/06
Project Title:	Beaverdam Geotech Investigation	Core Run Number(s):	1-3	Core Condition: (Dry/Wet)	DRY
Client:	AMNS	Depth (m):	7.78 to 10.17	Prepared by:	JB

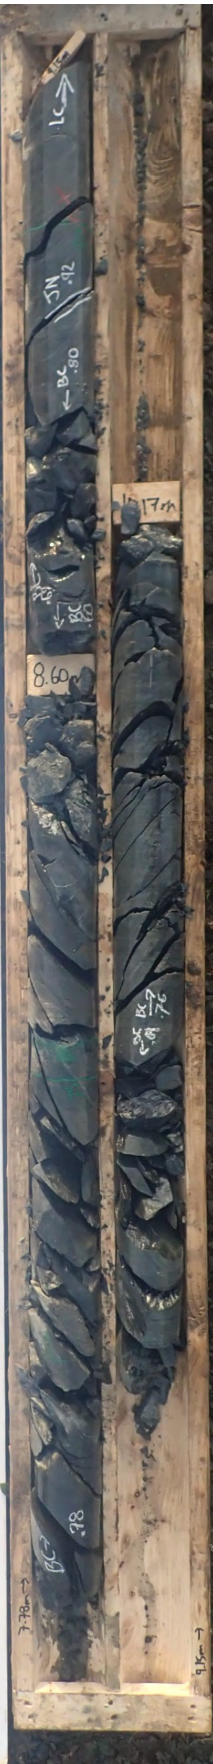
Project Number:	20142100	Borehole Number:	PND-BH20-02	Date (yy/mm/dd):	20/11/06
Project Title:	Beaverdam Geotech Investigation	Core Run Number(s):	1-3	Core Condition: (Dry/Wet)	Wet
Client:	AMNS	Depth (m):	7.78 to 10.17	Prepared by:	JB

NOTE: Core may not have been fully dried before taking "dry" photo.

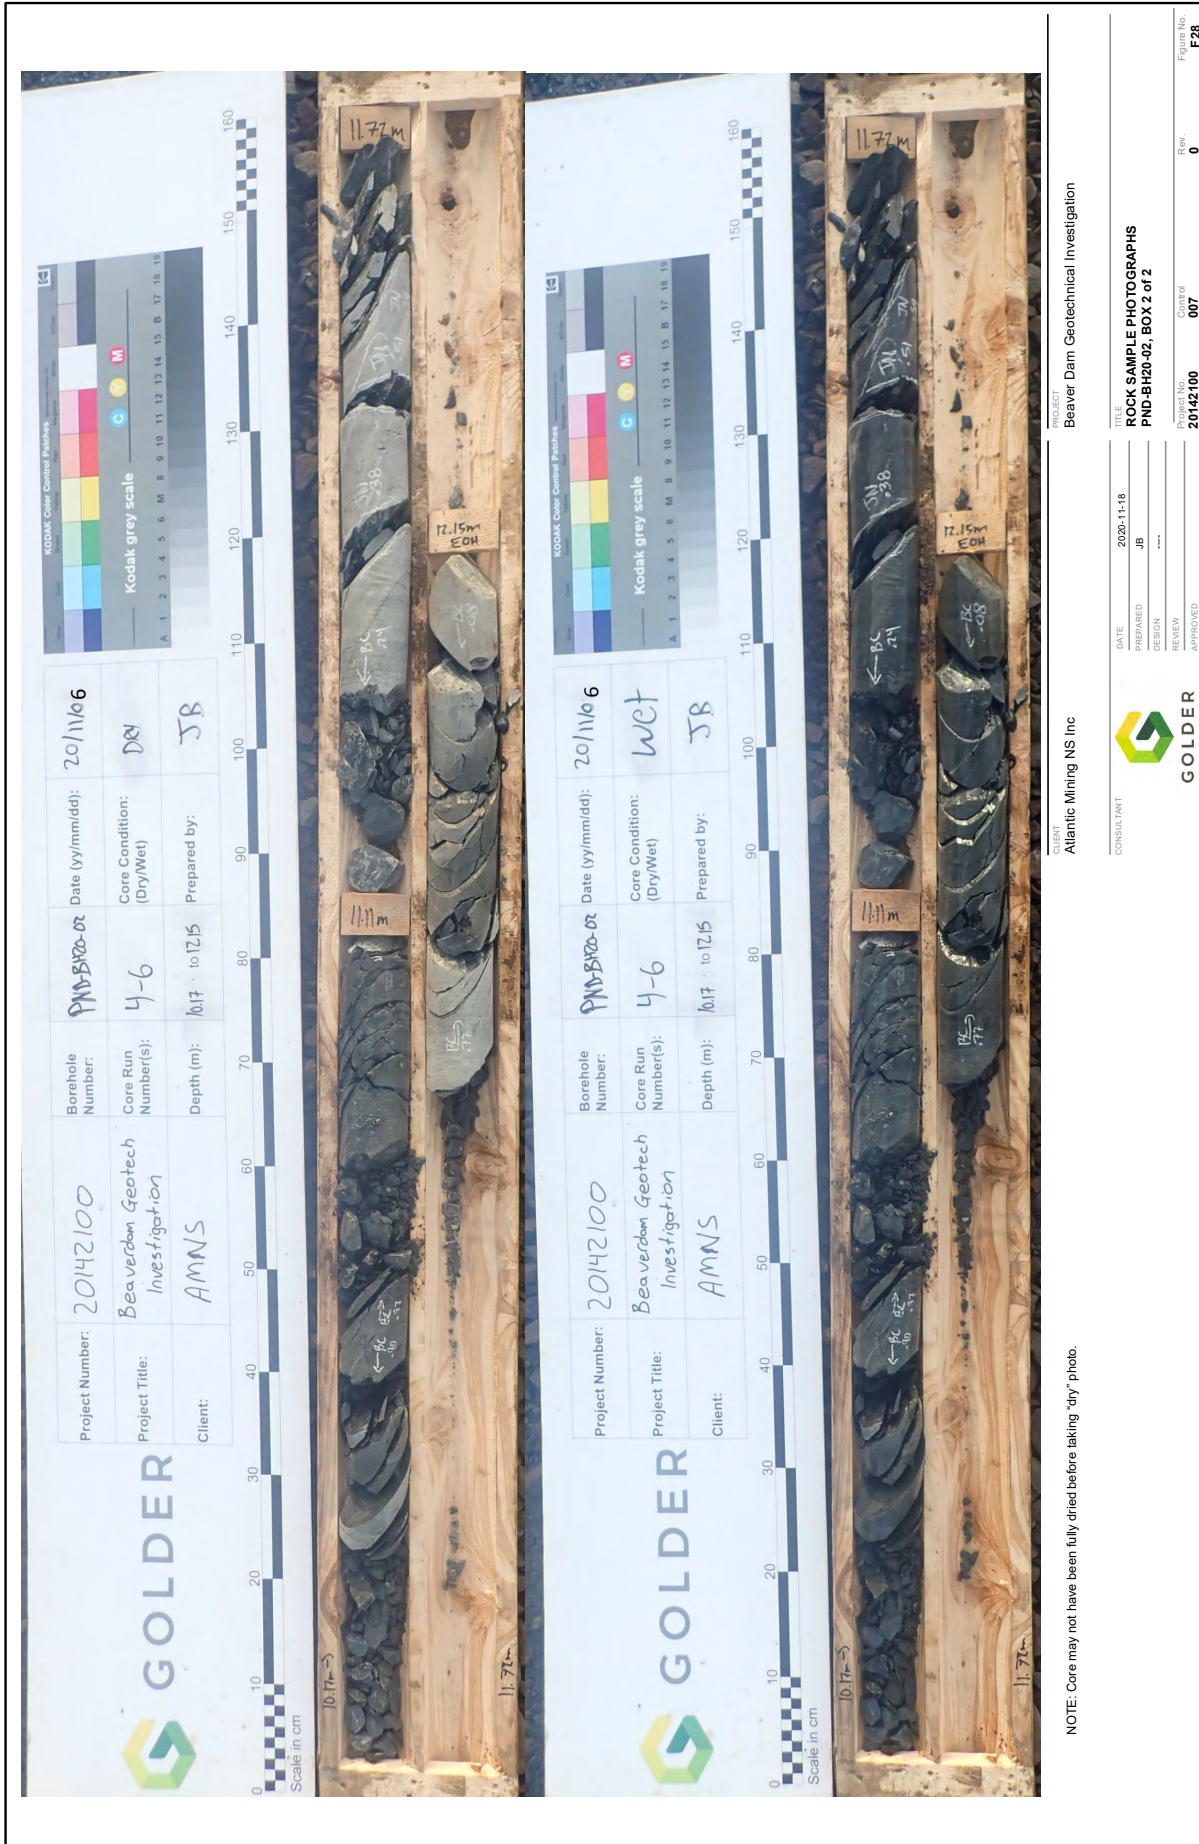
Project Number:	20142100	Borehole Number:	PMB-B102-02	Date (yy/mm/dd):	20/11/06
Project Title:	Beaverdam Geotech Investigation	Core Run Number(s):	4-6	Core Condition: (Dry/Wet)	Dry
Client:	AMNS	Depth (m):	10.17 to 12.15	Prepared by:	JB

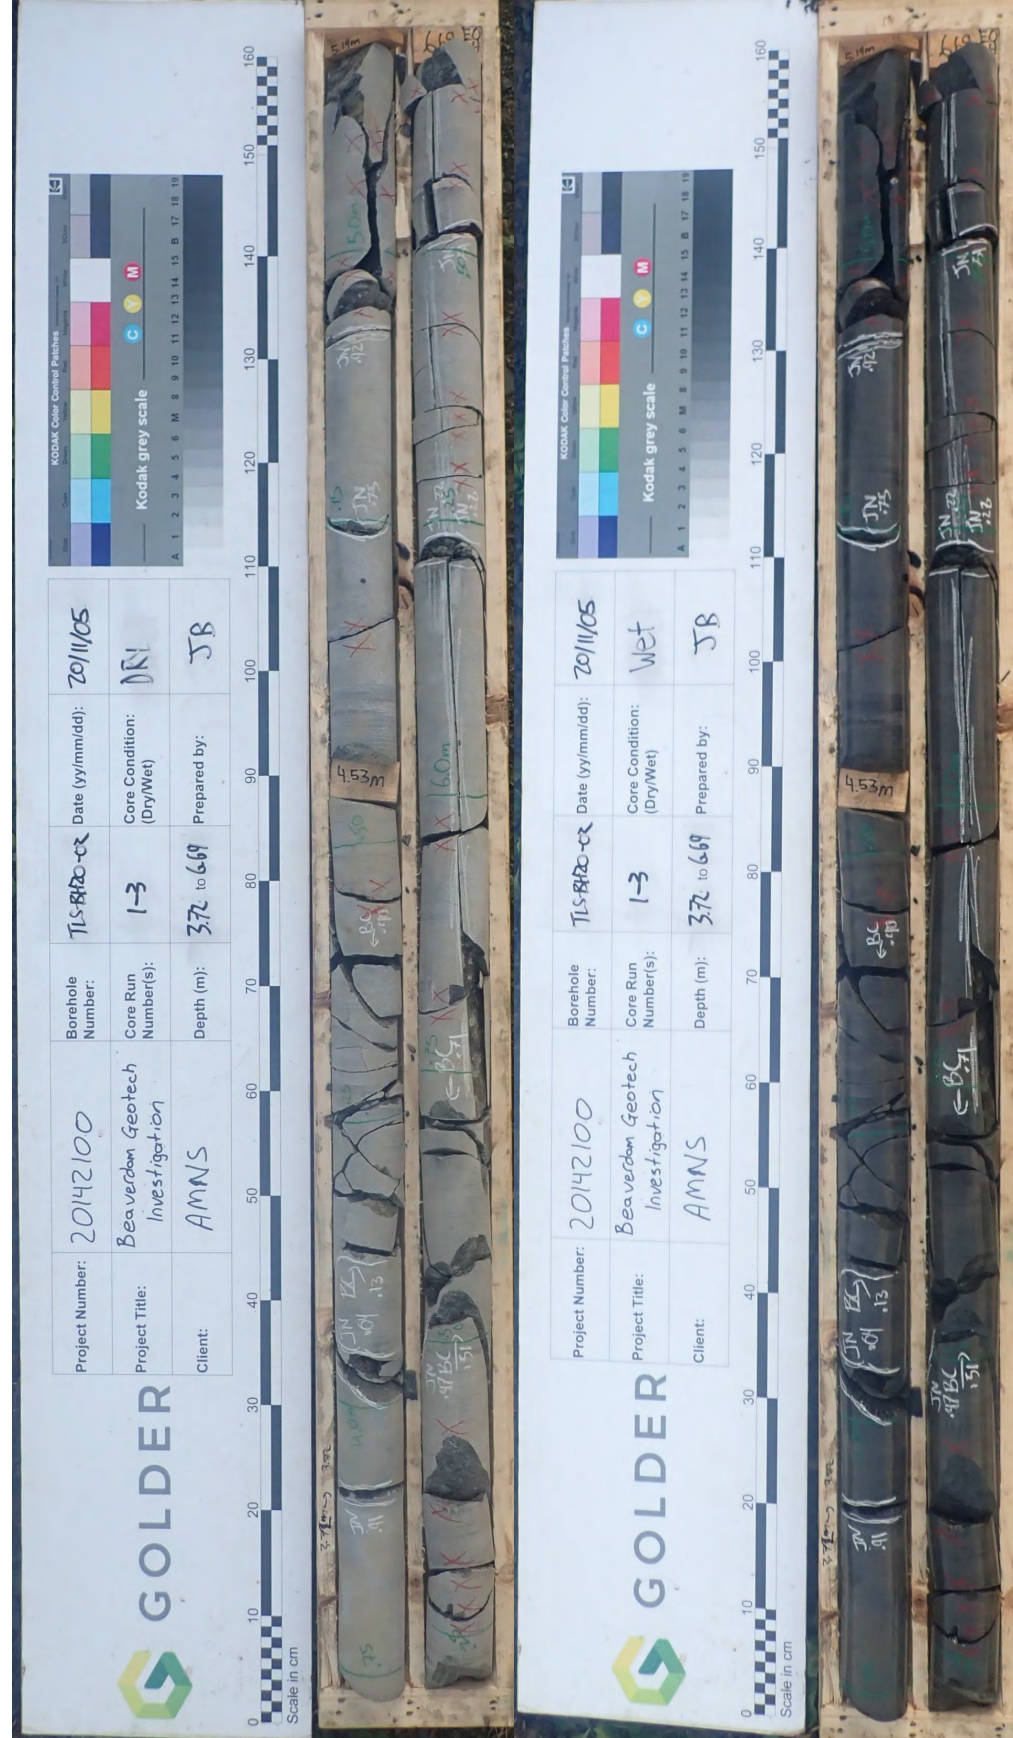
Project Number:	20142100	Borehole Number:	TLS-BH20-CR	Date (yy/mm/dd):	20/11/05
Project Title:	Beaverdam Geotech Investigation	Core Run Number(s):	1-3	Core Condition: (Dry/Wet)	DRY
Client:	AMNS	Depth (m):	37.2 to 66.9	Prepared by:	JB

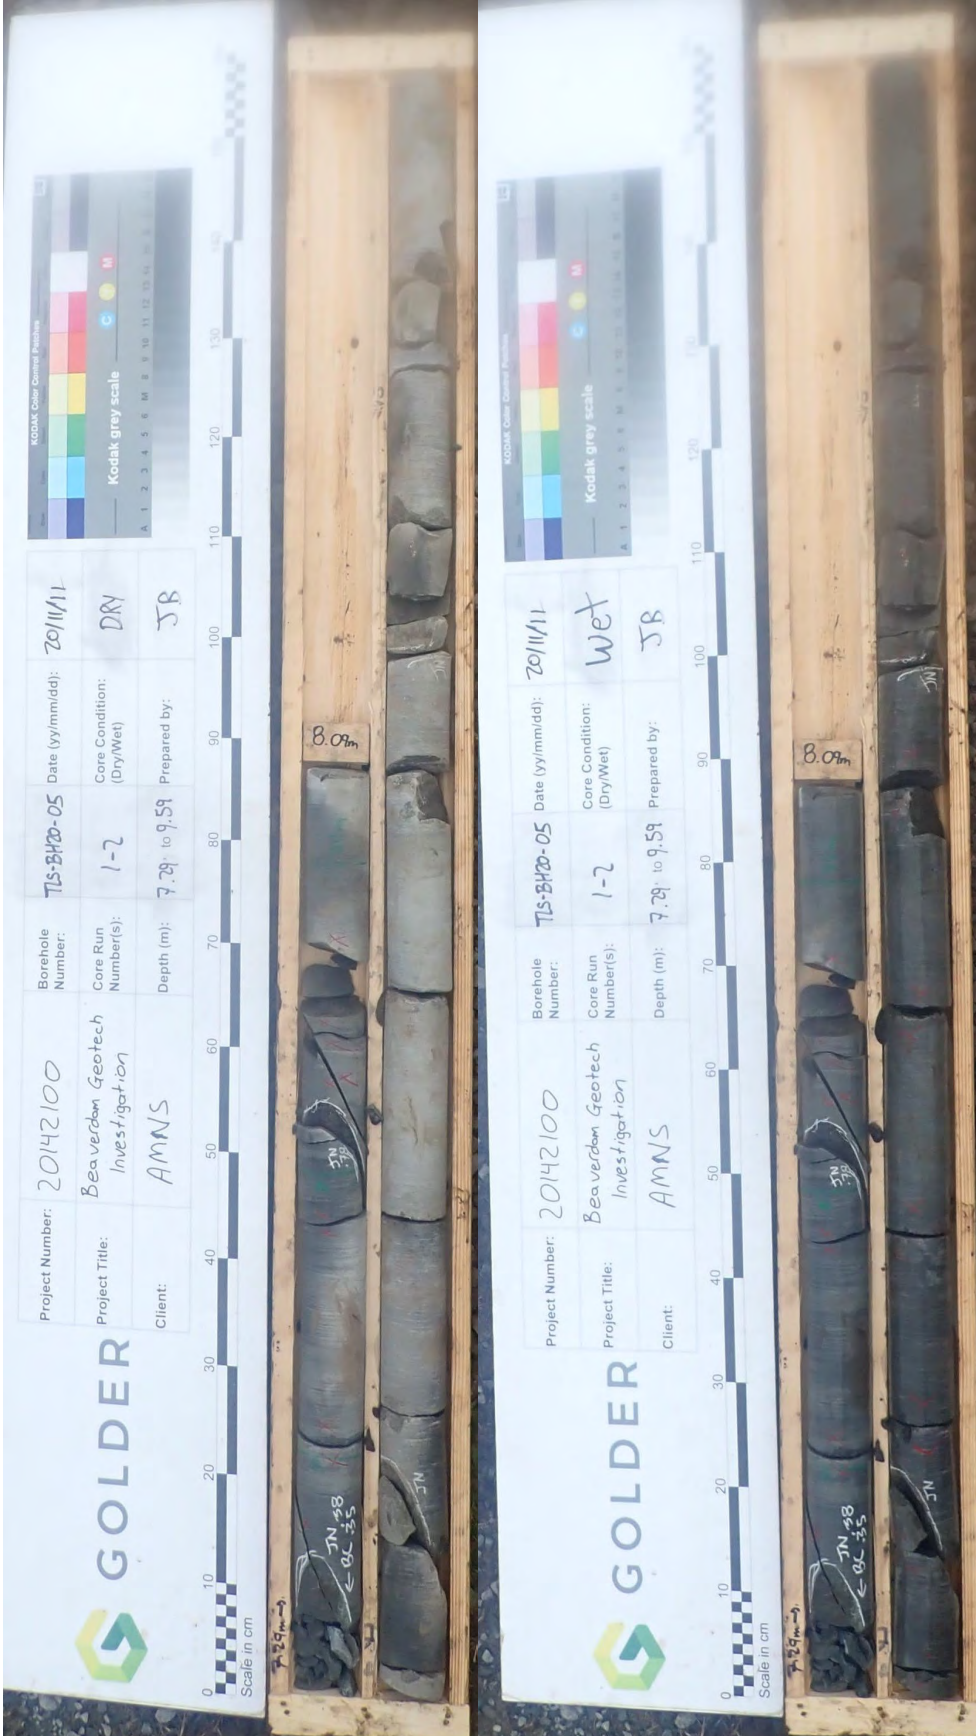
Project Number:	20142100	Borehole Number:	TLS-BH20-05	Date (yy/mm/dd):	20/11/11
Project Title:	Beaverdam Geotech Investigation	Core Run Number(s):	1-2	Core Condition: (Dry/Wet)	DRY
Client:	AMNS	Depth (m):	7.29 to 9.59	Prepared by:	JB

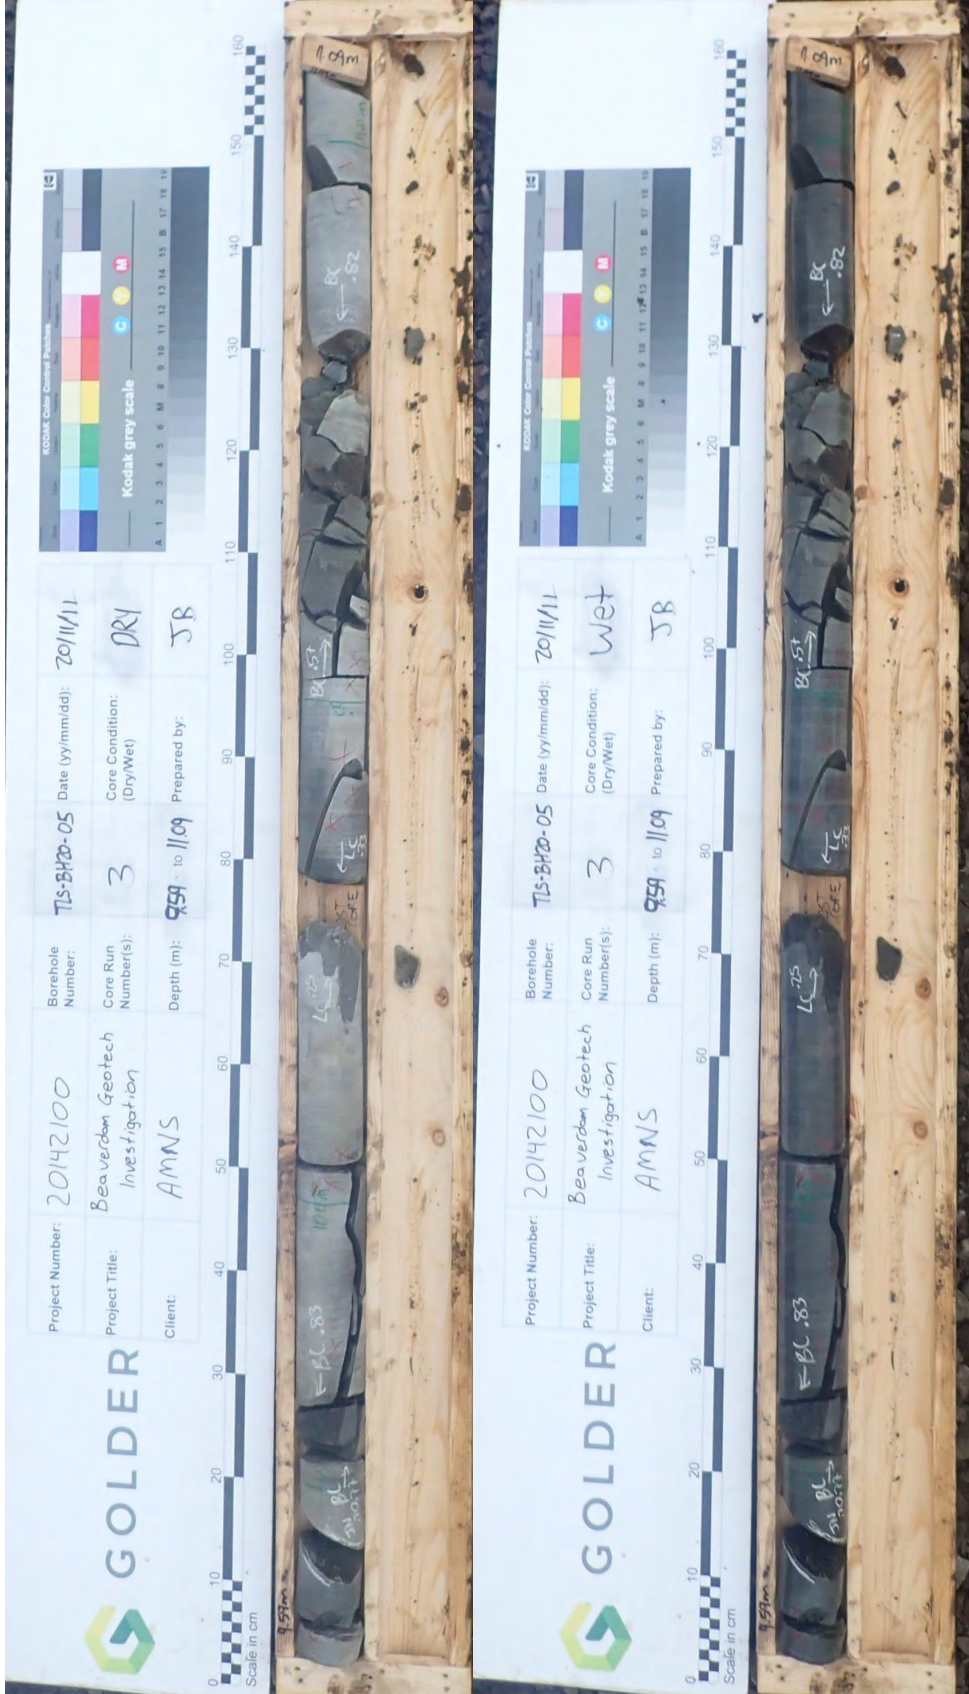
Project Number: 20142100  
 Borehole Number: T1S-BH20-05  
 Date (yy/mm/dd): 20/11/11  
 Project Title: Beaverdam Geotech Investigation  
 Core Run Number(s): 3  
 Core Condition: (Dry/Wet) DRY  
 Client: AMNS  
 Depth (m): 959 to 1109  
 Prepared by: JB
